Dryad, LLC

January 18, 2022

Re.: Tree inventory and evaluations. Project/Site: Downtown Library Project

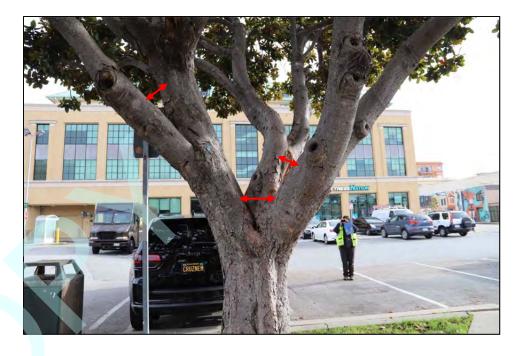
Above right: Codominant stems with weak, acute-angle

attachments.

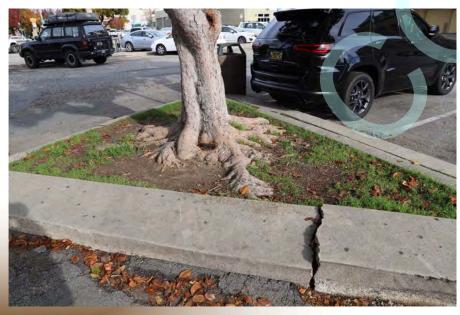
Below left: Restricted rooting area.

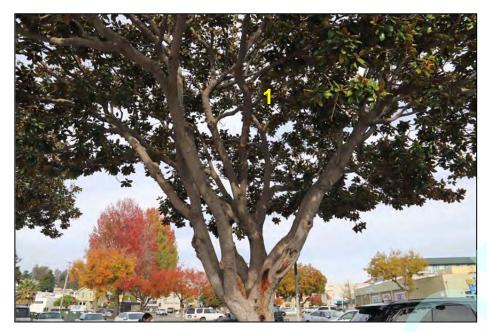
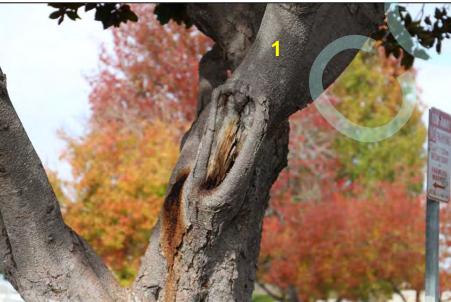
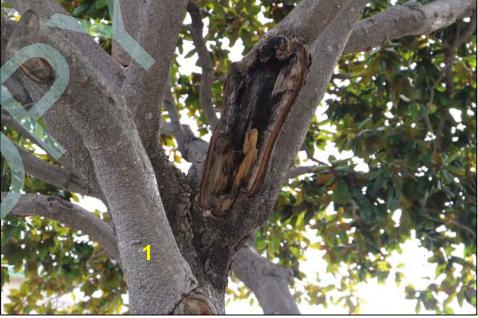
Left: Profuse acute-angle attachments, codominant limbs, lion-tail pruning, excessive thinning. Below right: Large decaying wound from limb failure. Below left: Decaying wound from past limb failure

and bacterial exudate.

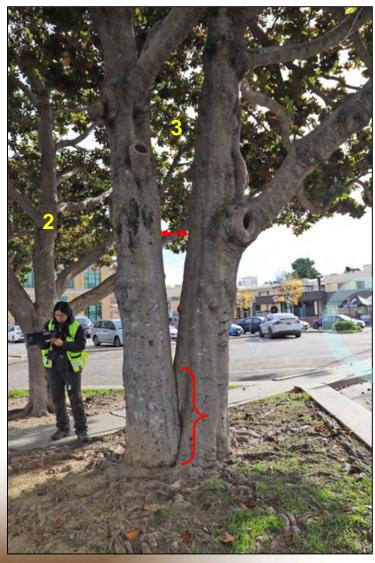
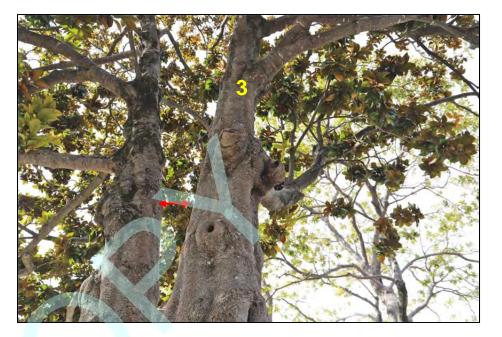
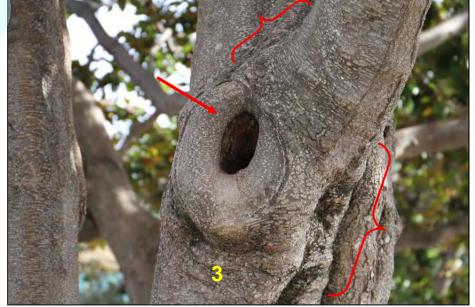
Below and above right: Codominant stems with acute-angle attachment.

Below right: Decayed flush cut and acute-angle

attachments.

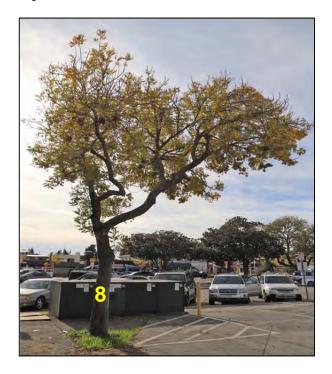
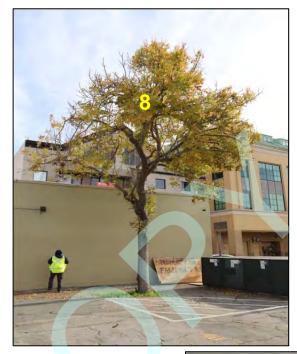
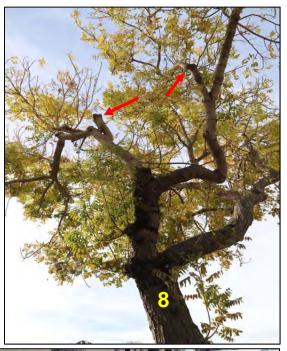
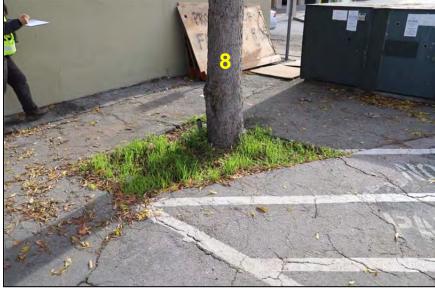
Above: Poor architecture, overpruning and restricted growing space.

Above right: Poor architecture, heading (topping) cuts.

Below right: Buried root collar and restricted growing space.

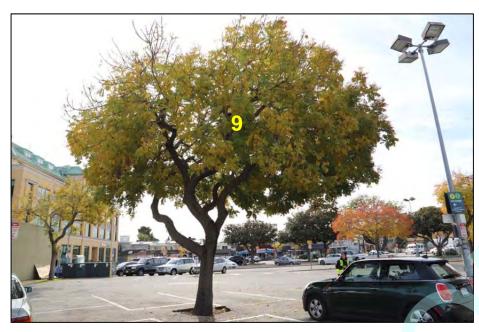
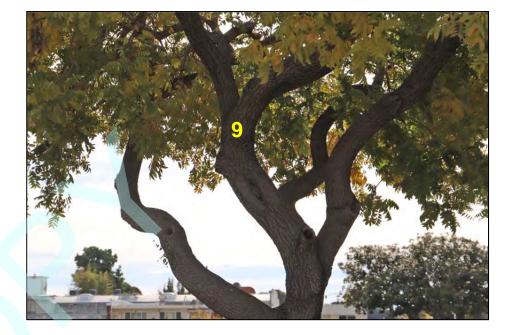
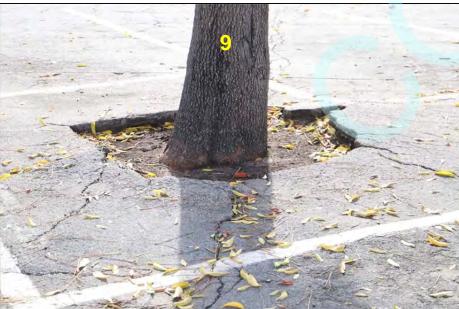
Above: Poor architecture, overpruning and restricted growing space.

Left: Buried root collar and restricted growing space.

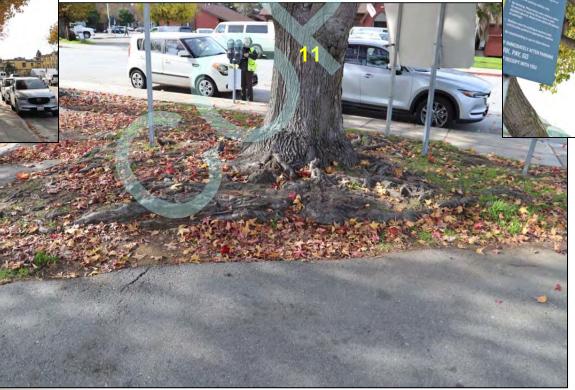
Right: Profuse acute-angle attachments, codominant limbs, lion-tail pruning, excessive thinning.

Below: Restricted growing space.

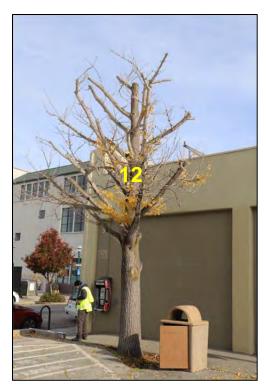
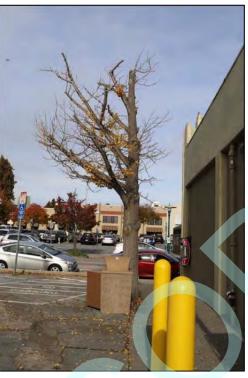
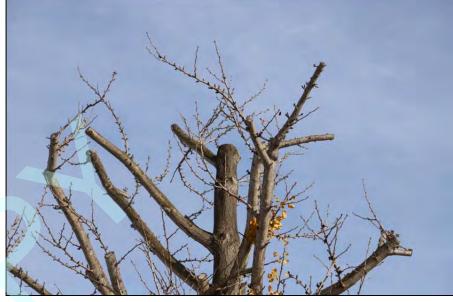
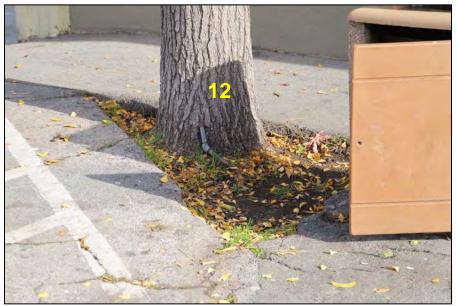
Above: Topped and headed throughout the canopy, all limbs removed on building side. Severe pruning has destroyed the structure and architecture of this tree. Right: Restricted growing space.
