A TREE RESOURCE ASSESSMENT AND PRELIMINARY RECOMMENDATIONS FOR TREE PRESERVATION  
CONCERNING THE PROPOSED SENIOR HOUSING DEVELOPMENT AT 126 EUCALYPTUS AVENUE  
SANTA CRUZ, CALIFORNIA

Site visit by:  
Nigel Belton – ISA Certified Arborist WE-0410A  
July 8, 2020

Job – The Watermark at Santa Cruz – 7.24.20

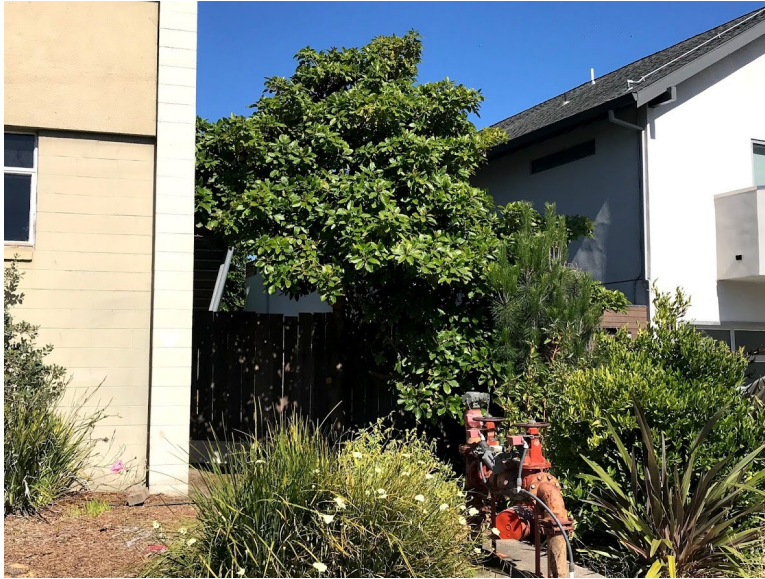
### **Tree #1 – 7-inch DBH Avocado (*Persea americana*):**

This healthy tree will need to be removed because it is located within the proposed construction footprint.

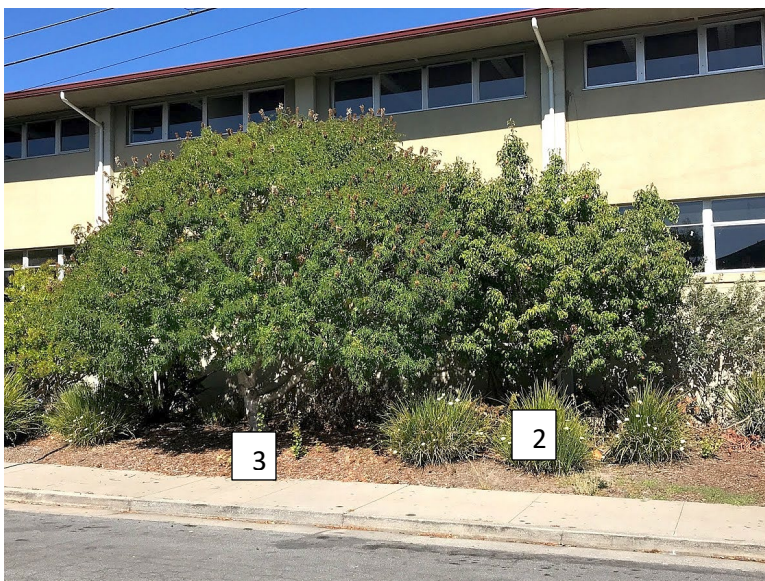
### **Tree #3 – 4.5, 4.5, 4 & 4-inch DBH California Buckeye (*Aesculus californica*):**

Both of these trees merit preservation based upon their health and structural condition ratings. The California Buckeye is a good specimen.

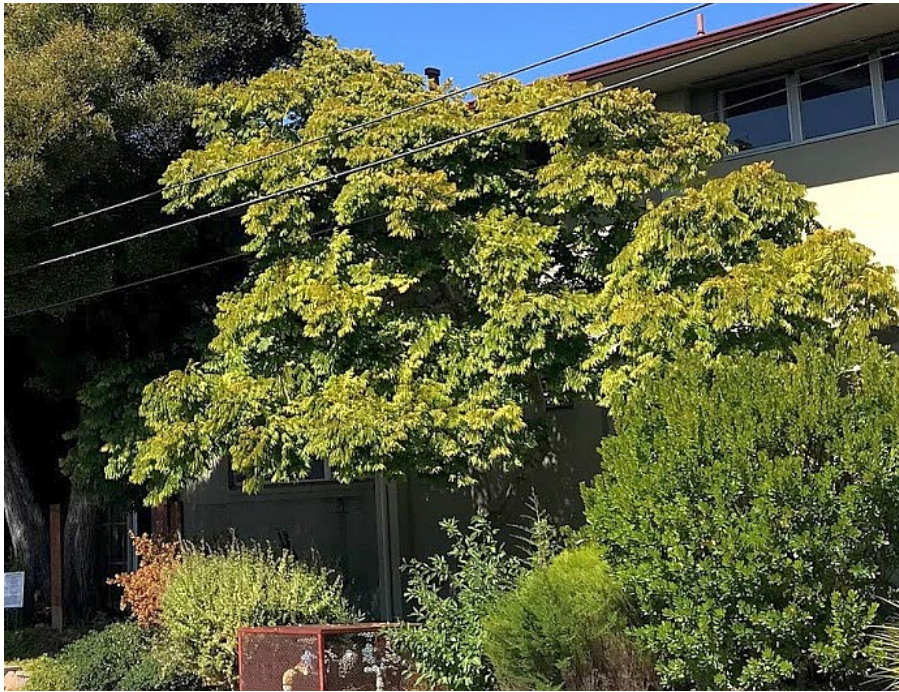
Tree #4 – 11-inch DBH Chinese Pistache (*Pistacia chinensis*):

This tree is suitable for preservation based upon its good health and structural condition rating.

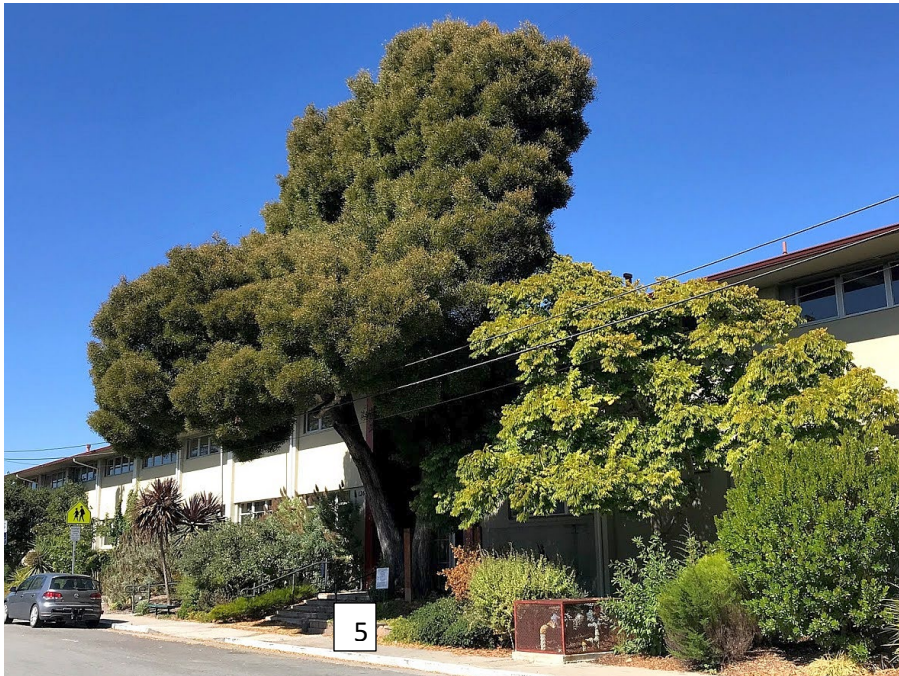
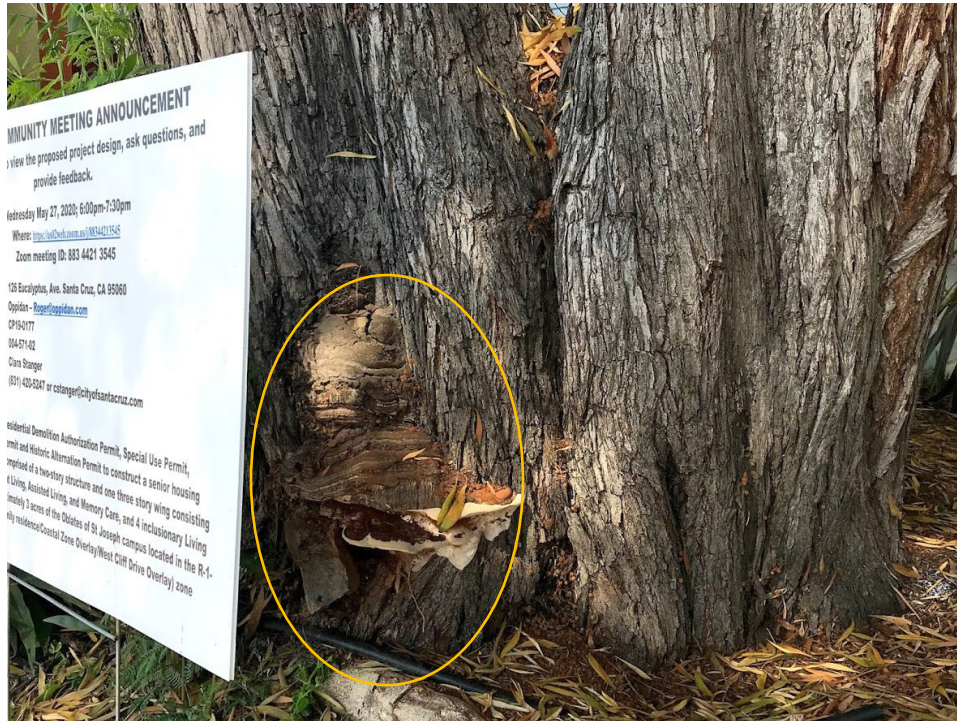
Tree #5 – 20.5 & 25-inch DBH Black Acacia (*Acacia melanoxylon*):

This tree exhibits good health and vitality but it has a very poor structural condition as a result of the fungal decay in the base of the two codominant trunks and within the proximity of their area of attachment to the stump. I identified the fruiting bodies of the Western Artist's Conk Fungus (*Ganoderma brownii*), on the west facing side of one of the trunks.

This tree is vulnerable to falling into Eucalyptus Avenue and it represents a significant potential hazard to life and property at this time. I recommend that this Black Acacia is removed as soon as possible in order to abate this potential hazard (a permit will be required for the removal of this protected Heritage Tree).

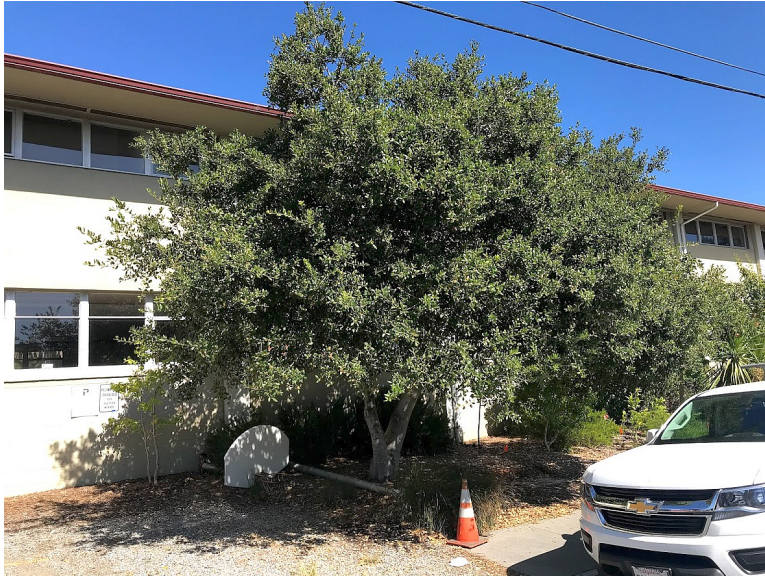
Tree #7 – 10 & 6.5-inch DBH Coast Live Oak (*Quercus agrifolia*):

This oak exhibit's good health and vitality and it is suitable for preservation and protection during the development period.

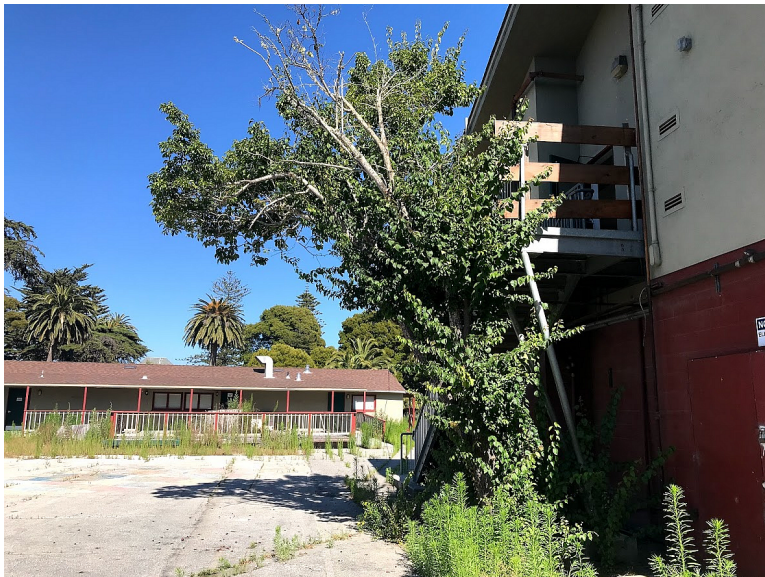
Tree #8 – 14.5-inch DBH Wild Plum (*Prunus spp.*):

This tree is located at the north end of the main classroom building. The plum is not suitable for preservation due to its poor health and structural condition ratings (I observed a dieback pattern in the upper canopy). Note that this tree qualifies as a protected Heritage tree (its trunk is greater than 14-inches diameter when measured at 54-inches above ground).

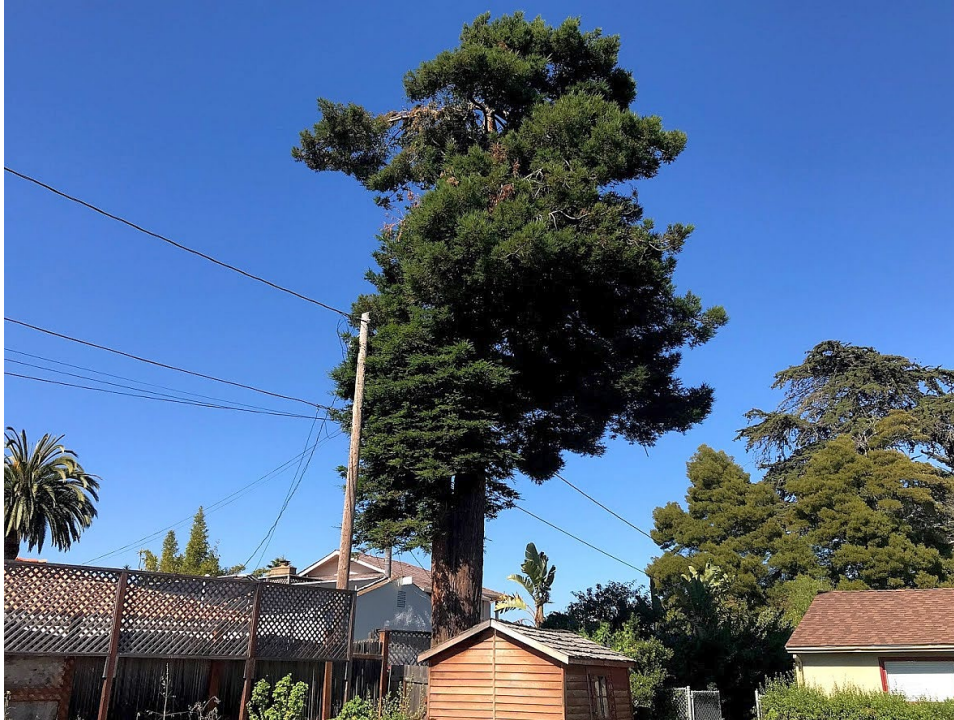
Tree #9 – 42-inch DBH Coast Redwood (*Sequoia sempervirens*):

The topographic map shows that the trunk of this large tree transects the north property boundary. The redwood effectively belongs to both property owners. It is suitable for preservation based upon its overall health and vitality. The tree has a poor structural condition because of its codominant growth pattern (it divides into two trunks which share a relatively weak area of attachment) and the development of a broad canopy with a heavy limb structure. The broad canopy developed as a result of the top being removed or because its apical growth was suppressed by the influence of salt laden winds from the ocean. I understand that a large limb recently fell into the adjacent property.

I noted that the preliminary development plan shows that the trunk of this tree will be situated within close proximity to the proposed building footprint in the northwest corner of the project site. Care will have to be taken during the design and construction phases of this project in order to preserve and protect as much of the Critical Root Zone area as possible (The CRZ is defined as the area within the tree canopy drip-line and it can also be calculated by a utilizing a factor of the trunk diameter).

I recommend that this protected Heritage Tree is preserved and that it is pruned to improve its structure and reduce the risk of limb failures. The heavy and overextended limb structure must be reduced in length and the width of the canopy reduced and shaped at the same time. These actions should effectively reduce the risk of limb failures occurring during strong winds and in storm conditions. Larger dead wood (over 1-inches diameter) and crossing limbs must also be removed at the same time. This work must be undertaken by a competent tree service provider and under the supervision of an ISA Certified Arborist (see that attached list of recommended tree service providers).

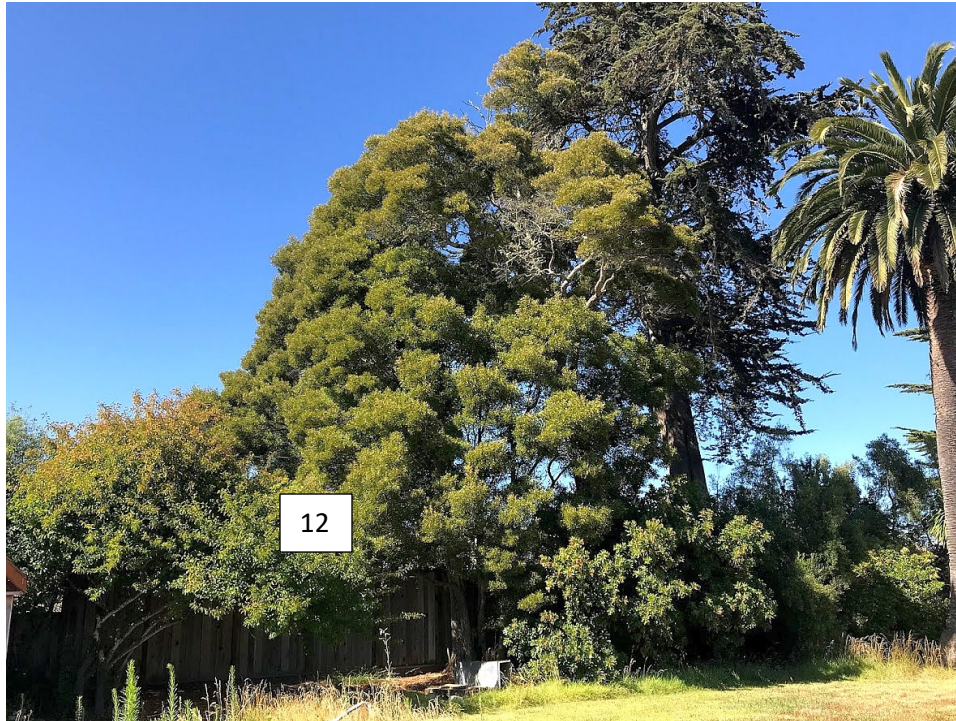
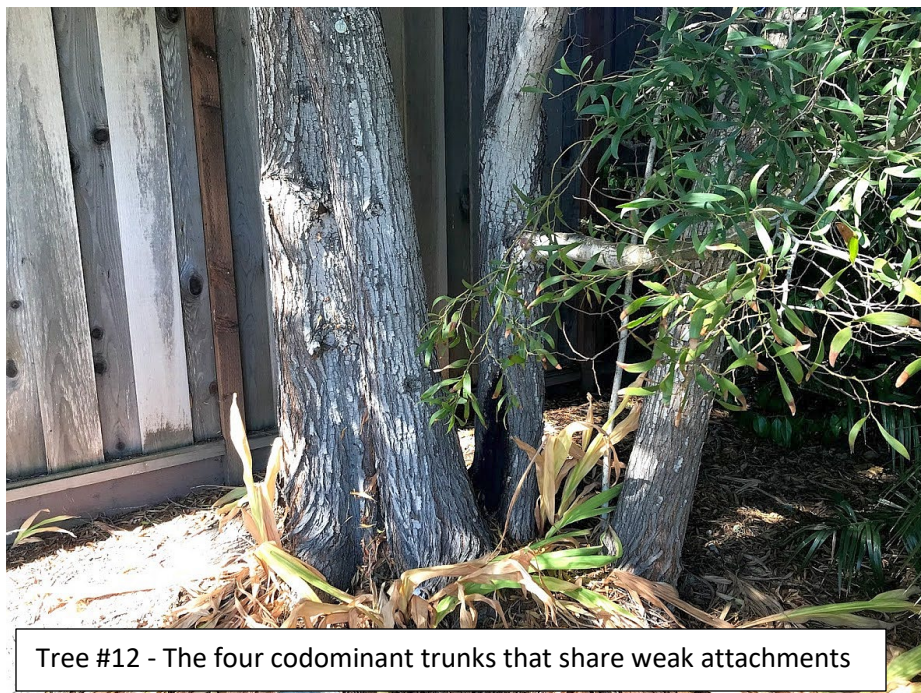
Tree #12 – 11, 9, 8 & 9.5-inch DBH Black Acacia:

This acacia exhibits good health and vitality.

The tree has a poor structural condition due to the development of a codominant structure comprising of four separate trunks. The trunks are weakly attached to each other they are more vulnerable to splitting apart during storm conditions.

I determined that this tree is suitable for preservation despite its poor structural condition (which cannot be effectively mitigated by the installation of support cables). I recommend that it is preserved because of its location in the landscape. It will be setback from the closest building shown on the preliminary site plan.

I recommend that the tree is pruned to remove dead and crossing branches.

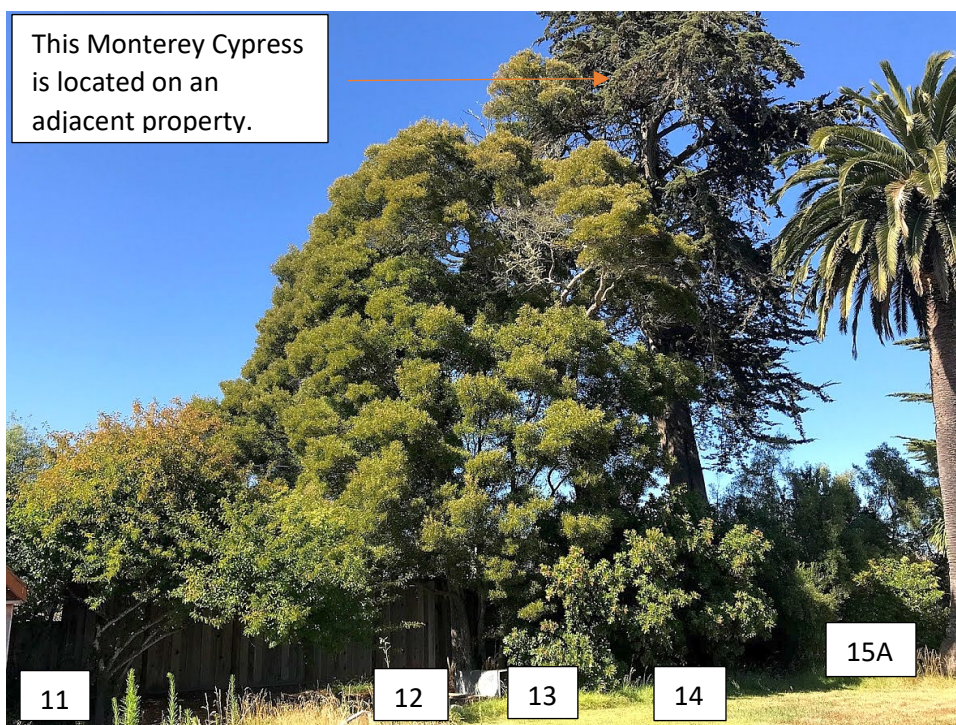
Tree #13 – 27-inch DBH Black Acacia:

This acacia exhibits fair health and vitality.

This tree has a poor structural condition due to the development of a weak codominant growth pattern, comprising of two secondary trunks at about five-feet above ground. The narrow area of attachment in between these secondary trunks is vulnerable to failing because of an extensive area of trapped bark in this area which is a significant structural defect. The tree is vulnerable to splitting apart at this time. This failure pattern will most likely occur in storm conditions when strong winds are present.

I recommend that this tree is preserved at this time, despite its poor structural condition and the elevated risk of it failing. I recommend that a support cable must be installed in between the two codominant trunks. The galvanized steel cable must comprise of 5/16-inch EHS Grade material and it must be attached to 5/8 through rods or cable end stops (not J-Lags). The tree must also be pruned to remove larger dead wood and the weight in the ends of any heavy and overextended needs to be reduced at the same time.

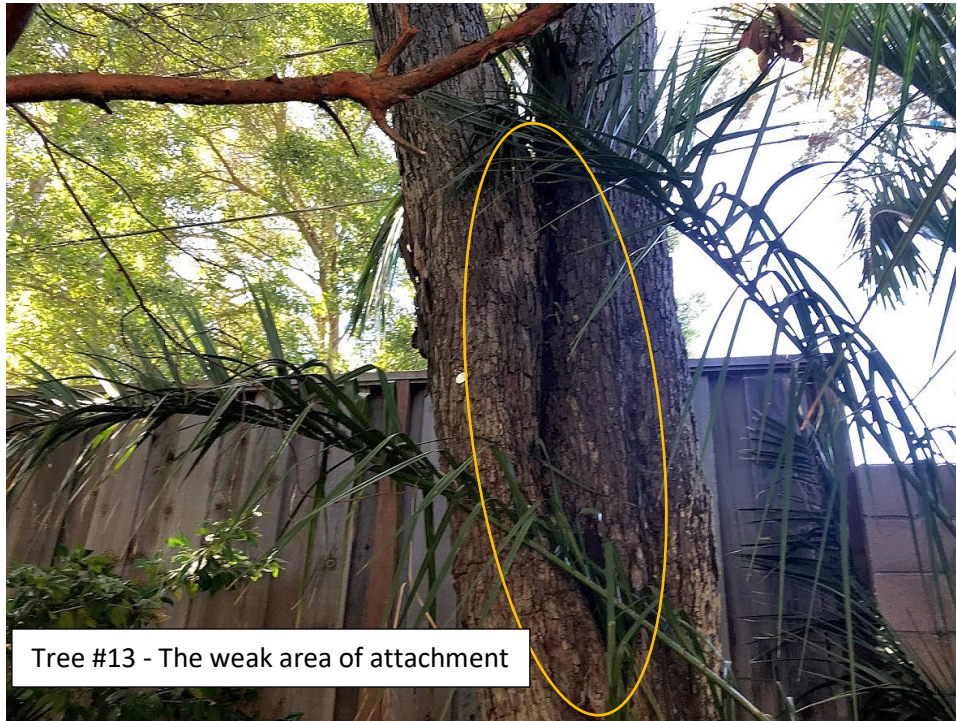
Tree #13 - The weak area of attachment

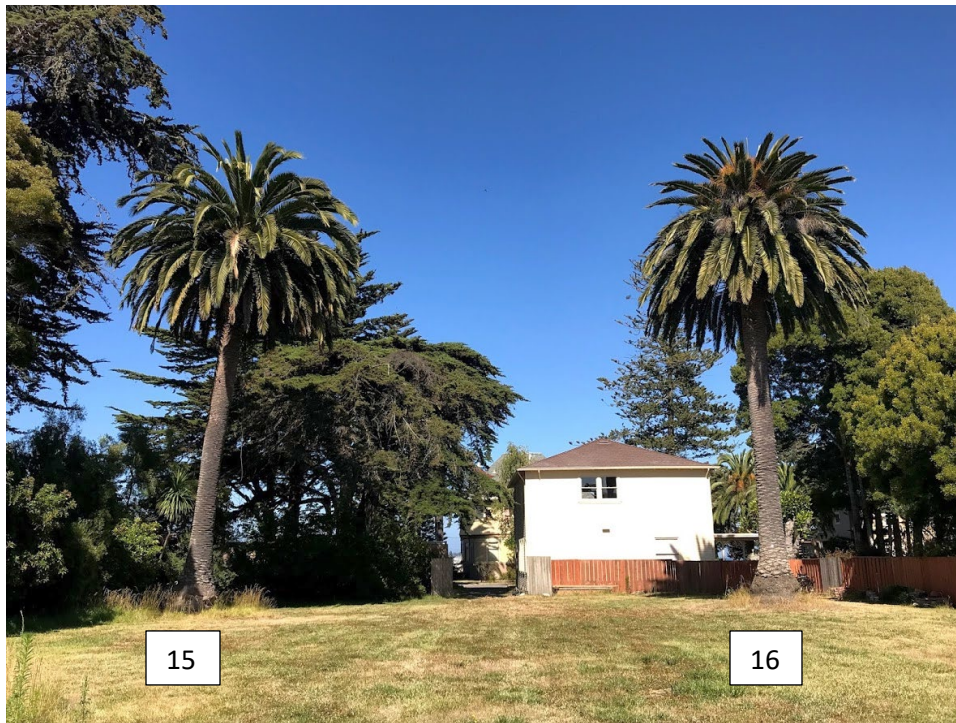
Tree #15 – 45-inch DBH Canary Island Date Palm (*Phoenix canariensis*):

This Heritage Tree is suitable for preservation and it must be protected during the construction period.

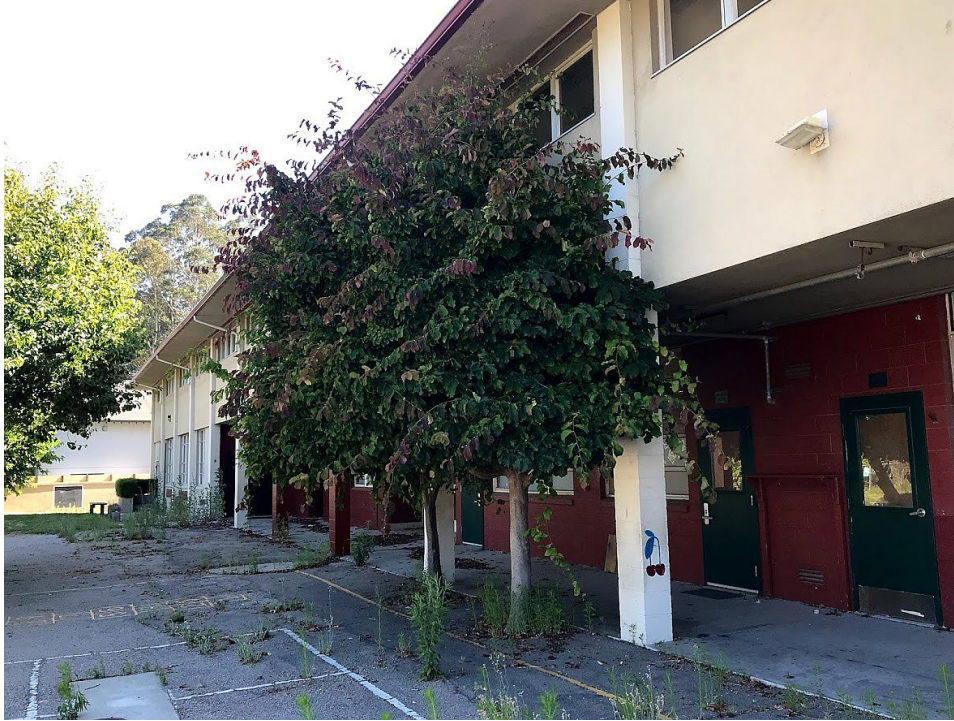
These trees are suitable for preservation based upon their good condition ratings. They will have to be removed because of their locations within the proposed construction footprint.

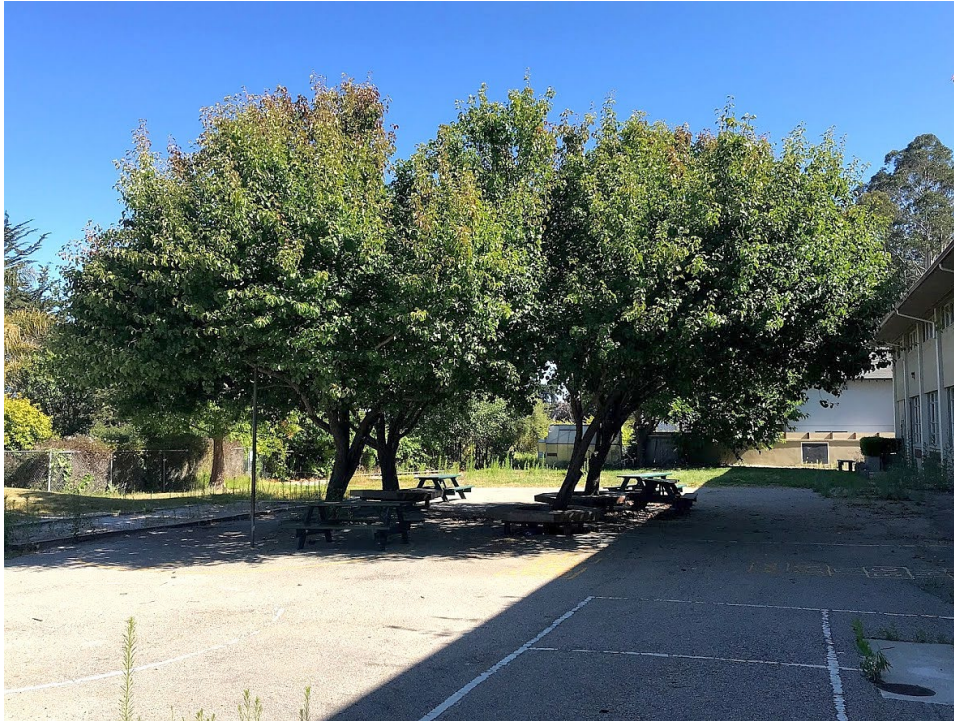
These pears are suitable for preservation based upon their good health condition ratings. The trees have poor structural conditions but can be pruned and strengthened by the installation support systems to improve their structural conditions. I observed that the tree's roots are damaging the surrounding asphalt surfaces.

These trees will likely need to be removed to facilitate the proposed development and landscape improvements as shown on the attached preliminary plan. In the event that they are to be preserved, they must be protected during the design and construction phases of this project (note that the root growth of these trees will not be compatible with the installation of any paved surfaces within their canopy drip-lines).

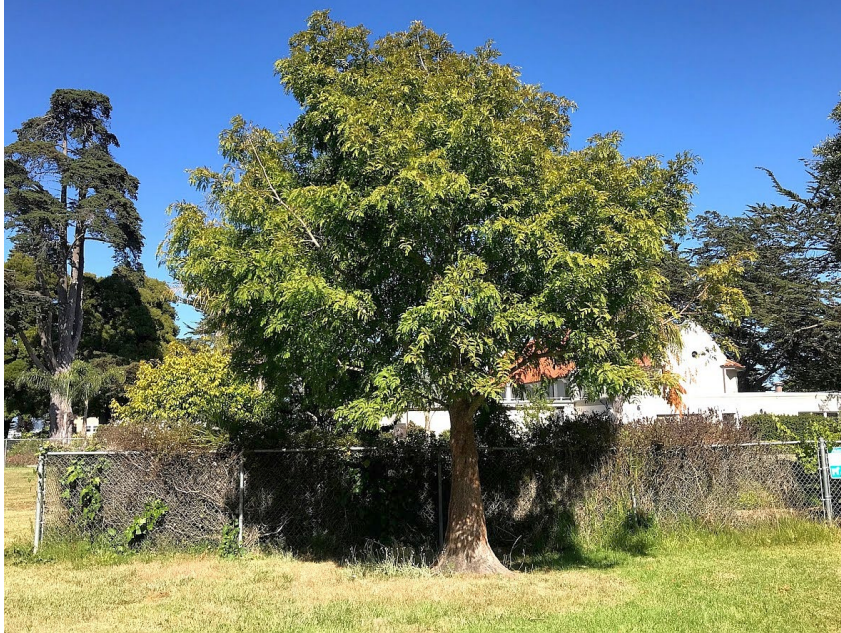
Tree #23 – 12.5-inch DBH Dawn Redwood (*Metasequoia glyptostroboides*):

This tree is suitable for preservation based upon its condition ratings. The tree will likely have to be removed because of its location within the proposed construction footprint.

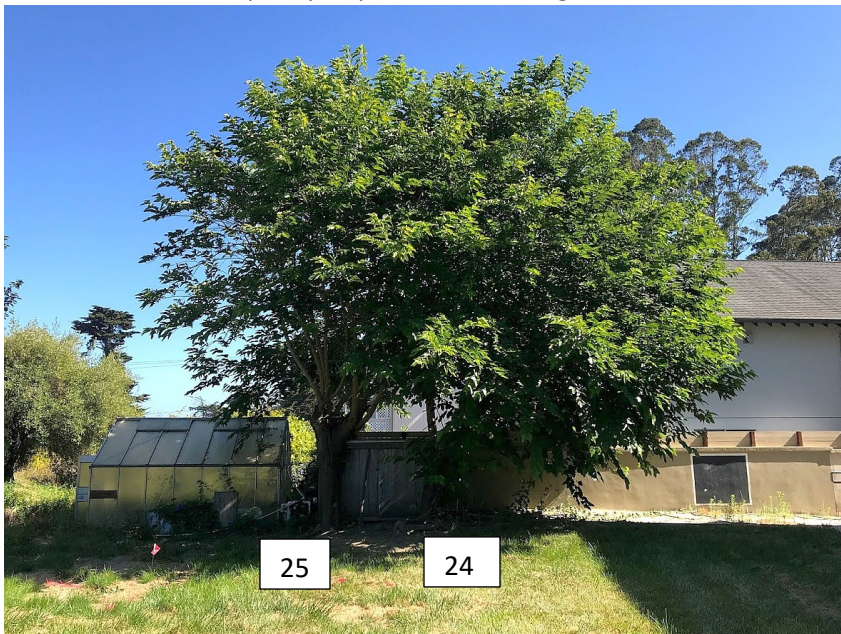
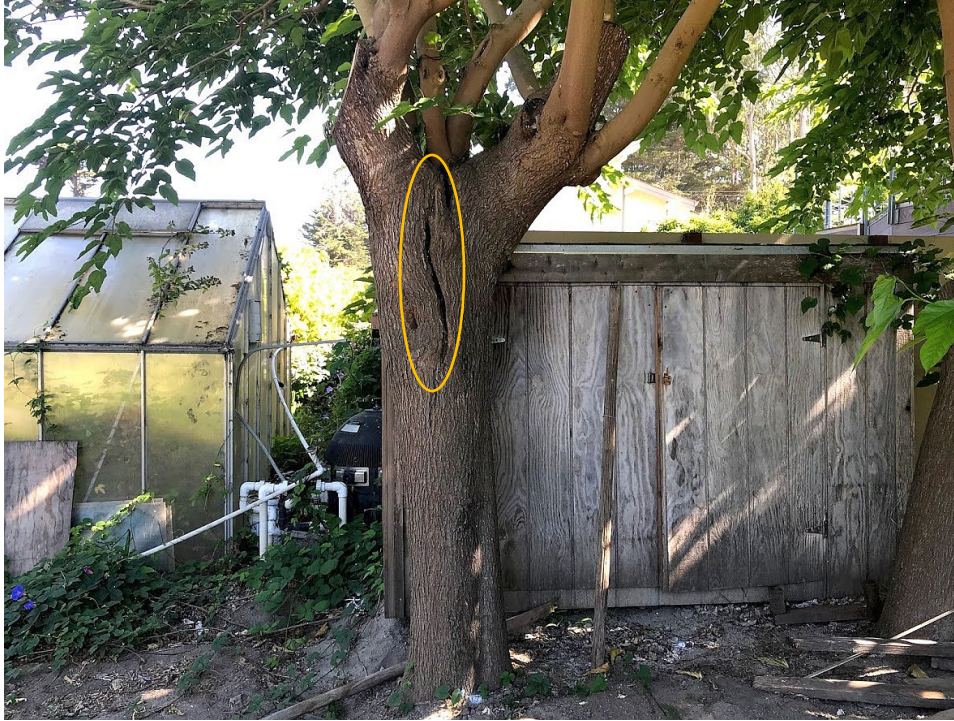
Both of these trees qualify as protected Heritage Trees.

Both of these trees are unsuitable for preservation because of their poor structural conditions and their weak growth patterns. Both trees were previously topped which resulted in the development of weakly attached limbs. These limbs will become increasingly vulnerable to failure over time. The large diameter topping cuts will also progressively decay over time. I observed several cavities on the trunk of Tree #25 which have resulted from an earlier structural crack and the presence of internal decay.

I recommend that these structurally compromised trees are removed and that they are replaced with different species as a component of the new landscape plan for this development.

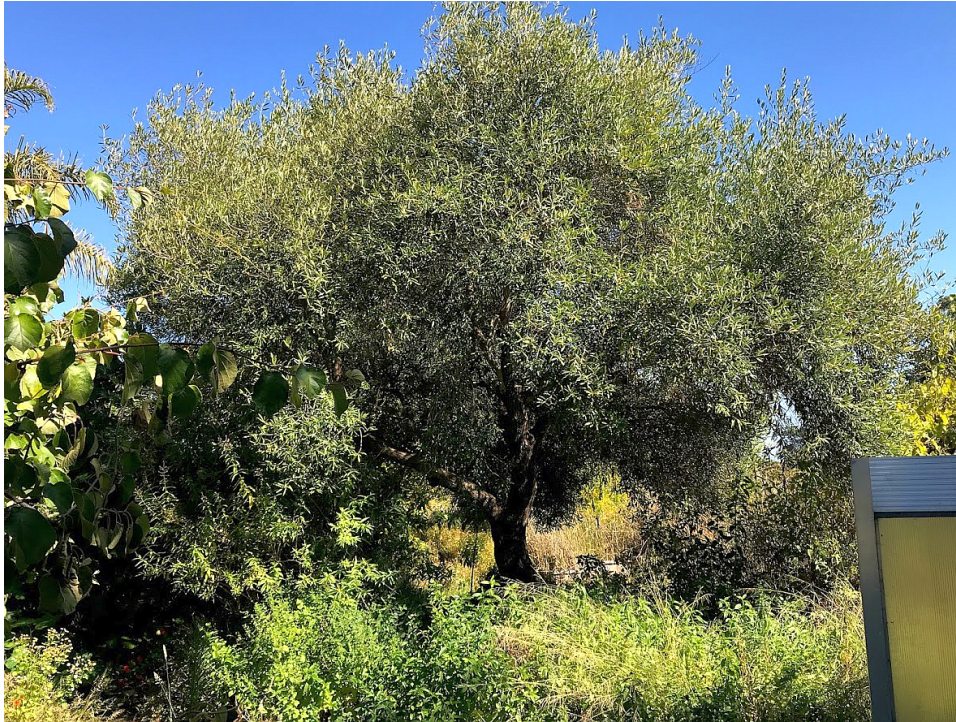
Tree #26 – 12-inch DBH European Olive:

This tree is suitable for preservation because of its good health and structural conditions. It is a good specimen.

The tree must be removed because of its location within the proposed parking lot footprint. The Olive is suitable for relocation to another area on the site.

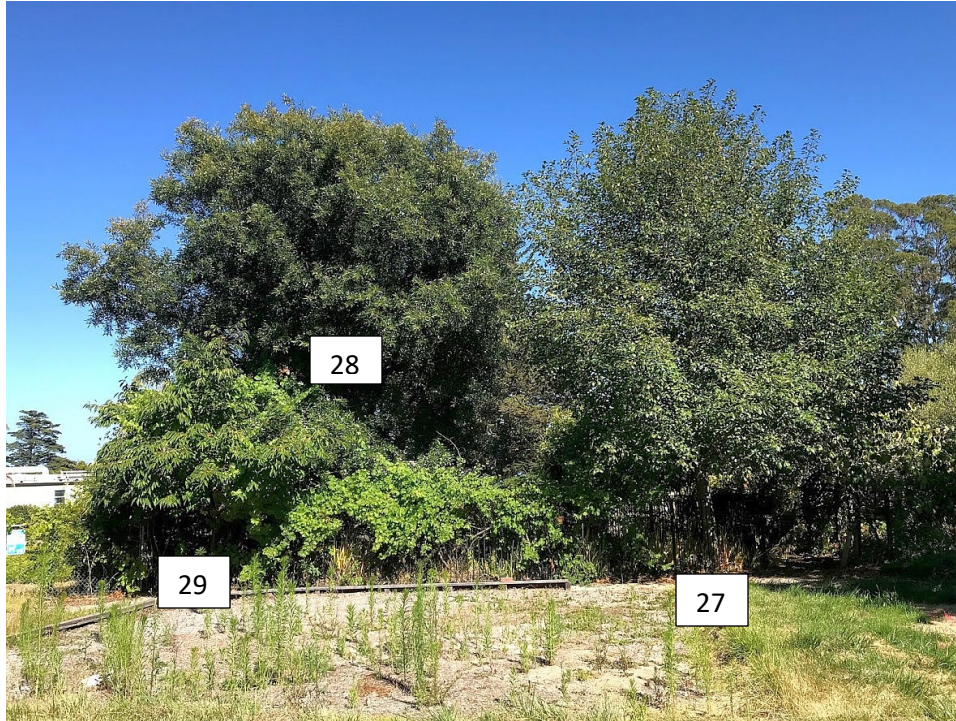
These trees are suitable for preservation because of their good overall condition ratings however they will have to be removed because of their locations within the proposed construction footprint.

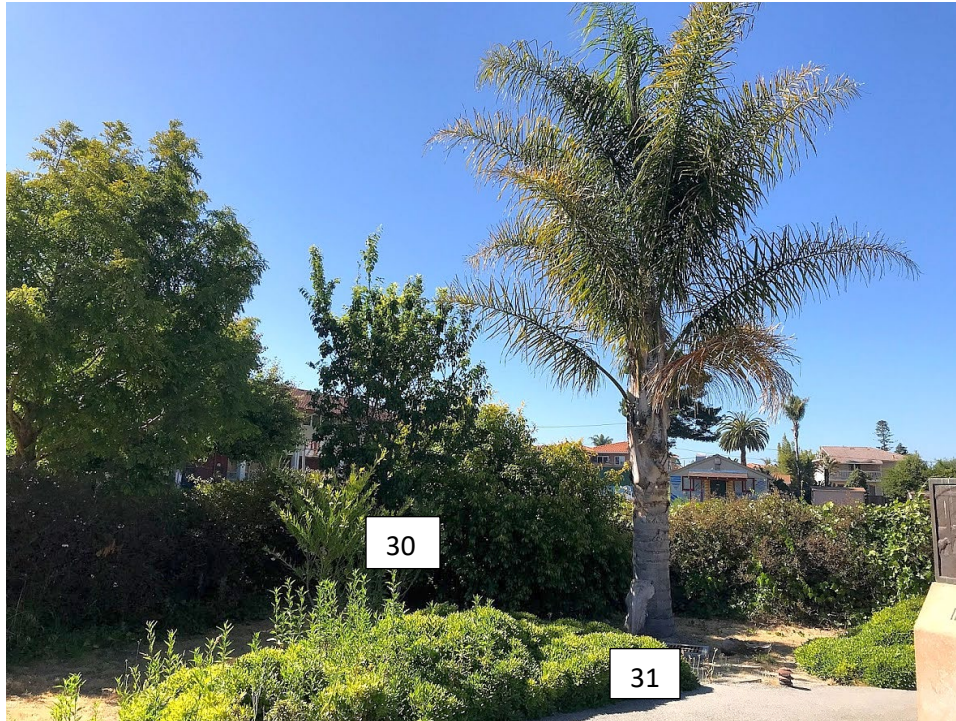
Both of these trees are suitable for preservation based upon their good overall condition ratings however they must be removed because of their locations within the proposed construction footprint. The Queen Palm qualifies as a protected Heritage Tree and its relocation elsewhere on the site is also an option.

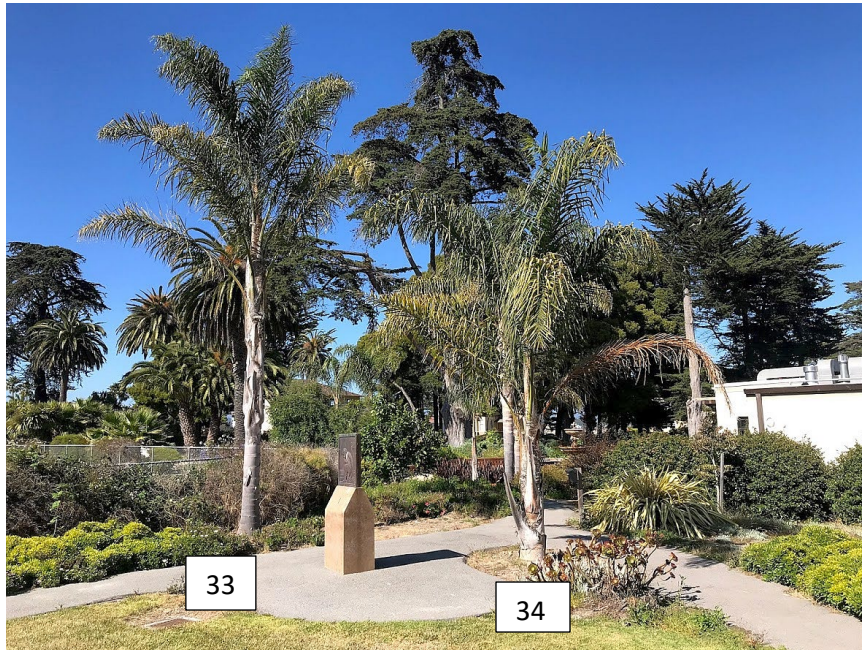
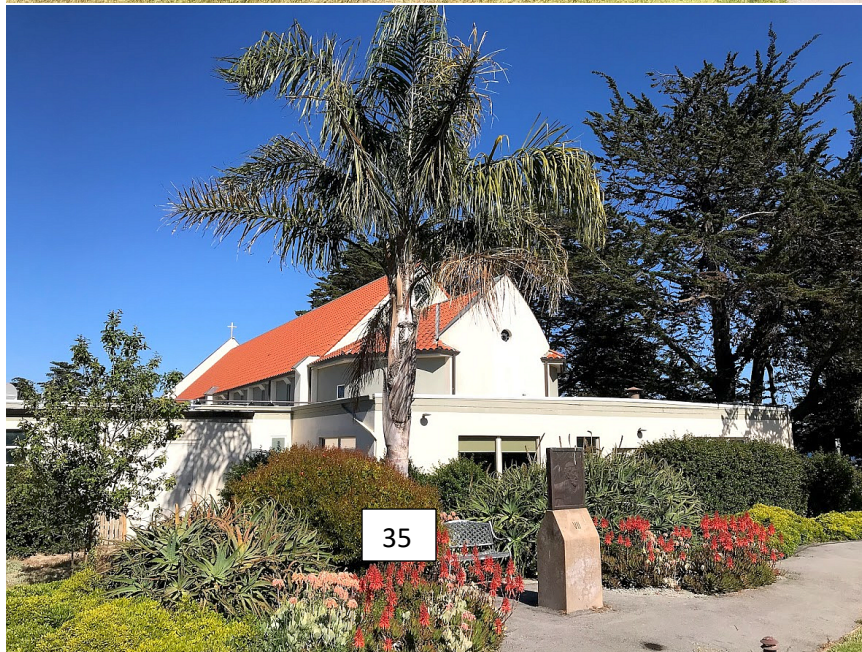
These palms are suitable for preservation because of their good overall condition ratings however they must be removed because they are located within the construction footprint (they could also be relocated to another site).

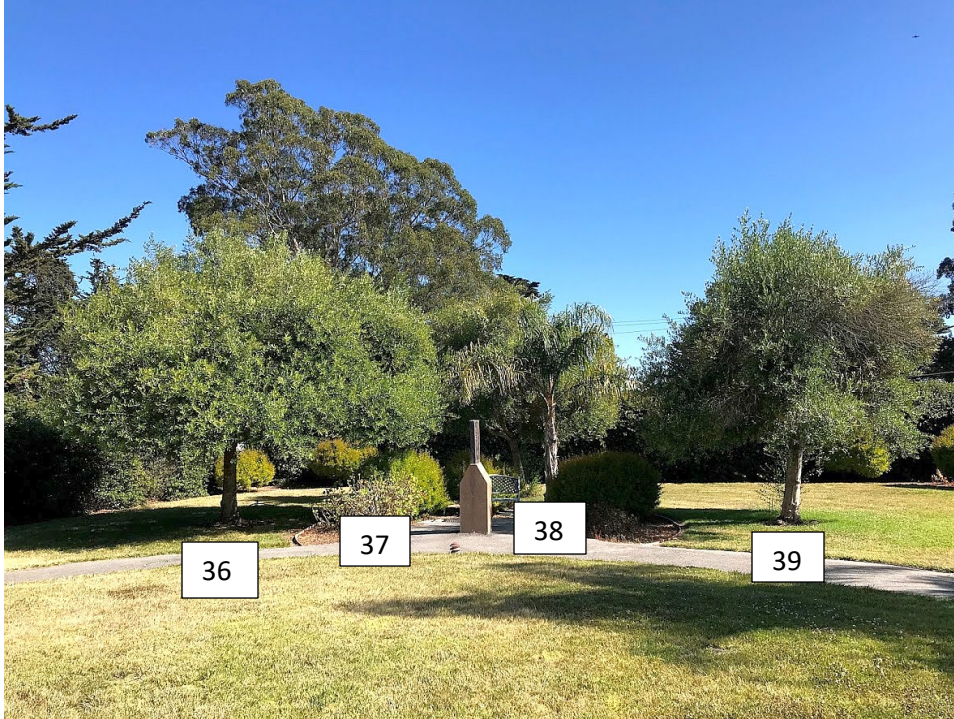
Tree #36 – 11-inch DBH European Olive:

This tree is suitable for preservation based upon its good condition rating. The tree must be removed because of its location within the proposed parking lot footprint. The relocation of this tree to another site is also an option.

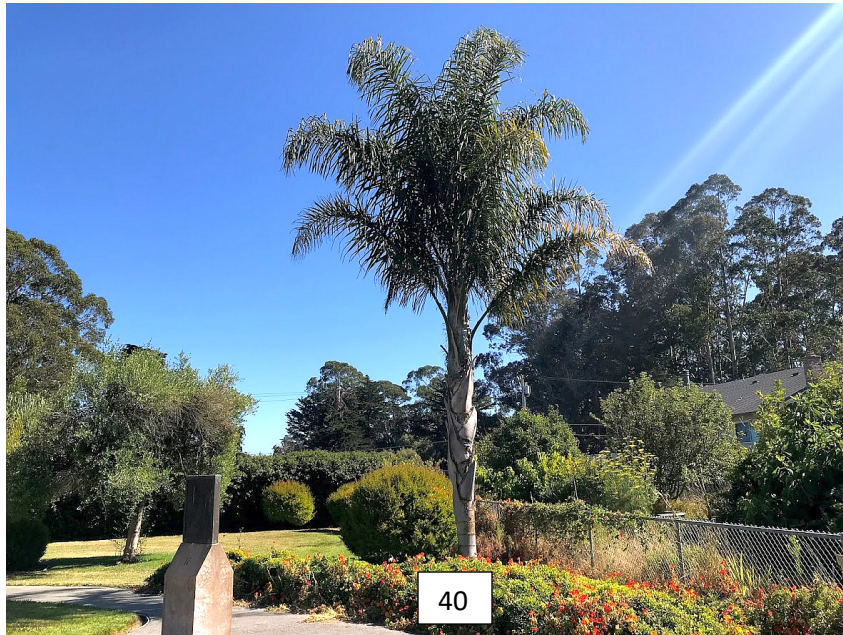
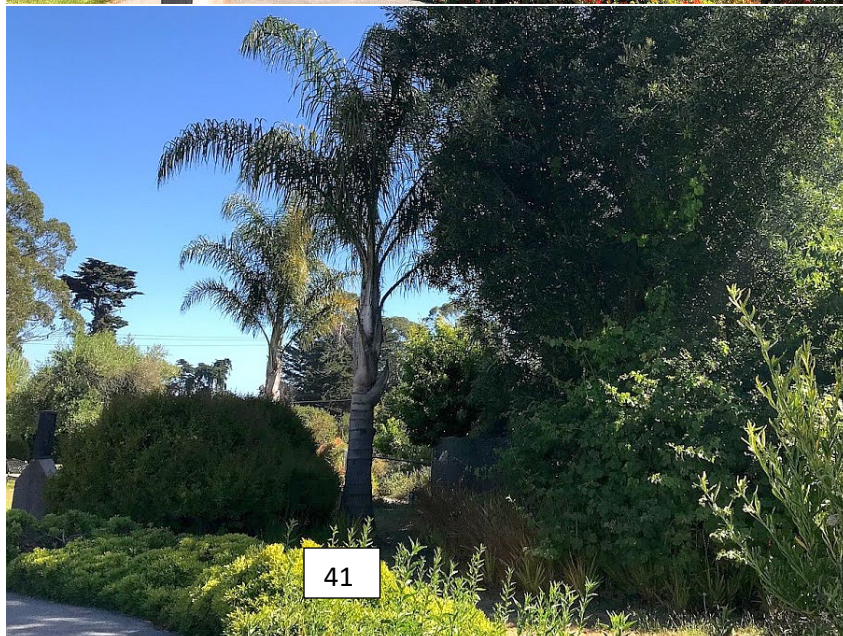
These trees are suitable for preservation based upon their good condition ratings. They must be removed or relocated because of their locations within the footprint of the proposed parking lot and construction area. Note that Tree #41 qualifies as a protected Heritage Tree.

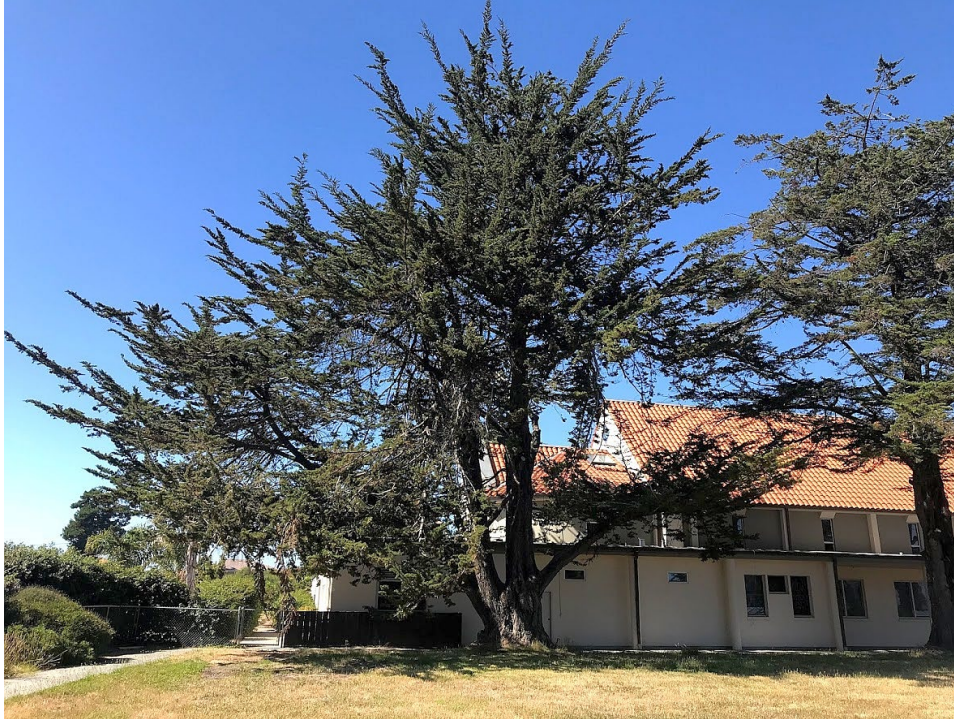
Tree #42 – Monterey Cypress (*Hesperocyparis macrocarpa*) - 69-inches at 30-inches above ground:

This significant Heritage Tree is located on the south side of the church sanctuary. It is situated outside of the proposed construction footprint. The tree is suitable for preservation and it must be protected during the design and construction phases of this development.

I estimate that the proposed parking lot will be setback approximately 20-feet from the trunk of this tree. This parking lot will be situated within this tree's Critical Root Zone as defined by its canopy drip-line and an extrapolation of its trunk diameter. Care must be taken to protect the Critical Root Zone Area beyond the edge of the new parking lot footprint. Significant roots must be pruned properly at the edge of the grading work and not be torn by equipment (prune all roots 2-inches and larger in diameter).

I recommend that this tree is pruned to improve its structure before construction work proceeds. The lower limbs on the west side of the canopy are vulnerable to failing because they are heavy and overextended. I recommend that the weight is reduced in the ends of these limbs and that dead and crossing branches are removed at the same time. The low limbs on the west side of the canopy will also need to be removed to facilitate the construction of the parking lot.

I recommend that the soil surface within the canopy perimeter is mulched with a four-inch deep layer of wood chips in order to conserve soil moisture and mitigate root loss. I also recommend that supplementary irrigation is installed around this tree and that it is irrigated for at least four-years after the construction ends (apply at a rate of 700-gallons every three weeks over the summer months).
