# **ARBORIST REPORT-**

Tree Survey, Impact Assessment & Tree Protection Plan for:

150 Felker Street APN: 008-181-23 Santa Cruz, CA November 15, 2021

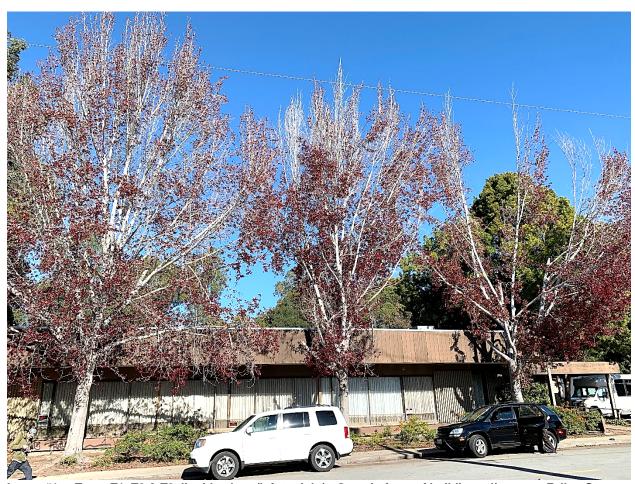
Image #1 - Trees T1, T2 & T3, liquidambar, (left to right). Grow in front of building adjacent to Felker Street.

The three liquidambars have trunk diameters between 16" and 24". Trees T1 and T2 are in fair condition. The trees have normal canopy density and most branches appear well attached. Tree T3 is in poor condition. Several major scaffolds have failed, and deadwood and decay have formed at the limb tear out locations. The center of the canopy has no structural limbs and there is some tip dieback.

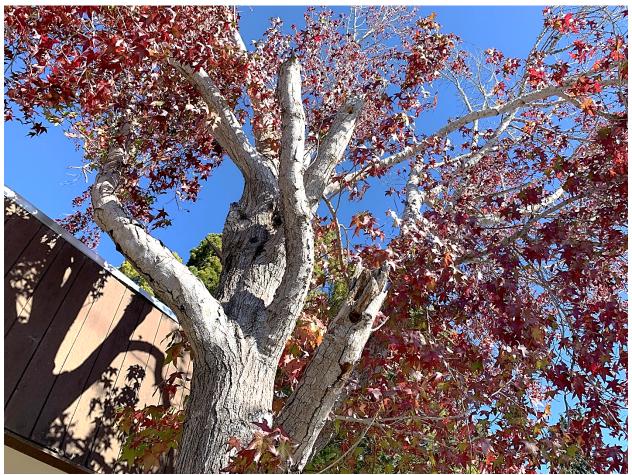
Tree T3 liquidambar showing deadwood and decay at several limb tear outs, (Image #2)

Image #2 – Tree T3, liquidambar. Note broken scaffolds with deadwood and decay.

The liquidambar is showing a pattern of limb failure progressing to decay and is in significant decline.

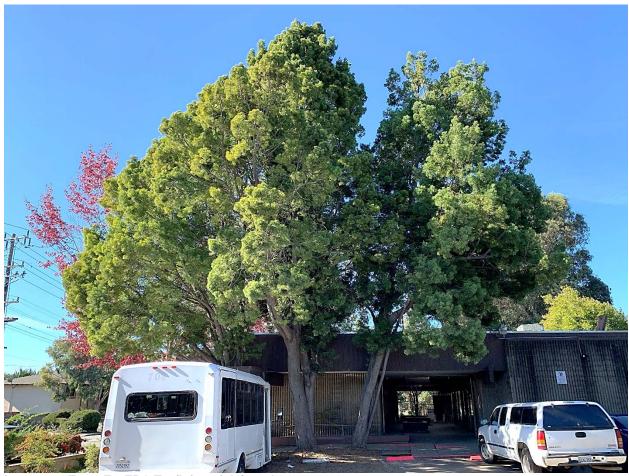
Image #3 - Trees T4, T5 & T6, (left to right), podocarpus.

The podocarpus have trunk diameters between 15" and 24". The three podocarpus grow in a landscape planter adjacent to the building. All three trees have developed a co-dominant trunk growth habit and are in fair condition.

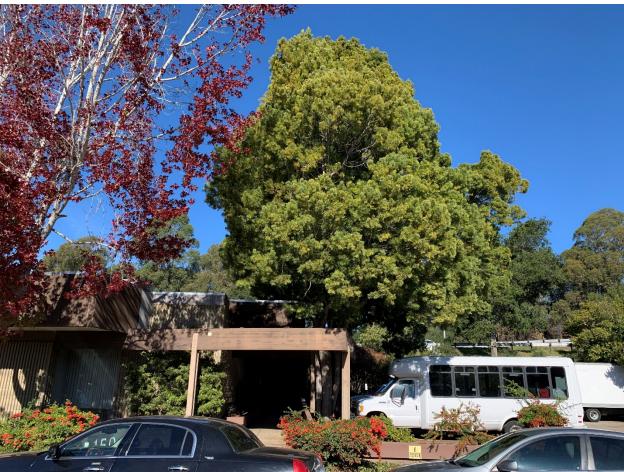
The three podocarpus have dense canopies and grow over the exising breezeway entry, (Image #4).

Image #4 – Tree T4, T5 & T6, podocarpus. Grow over breezeway overhang.

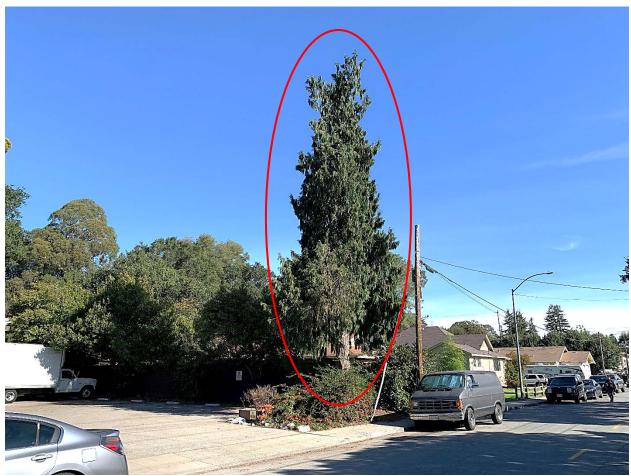
Image #5 - Tree T7, Incense cedar, (circled).

The cedar is in good condition.

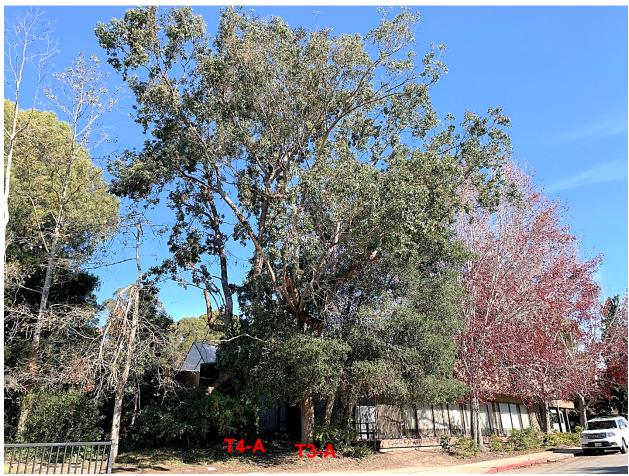
Image #6 - Trees T3-A and 4-A, silver dollar gum. The tree grows near the west corner of the property.

Tree T3-A is a mature, 26" diameter silver dollar gum in poor condition. The gum has a thin canopy density, with tip and branch dieback in limbs up to 10-inches in diameter.

Tree T4-A is a mature 34" diameter silver dollar gum in fair to poor condition. There canopy is thin and there is some tip dieback. A few limbs and co-dominant stems have failed up to 10-inches in diameter.

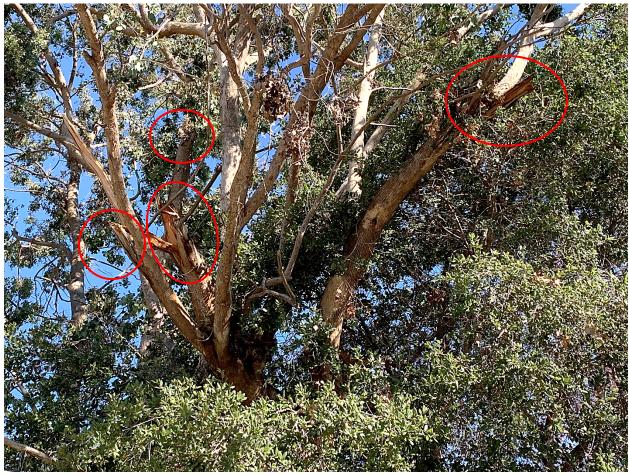
Tree T3-A has multiple limb tear outs in branches up to 10-inches in diameter, (Image #7).

Image #7 - Tree T3-A, silver dollar gum. Note limb tear outs, (circled).

Two protected silver dollar gum (T3-A & T4-A), grow on the adjacent property and have canopies that overhang the new project limits. Tree T3-A, a 26" diameter gum, is a mature tree in poor condition. Significant tip and branch dieback can be seen, and the tree is in decline. It has had several limb failures between 8" and 10" in diameter. Targets in the event of failures include frequent bike and pedestrian traffic. Once the new building is built, the grounds on the west edge of the property will be a target.

Because of its poor condition, pattern of limb breakage, and the frequency of use by bicyclists and pedestrians, I recommend the removal of tree T3-A. Consideration should also be given to the removal of tree T4-A, or risk reduction pruning performed, because of a pattern of limb breakage. However, this tree will provide a significant visual buffer from the new building.

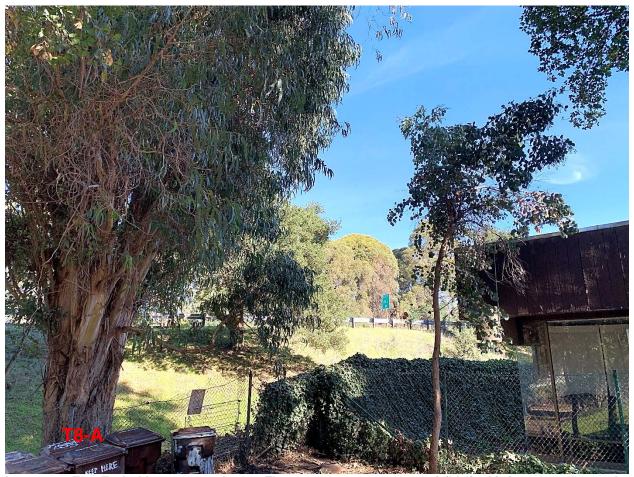
Image #8 - Tree T6-A, blue gum eucalyptus. The trees upper canopy, not visible in this image overhangs the existing building.

The eucalyptus is in fair condition and has a trunk diameter of 48-inches. The canopy overhangs the existing building by 8-feet.

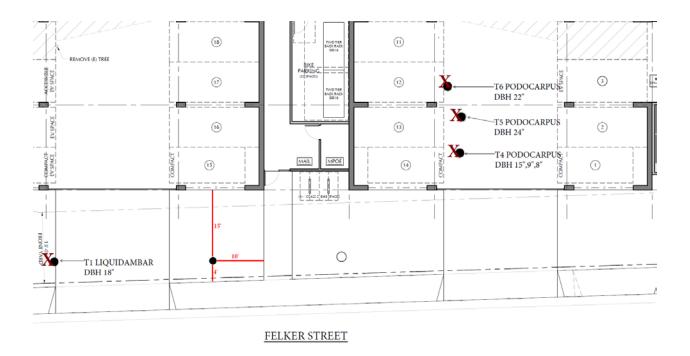
Four protected trees will be highly impacted by the new project and their removal will be necessary. This includes trees T1, liquidambar, and T4,T5, and T6 podocarpus, (Image #9).

Image #9 - Tree T1, liquidambar and trees T4, T5 & T6, podocarpus, are within construction element footprint.

Tree T1 is within the driveway footprint and trees T4,T5, and T6 are within the building footprint.

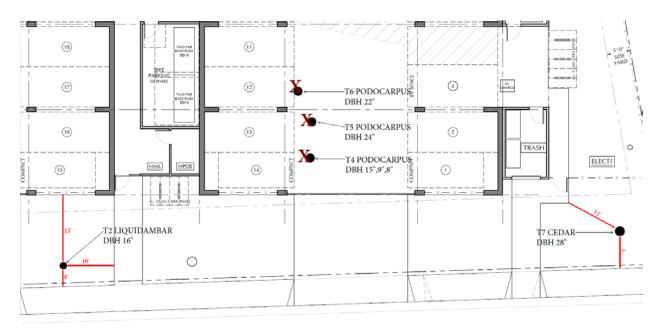
Trees T2, liquidambar and T7, cedar will be moderately impacted, and can be incorporated into the project, (Image #10).

Image #10 – Tree T2, liquidambar and tree T7, cedar, distance to construction elements.

- 1. <u>Utilities / Gas, Sewer, Water or Electrical</u> Utilities shall be routed as far as feasible from the trunk of T2, liquidambar and T7 cedar. Any excavation for a utility line that is within the canopy dripline of tree T2, liquidambar or T7 cedar, shall be by hand methods. Any roots found less than 2" in diameter, shall be cleanly pruned with loppers, hand saw or Sawzall. If roots are encountered 2" in diameter or greater, the root shall be retained with the root "bridging" the trench, and the pipe shall be installed under or over the root.

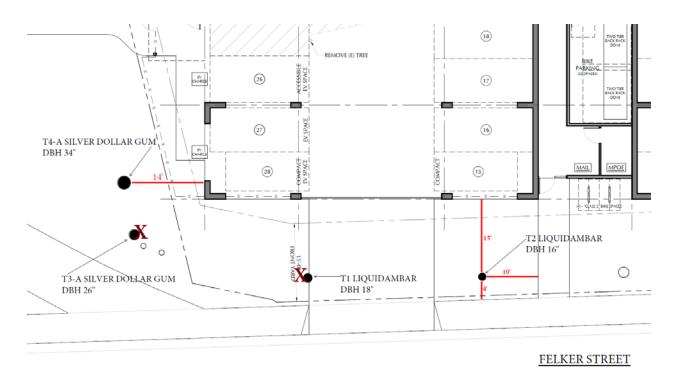
Tree T4-A, silver dollar gum will have moderate construction impacts, (Image #11).

Image #11 - Tree T4-A, silver dollar gum, distance to new building.

Tree T4-A, a 34" silver dollar gum, will be within 14-feet of the new building. This is within the trees critical root zone. The tree will suffer some root loss, can tolerate the loss and will require tree protection measures, to reduce root loss impacts. Canopy clearance pruning will be necessary to allow space for construction of new building.

- 2. New Building Excavation for new foundation adjacent to tree T4-A, silver dollar gum, shall be by hand methods, (see tree protection plan Sheet T1, for location). Stake foundation location adjacent to tree T4-A. Hand trench and root prune. Any roots found less than 2" in diameter, shall be cleanly pruned with loppers, hand saw or Sawzall. If roots are encountered 2" in diameter or greater, they shall be pruned under supervision of the Project Arborist. Roots shall be pruned by methods indicated on Tree Protection Plan sheet T1, Pre-Construction Root Pruning. No use of machinery is permitted.
