ARBORIST REPORT-

Tree Inventory & Preliminary Construction Impacts for:

Ocean Place — Ocean/Hubbard Streets & May Avenue APN Numbers: 008-331-03 & 04,05,06,07,08,12,13,14,15,25,26,27,28,29,30,31,32,35,41 Santa Cruz, CA 95060 May 15,2020

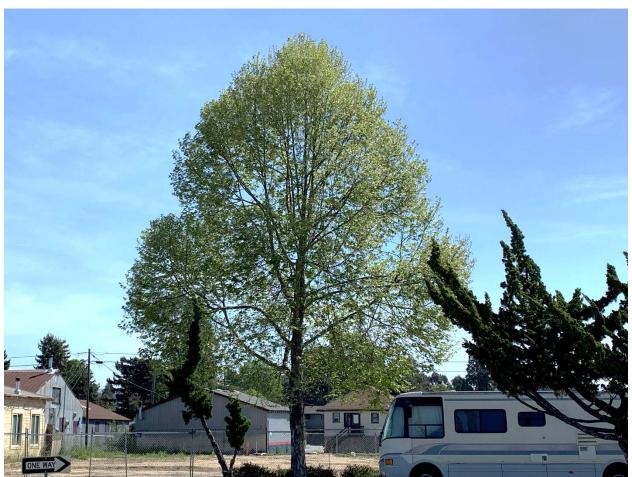
All the London planes are mature trees in good condition (Images #1 & 2).

Image #1 – Tree T2, London plane. In sidewalk cutout along Ocean Street. The tree has good structure and is in good condition.

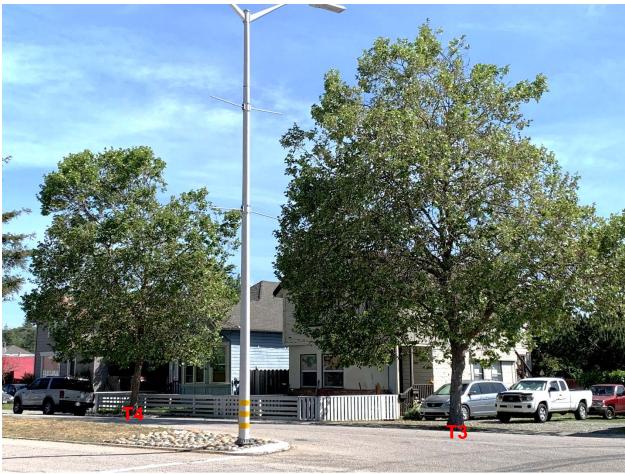
Image #2 - Trees T3 & T4, mature London plane trees, in sidewalk cutouts along Ocean Street. The two trees are in good condition.

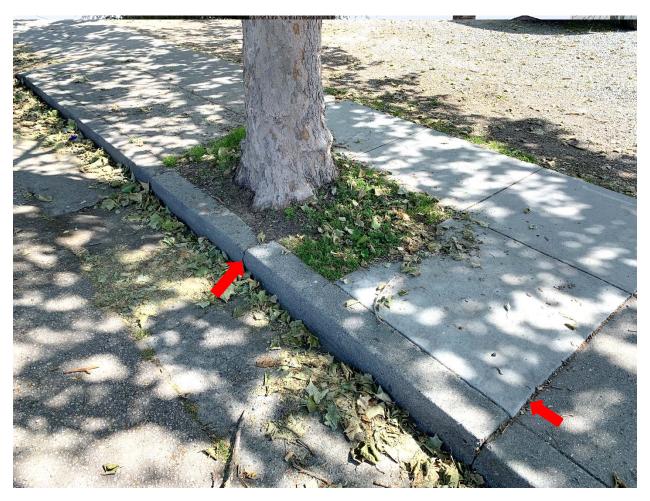
Most of the street trees show evidence of sidewalk repair in the recent past as evidenced by newer concrete sections. Some evidence of shallow surface roots and root diameter expansion causing sidewalk and curb lifting and cracking at some trees is noted (Image #3).

Image #3 - Tree T3, London plane. Note lighter colored concrete is more recent. Also lifting of sidewalk and curb cracking (arrows).

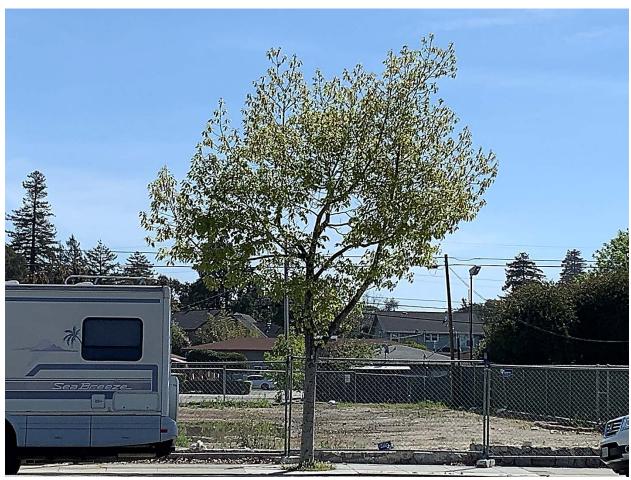
Tree T1, a younger red oak is in fair condition (Image #4).

Image #4 - Tree T1, red oak street tree, in sidewalk cutout along Ocean Street,

- One "protected" street tree, T1, is within the footprint of the ramp down for basement garage and is recommended for removal.
- Four protected street trees will receive moderate construction impacts and can be retained including trees T2 T5.

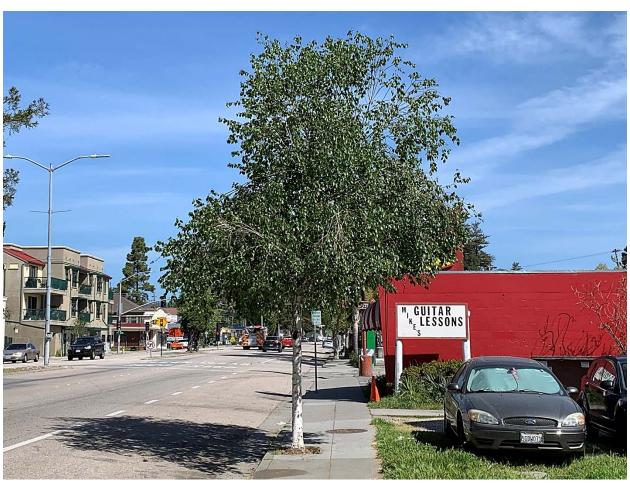
Tree T5 is a young Himilayan birch in good condition (Image #5).

Image #5 -Tree T5, Himalayan birch street tree, in sidewalk cutout along Ocean Street.

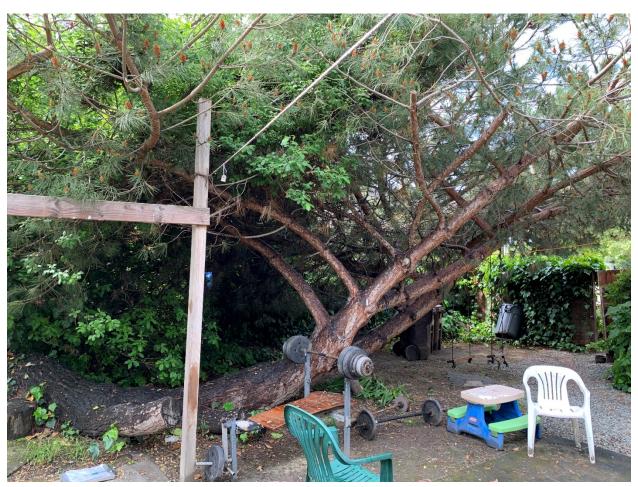
Image #6 – Tree T8, Italian stone pine. Note horizontal trunk along ground. Despite its poor trunk growth habit, the structure is stable and does not present any risk. The canopy appears vigorous and the tree is in good health.

Tree #	Species	Trunk Diameter @ 54 inches a.g.	Protected Tree	Crown Height & Spread	Health Rating	Structural Rating	Suitability for Preservation (Based Upon Condition)	Tree Protection Zone (in feet)	Construction Impacts (Rating & Description)	Retention or Removal Code	Comments
T5	white barked Himalayan birch (Betula utilis var. jacquemontii)	6"	Yes	15'X10'	Good	Fair	Good	6'	Moderate to High - Depending on hardscape & other site ammmenities	R.T.	Street tree in 2'X2' sidewalk cutout.
Т6	walnut (Julgans spp .)	7",7"	No	15'X15'	Good	Fair	Fair	10'	High -Within grading limits	R.I.	Co-dominant trunks at 1' above grade.
Т7	plum (<i>Prunus spp.</i>)	Multiple trunks all <6"	No	15'X15'	Good	Fair	Fair	10'	High -Within grading limits	R.I.	
Т8	Italian stone pine (Pinus pinea)	16"	Yes	15'X15'	Good	Poor	Poor	12'	High -Within grading limits	R.C., R.I.	First ten feet of trunk grows along ground, then trunk goes vertical.

- Nine "protected" trees inventoried were in good or fair condition, and three were in poor condition.
- Seven "protected" trees are located within the grading limits will suffer high construction impacts and are recommended for removal, including trees T8, T11, T13, T14, T16, T17 & T21.

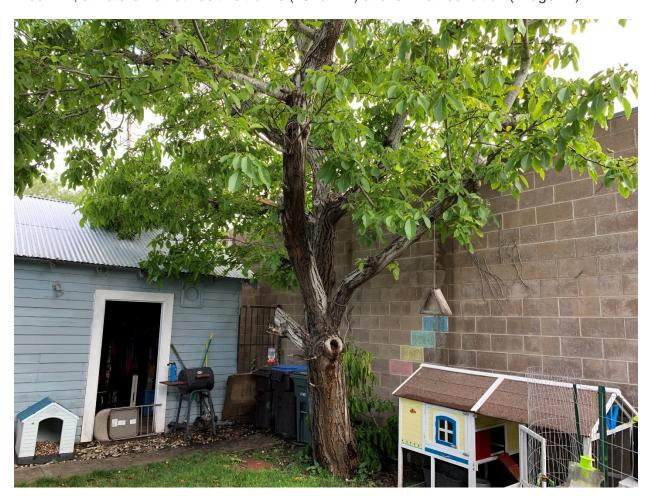
Tree T11, a mature walnut has two trunks (18" & 14") and is in fair condition (Image #7).

Image #7 – Tree T11, walnut. A 4"X4" cavity is visible at 4' above grade. Decay from the cavity is not extensive and the tree is in fair condition.

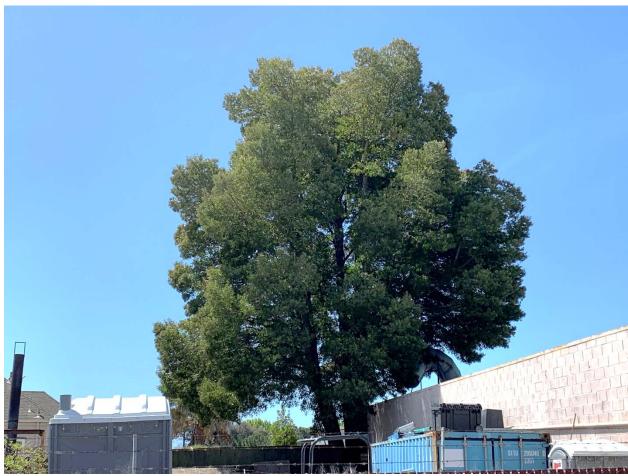
Tree T16, blackwood acacia is in fair condition, (Image #8).

Image #8 – Tree T16, Blackwood acacia. The tree has three co-dominant trunks and grows very close to existing building.

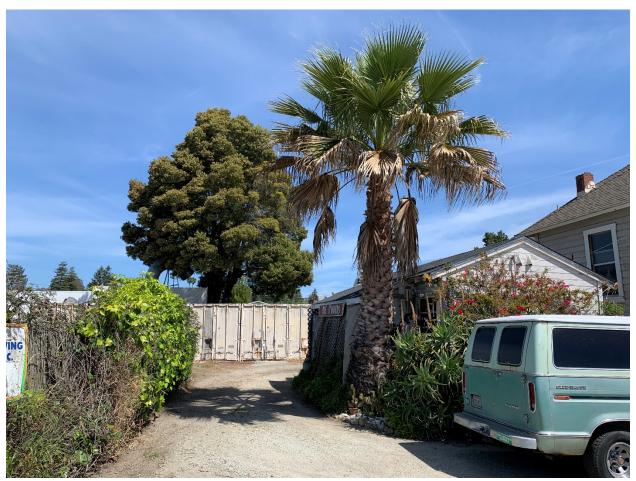
Tree T17 is a fan palm located in the back yard a residential property, adjacent to May Avenue. (Image #9).

Image #9 – Tree T17, fan palm. Tree is in good condition. The trunk is growing against the adjacent unit and needs pruning of dead fronds.

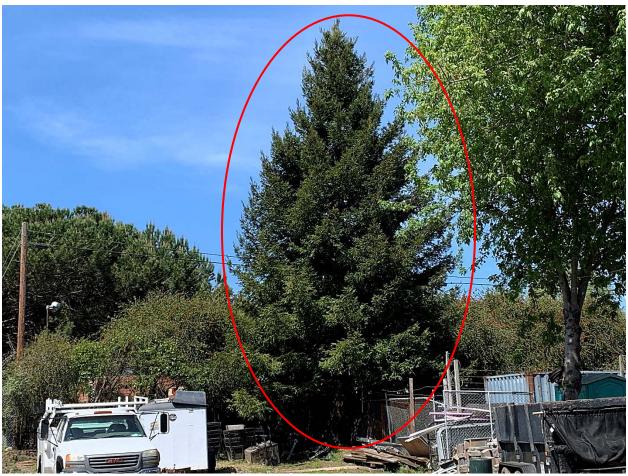
Image #10 - Tree T23, coast redwood (circled).

Tree T23 a coastal redwood, is in a commercial lot adjacent to May Avenue (Image #10). The tree is in good condition.

One 24" diameter coast redwood, tree T23, is in good condition. See page 13, image #10. The 60-foot-tall tree has an average canopy diameter of 15 feet and could be boxed, stored on-site, and transplanted during the landscaping phase. Access to the tree is good. The redwood would require a minimum box size of 8X8 feet, and if used would need watering during storage, and a scheduled post planting monitoring program, to ensure irrigation amounts are appropriate until reestablished. If a location can be found on site that works with the landscape scheme, it could be an asset to the project.

- An overall conceptual landscape plan (Sheet L1.1), includes approximately 170 trees to be planted on site.
- One "protected" tree recommended for removal, coast redwood, T23, should be considered for boxing and reuse on site.

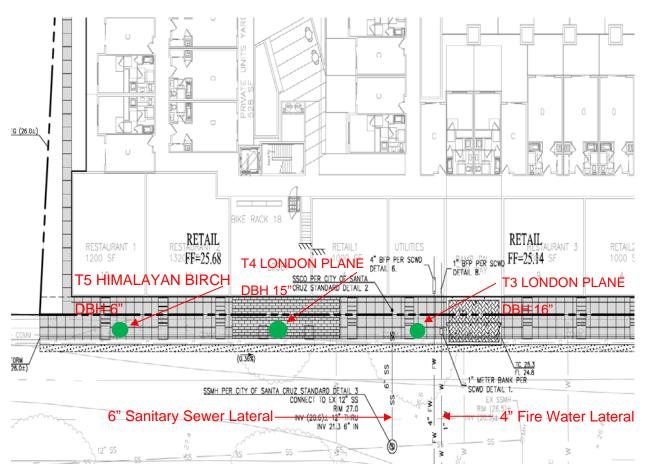
Further, the new 4" diameter fire water service lateral and the new 6" sanitary service lateral will each be within ten feet or less (one line on either side), from tree T3. Trenching to install the laterals will require some root loss and the trees ability to absorb water will be reduced. However, with tree protection measures, impacts from this work can be reduced from high to moderate and tree retention is possible.

Tree T3, London plane is in 3-foot by 5-foot sidewalk cutout, and T4, London plane and T5 Himalayan birch are in 2-foot by 2-foot sidewalk cutouts. Their location is shown below in the proposed grading and utility plan (Image #11).

Image #11 – Trees T3 & T4, London plane and T5, Himalayan birch. Note location of utility laterals adjacent to tree T3 London plane.
