**PRELIMINARY TREE RESOURCE ANALYSIS
111 ERRETT CIRCLE**

**Prepared for
Brett Packer**

July 2018

**PROJECT IMPACT ANALYSIS
111 ERRETT CIRCLE, SANTA CRUZ**

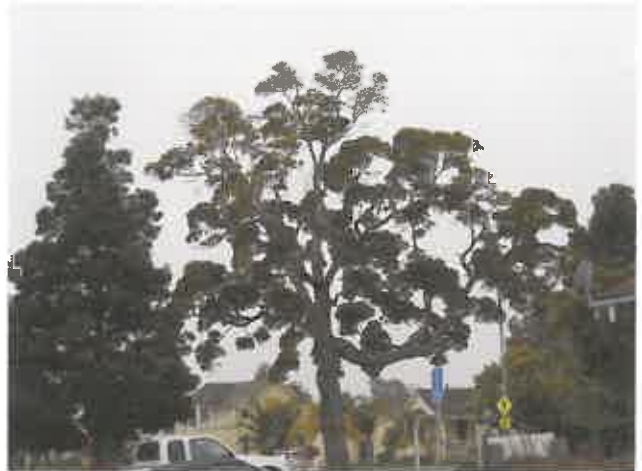
Tree #18 is pictured at right. The canopy displays significant thinning and faded foliar color at the top of the canopy. Several areas of decay, along with evidence of past fungal fruiting bodies are visible near the base of the trunk.

The structure of trees #1 and #2 could be improved with weight reduction pruning, trees #5 and #18 should be considered for eventual removal. There are no arboricultural treatments available to improve the health or structural stability of the trees.

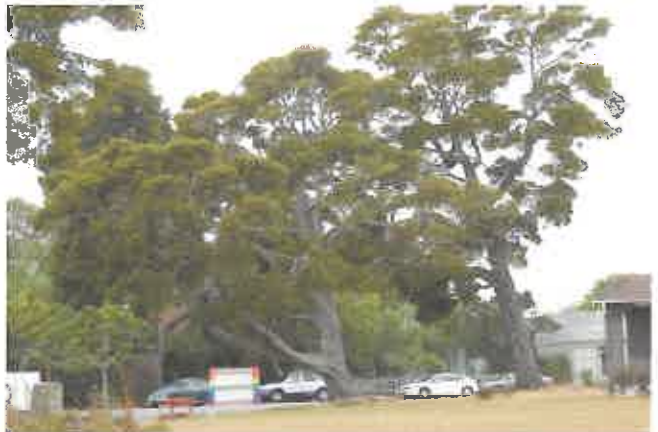
Trees #1 and #2 are pictured at right. Both have dense foliar canopies and lean toward the public street.

Decay is visible at the base of tree #1 in five separate areas. Tree #2 is decayed on the main trunk at a point six feet above the ground. The upper canopy is thinning.

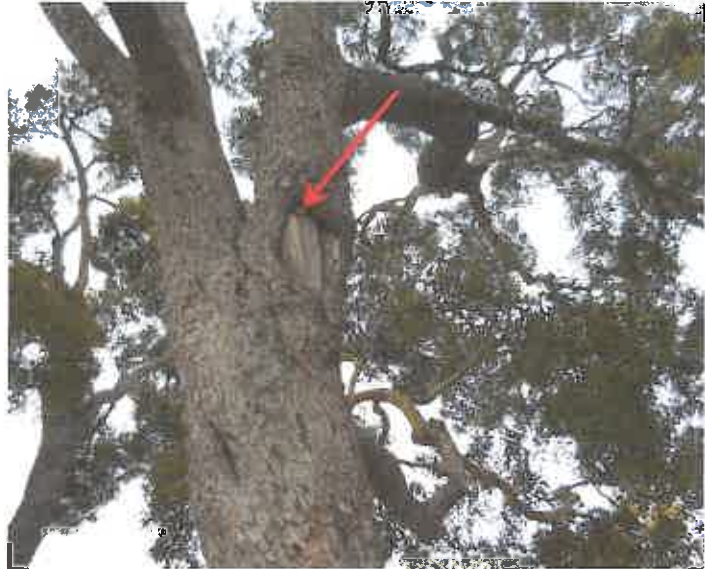
Tree #5 is pictured at right. A large area of decay on the upper trunk is shown at arrow.

The main trunk has additional areas of decay along with weak branch attachments.

The tree canopy is thinning with faded foliar color.

Several mature black acacia growing on this site have failed in the past due to uprooting.

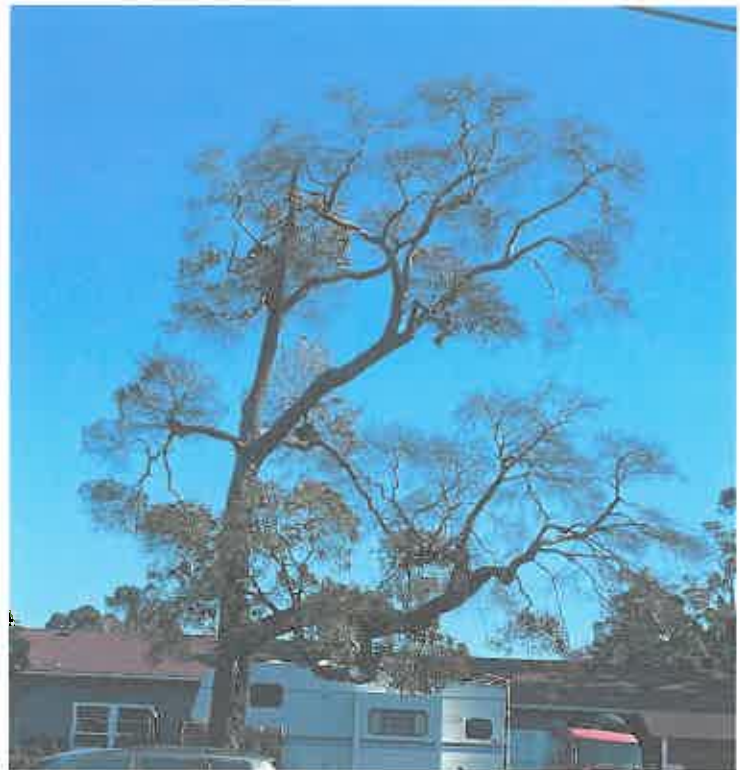
Trees #18 and #5 have significant decline in the foliar canopies. The condition of tree #5 has declined considerably since the initial inspection in July (pictured at right).

4	madrone	5.5 & 4.2	fair	high	sidewalk, curb, gutter construction	4	young tree with 2 stems, growing within proposed curb, gutter and sidewalk/Remove due to impacts
5	black acacia	24.9	poor	high	sidewalk, curb, gutter construction	18	Areas of decay on main trunk, canopy is 90% dead. Within proposed curb, gutter and sidewalk. Tree is not suitable for preservation/Remove and replace
