Downtown Library and Affordable Housing Project

Environmental Review - February 2023

Phase II Archaeological Testing and Evaluation Report

Downtown Library Mixed-Use Project Santa Cruz, California

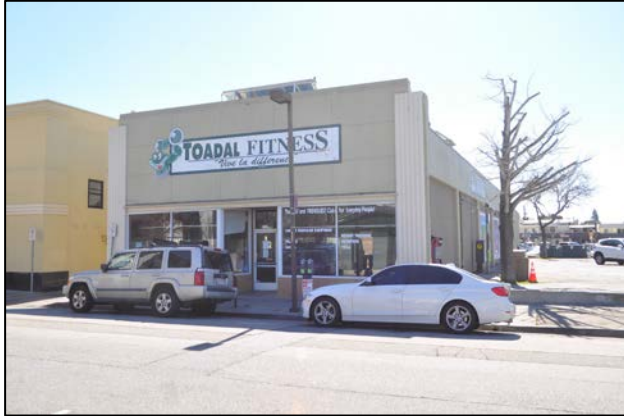
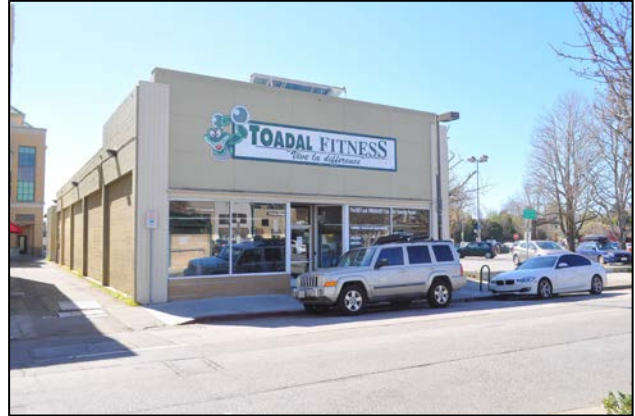
Figures 2 and 3. Left image shows the front (north) and right side (west) elevations viewed from Lincoln Street. The storefront was replaced in 1980. Right image details the front (north) and left side (east) elevations.

The parcel contains a reinforced concrete commercial building (1941) constructed in a simplified Streamline Moderne style. The building has a rectangular plan, a flat roof with parapets skylights and recent solar panels, stucco wall cladding and a replaced storefront. (**Figures 2 - 5**).

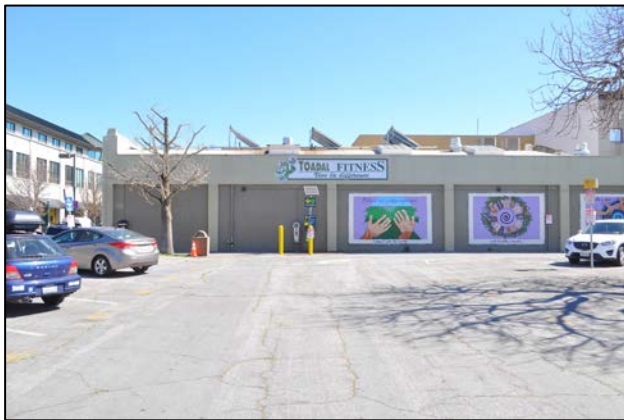
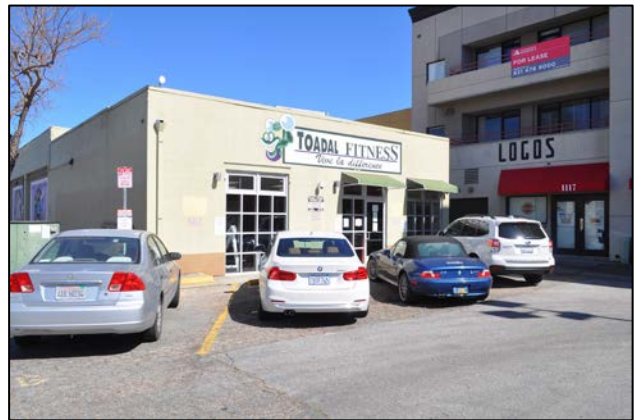
Figures 4 and 5. Left image shows the west elevation, with solar panels installed on the roof. Right image details the rear (south) elevation, which contains the 1986 rear addition with metal windows, metal doors and awnings.

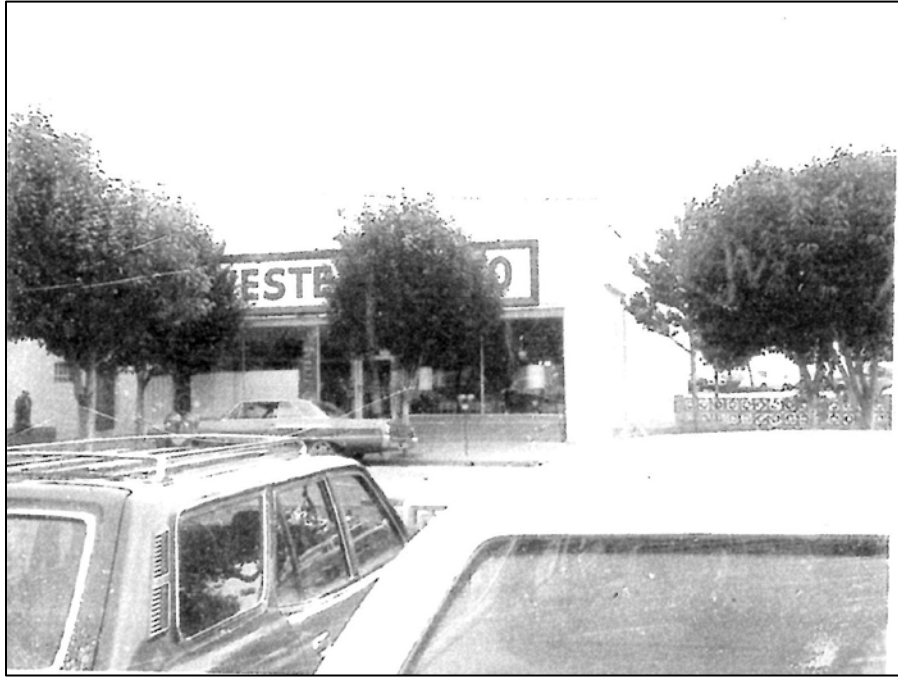
Figure 6. 1974 Santa Cruz County Assessor's photograph of the front (north) elevation. Note the earlier storefront and Western Auto sign.

The building has been altered substantially since its 1941 construction date (**Figures 6 - 8**).

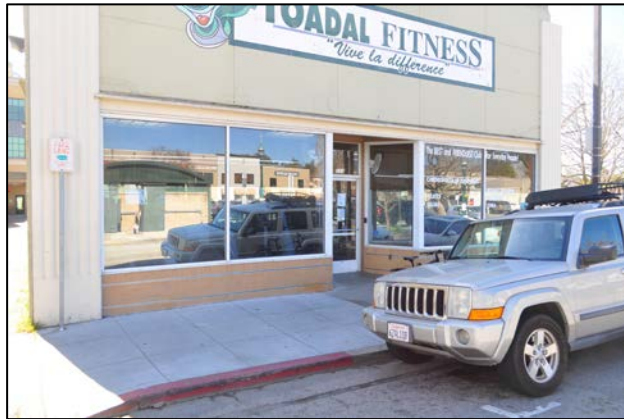
Figures 7 and 8. Left image details the north elevation, showing the replaced storefront. Right image details the east elevation and the 1986 rear addition (arrow).

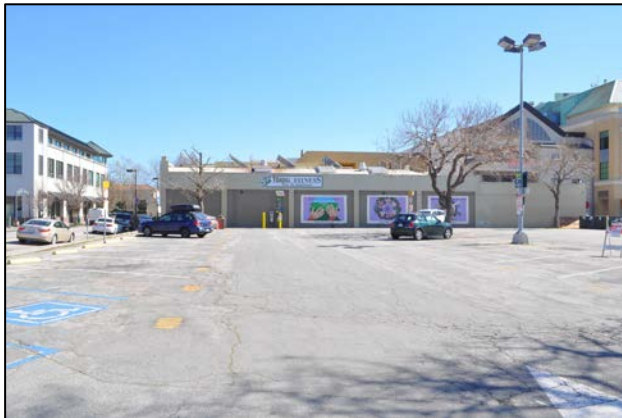
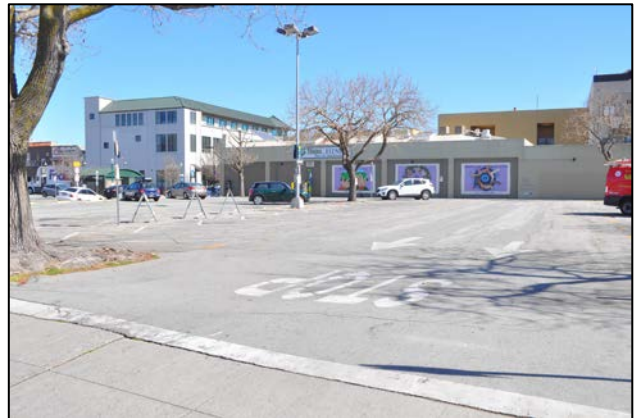
Figures 9 and 10. Two views of the commercial building at 113 Lincoln St. taken from the adjacent parking lot (005-141-21) looking east and northeast, respectively.

The parcel is now an empty parking lot. Sanborn maps (see **Figures 13 and 14**) indicate a commercial building once occupied the parcel; this building has been removed. Current views of the parking lot appear below (**Figures 9 and 10**).

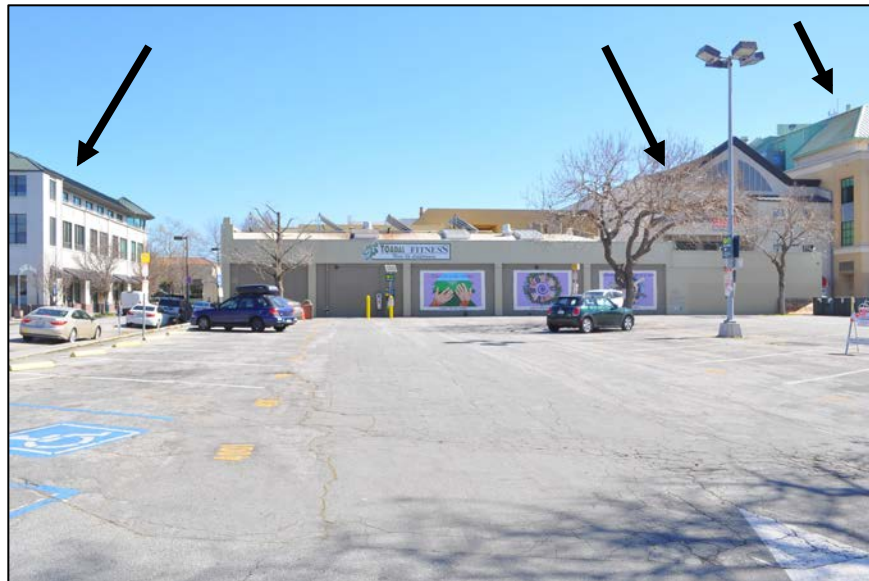
Figure 12. Looking east down Lincoln Street toward Pacific Avenue, showing the two subject properties and the modern buildings that have altered the existing setting (arrows).

The 1989 Loma Prieta Earthquake changed the commercial core of Santa Cruz irrevocably, with the destruction of many buildings downtown along the entire length of Pacific Avenue. The historic commercial core north of Soquel Avenue was substantially damaged; and the area no longer possesses enough of a concentration of historic buildings to form a district. Intended to be fireproof, the post-1894 unreinforced masonry buildings suffered heavily, with only several landmark buildings remaining. The considerable destruction of many historic buildings, the subsequent demolition of unsafe buildings, and the façade improvements of surviving buildings have changed the look of the downtown commercial core considerably. The 1986 National Register-listed Downtown/Pacific Avenue Commercial District was delisted in 1991 as a result of the number of buildings lost in the earthquake.¹⁰ The historic setting of the subject properties one block away from the city's commercial artery has also been modified with the removal of buildings and new construction since 1989 (**Figure 12**).

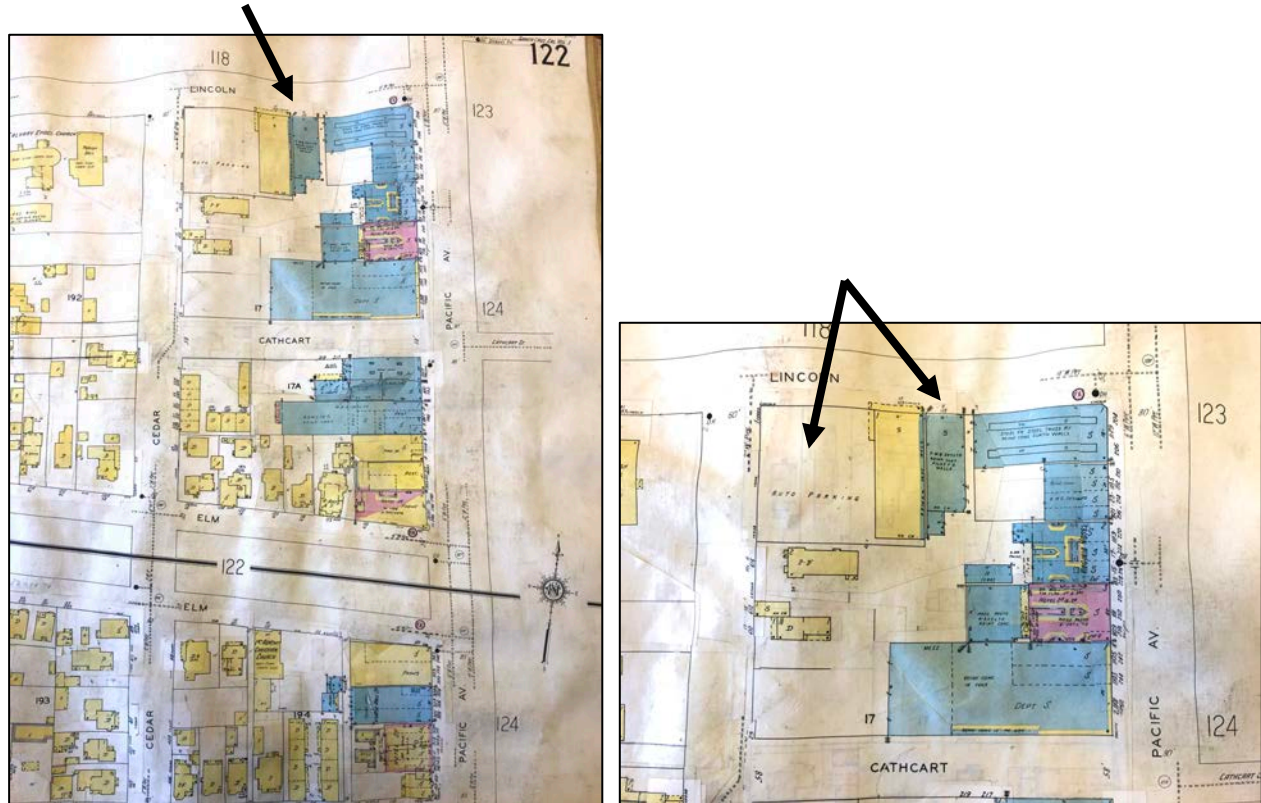
Figures 13 and 14. Left image is a 1947 Sanborn map of the project area. Right image details the subject properties (arrows).

With the City's population growth and subsequent expansion, portions of the residential blocks adjacent to and west of Pacific Avenue began to be redeveloped for commercial use. Sanborn maps from 1947 indicate the development in the project area (**Figures 13 and 14**).

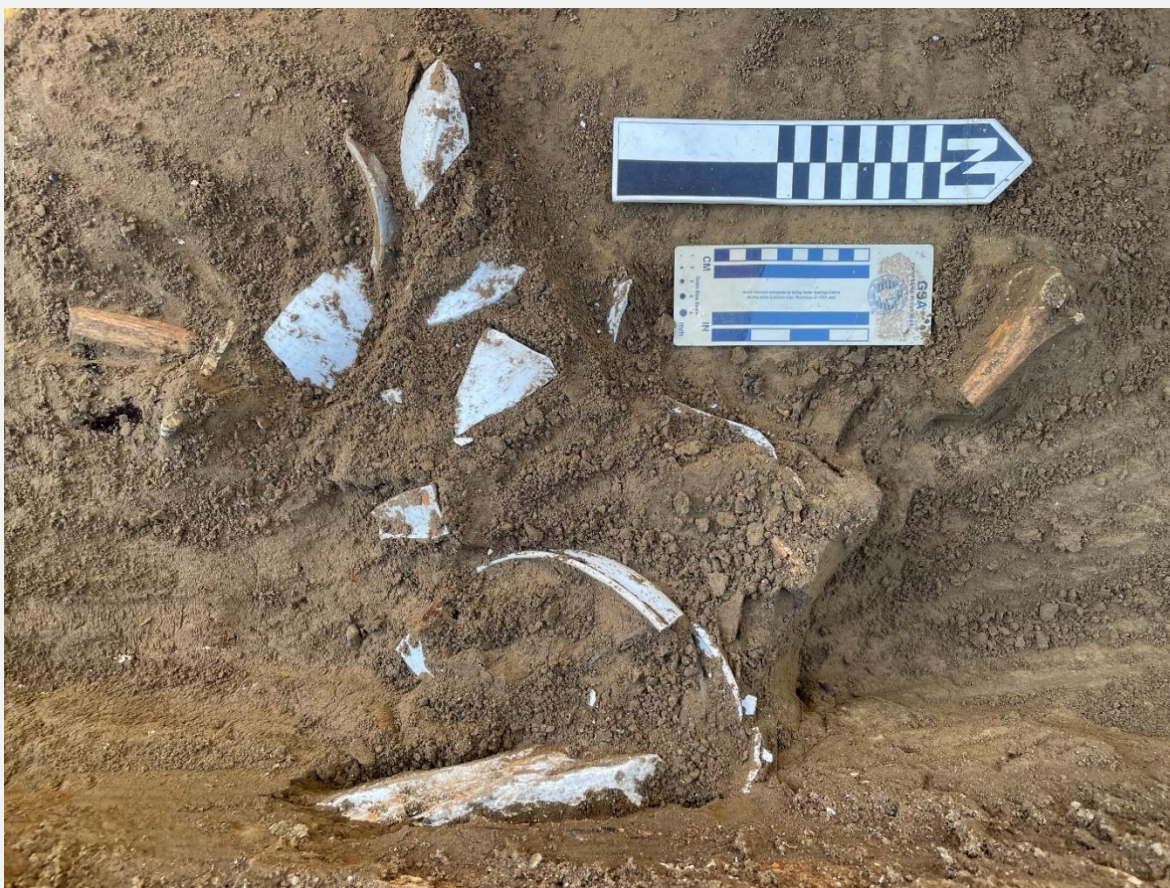
Figure 10. Feature 1 Plan View at 20 Inches Below Surface (1240)

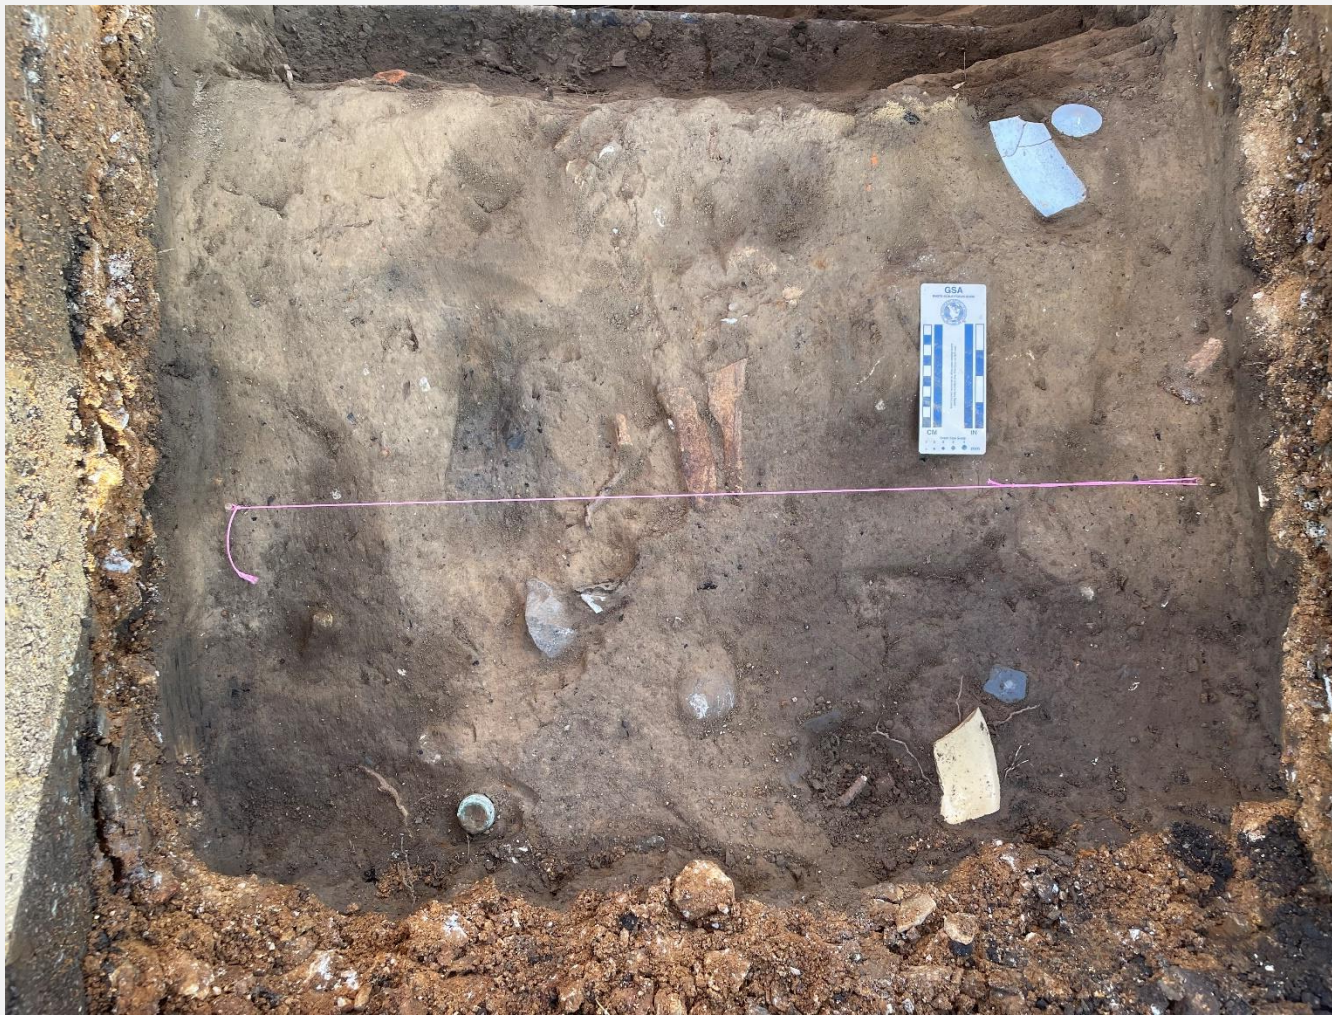
Figure 12. Feature 3 Plan View Before Excavation (showing bisect line) (IMG_1297)

A total of 138 historic period artifacts, 994.3 grams of faunal bone, and 24.3 grams marine shell were recovered from Feature 3. Specific collected material included 43 ceramic whiteware sherds, 1 brick fragment, 15 glass bottle shards, 1 pane glass shard, 27 nails, 1 spoon with a bone or ivory handle, 48 miscellaneous slag-covered pieces of hardware, 1 bottlecap, 1 fragment from a lock, 2 bullet casings, 1 fragment of slate, and 1 large fragment of pencil lead. None of the artifacts were temporally diagnostic or bore unique patterns, marks, and/or characteristics. See Section 6.2 below for a detailed analysis of the recovered artifacts. Feature 3 is shown in profile in Figure 8 and in plan view in Figure 12.

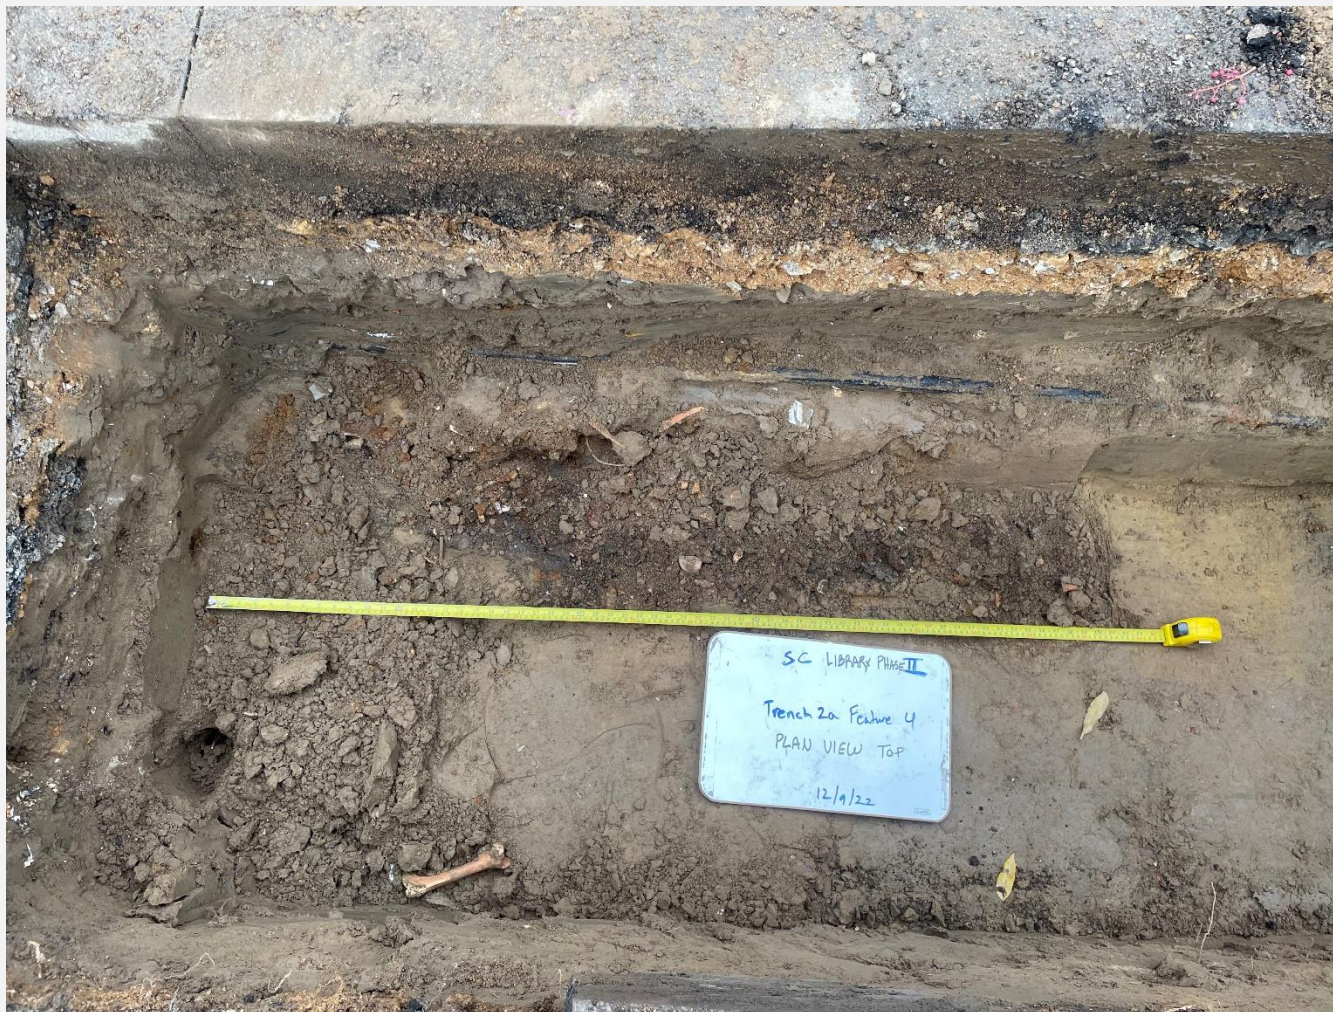
Figure 13. Feature 4 Plan View Before Excavation (IMG_017)

Feature 4 was exposed in the north sidewall of TT 2a. Feature 4 was found deeper than the other features, just below the 2-inch modern metal utility pipe, approximately 30 inches below the surface. The observable dimensions of Feature 4 were 62 inches long (east-west), 10 inches wide (north-south), and 10 inches thick. However, the

A total of 25 historic period artifacts and 188.8 grams of faunal bone were recovered from Feature 4. Specific collected material included 4 ceramic whiteware sherds, 1 porcelain sherds, 1 clay pipe stem fragment, 13 glass bottle shards, 3 miscellaneous slag-covered pieces of hardware, 2 fragments of tin cans, 1 fragment of a purse clasp, and 1 decorative metal embellishment. A few of the artifacts were relatively temporally diagnostic or bore unique patterns, marks, and/or characteristics. See Section 6.2 below for a detailed analysis of the recovered artifacts. Feature 4 is shown in profile in Figure 7 and in plan view in Figure 13.

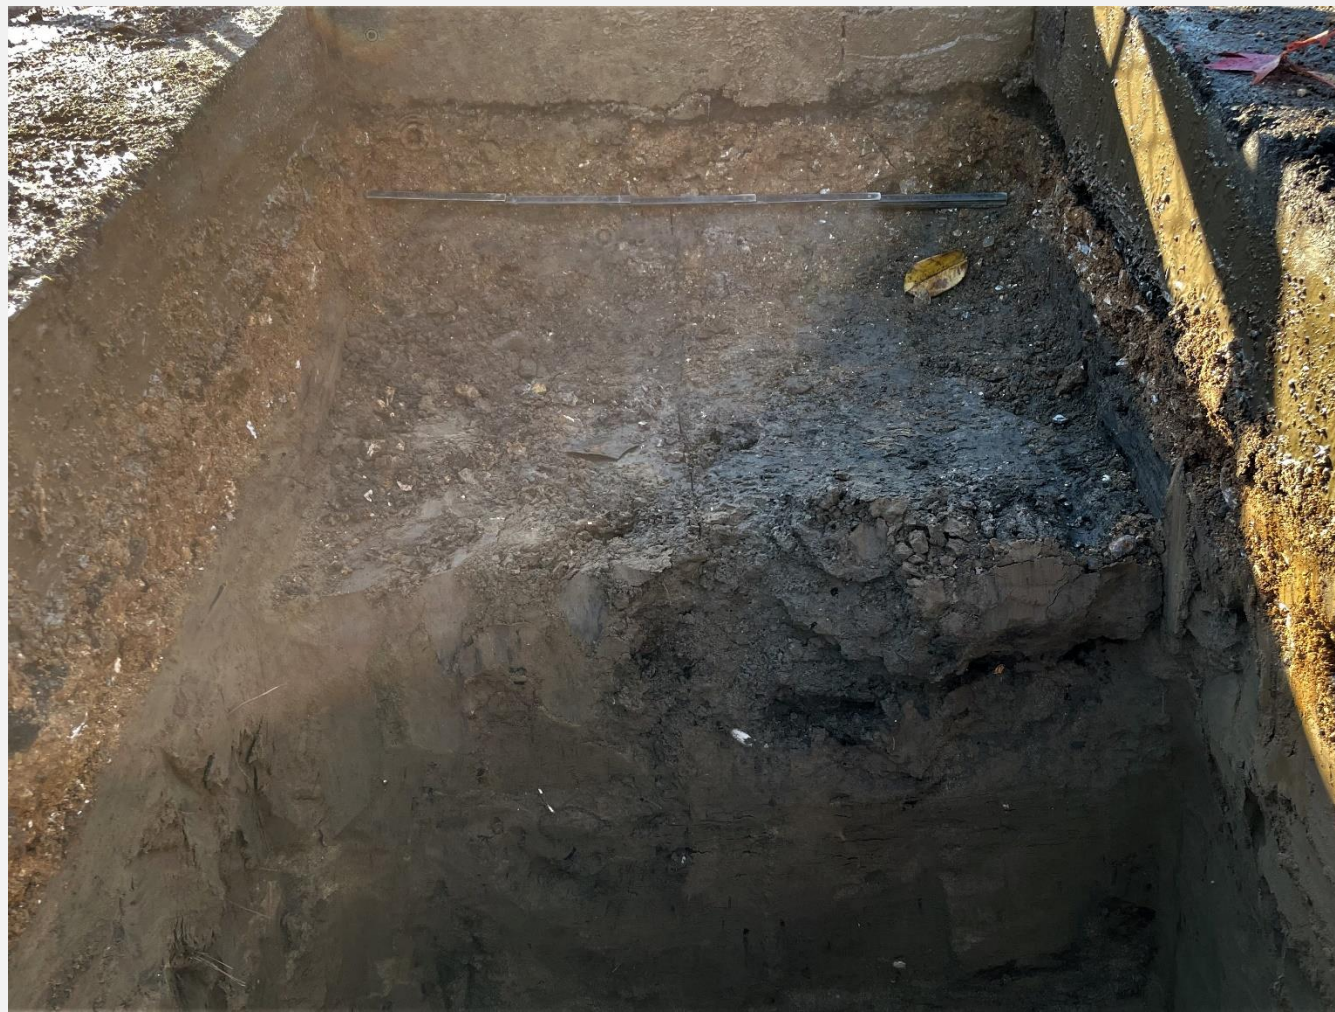
Figure 14. Feature 5 Plan View Before Excavation (IMG_1311)

Like Features 2 and 3, Feature 5 was found immediately below the gravel fill supporting the asphalt parking surface in TT 6. Feature 5 was most like Feature 3 regarding the density of artifacts. The top of Feature 5 was uncovered at about 14 inches below the surface in the southeast corner of TT 6, however the gravel fill in this location was not level and intruded into the top of Feature 5 to a depth of approximately 23 inches below the surface. The feature consisted of a concentration of historic refuse with three vertical contexts. Context A extended from the uneven top of the feature to about 27 inches and consisted of dark brown sandy loam clearly disturbed by placement of the modern fill. Context B was a layer of black silty clay loam extending from about 27 inches to 32 inches below the surface. Context C was black/dark gray clay loam extending from 32 to 46 inches below the surface. All three contexts appeared intrusive into native silty sand, which extended to the bottom of the modern fill in the southeast corner of TT 6.

A total of 378 historic period artifacts, 578.7 grams of faunal bone, 399.6 grams of marine shell, 9.3 grams of charcoal, and 11.5 grams of burned seeds/fruit pits were recovered from Feature 5. Specific collected material in Context A included 3 ceramic whiteware sherds, 1 salt-glazed tile sherd, 5 clay pipe fragments, 4 sherds of a porcelain toy tea set, 1 sherd of blue-ombre painted porcelain, 14 glass bottle shards, 42 pane glass shards, 1 glass bottle stopper, 1 intact milk glass button, 70 nails, 27 miscellaneous slag-covered pieces of hardware, 1 fragment from a lock, and 2 pieces of a watch or jewelry chain. Specific collected material in Context B included 22 ceramic whiteware sherds, 1 porcelain sherd, 5 clay pipe fragments, 4 sherds of a porcelain toy tea set, 2 porcelain doorknobs, 47 glass bottle shards, 25 pane glass shards, 2 intact glass bottles, 1 glass marble, 78 miscellaneous slag-covered pieces of hardware, 1 large metal handle, 1 possible napkin ring, 1 large spoon, and 1 fragment of saw-cut slate. Additional artifacts were recovered from Context C, specifically 2 ceramic whiteware sherds, 2 porcelain sherds, 2 glass bottle bases, 3 glass champagne flute shards, 2 intact glass bottles, and 1 fragment of saw-cut slate. Many of the artifacts from Feature 5 were temporally diagnostic or bore unique patterns, marks, and/or characteristics. See Section 6.2 below for a detailed analysis of the recovered artifacts. Feature 5 is shown in profile in Figure 9 and in plan view in Figure 14.

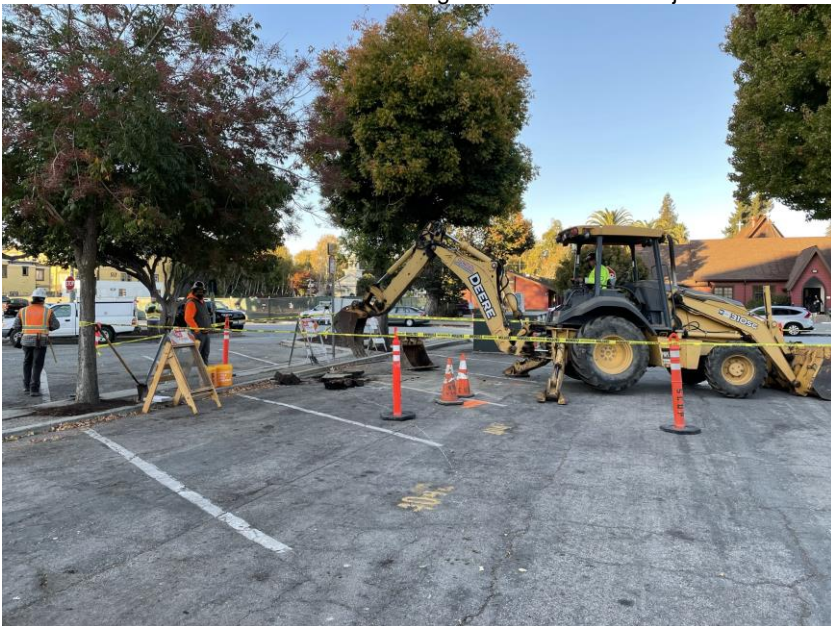
P5b. Description of Photo: Locus 1 Overview with Calvary Church in background (Excavation of Trench 2 in progress). View W

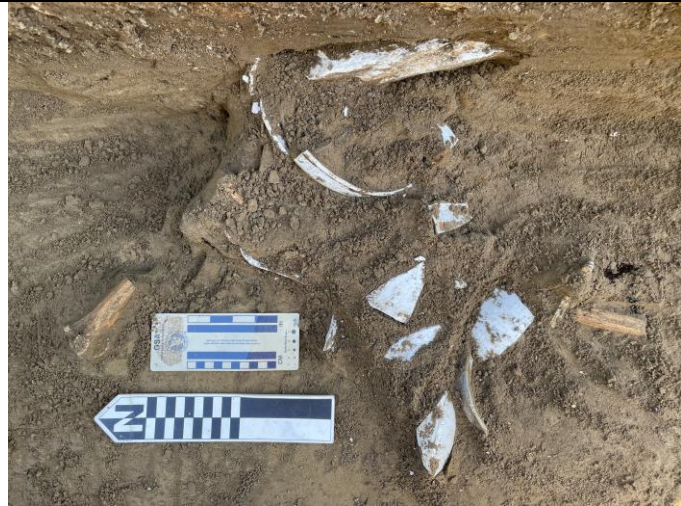
Exhibit 1: Feature 1 (Trench 2) at 20 inches below surface.
View E

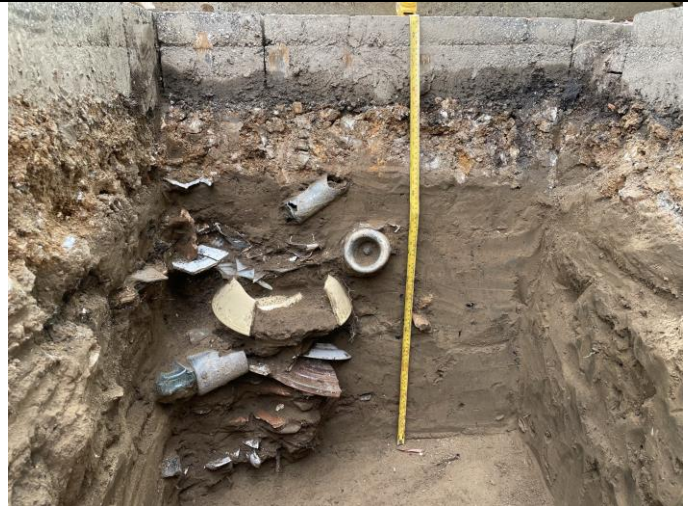
Exhibit 2: Feature 2 (Trench 2) south profile. View S

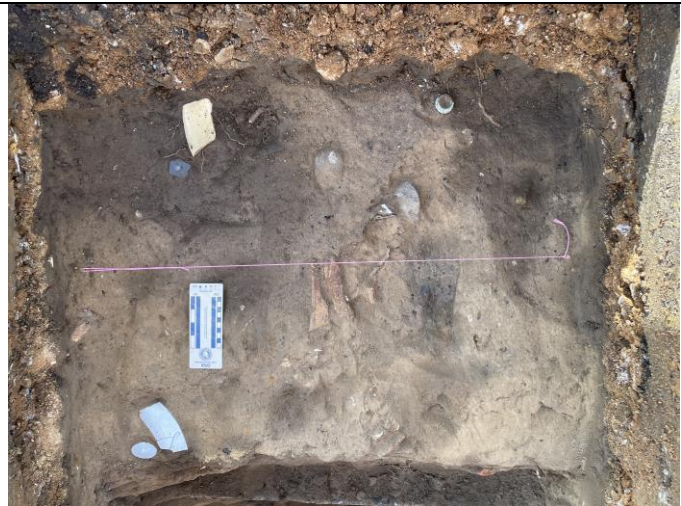
Exhibit 3: Feature 3 (Trench 5) at 15 inches below surface.
View N

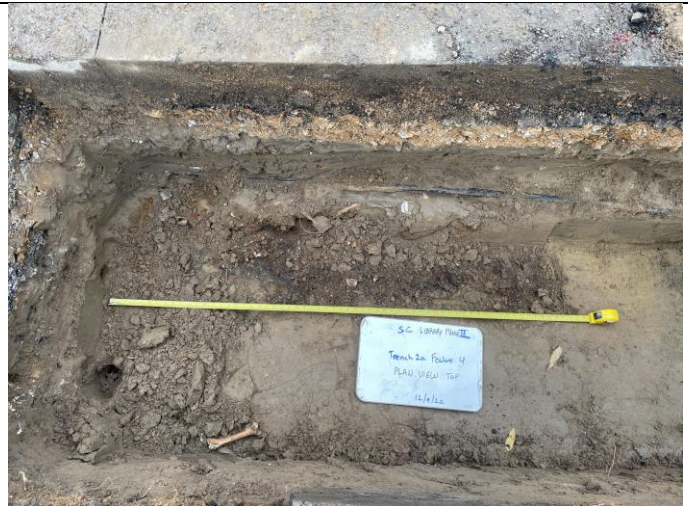
Exhibit 4: Feature 4 (Trench 2a) at 30 inches below surface.
View W

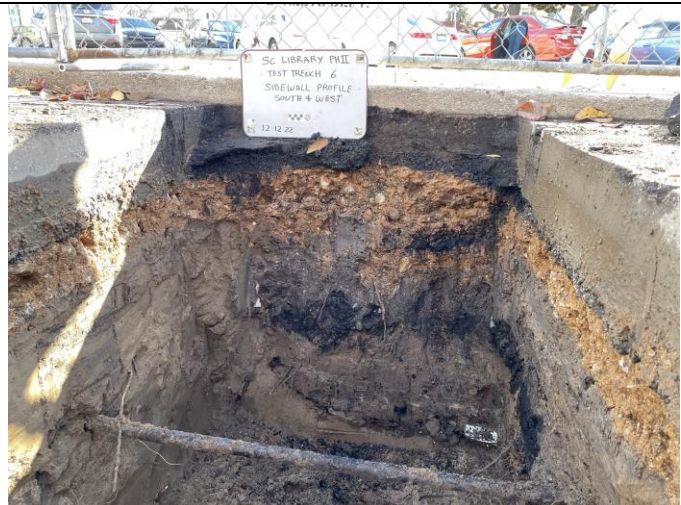
Exhibit 5: Feature 5 (Trench 6) south wall profile. View S

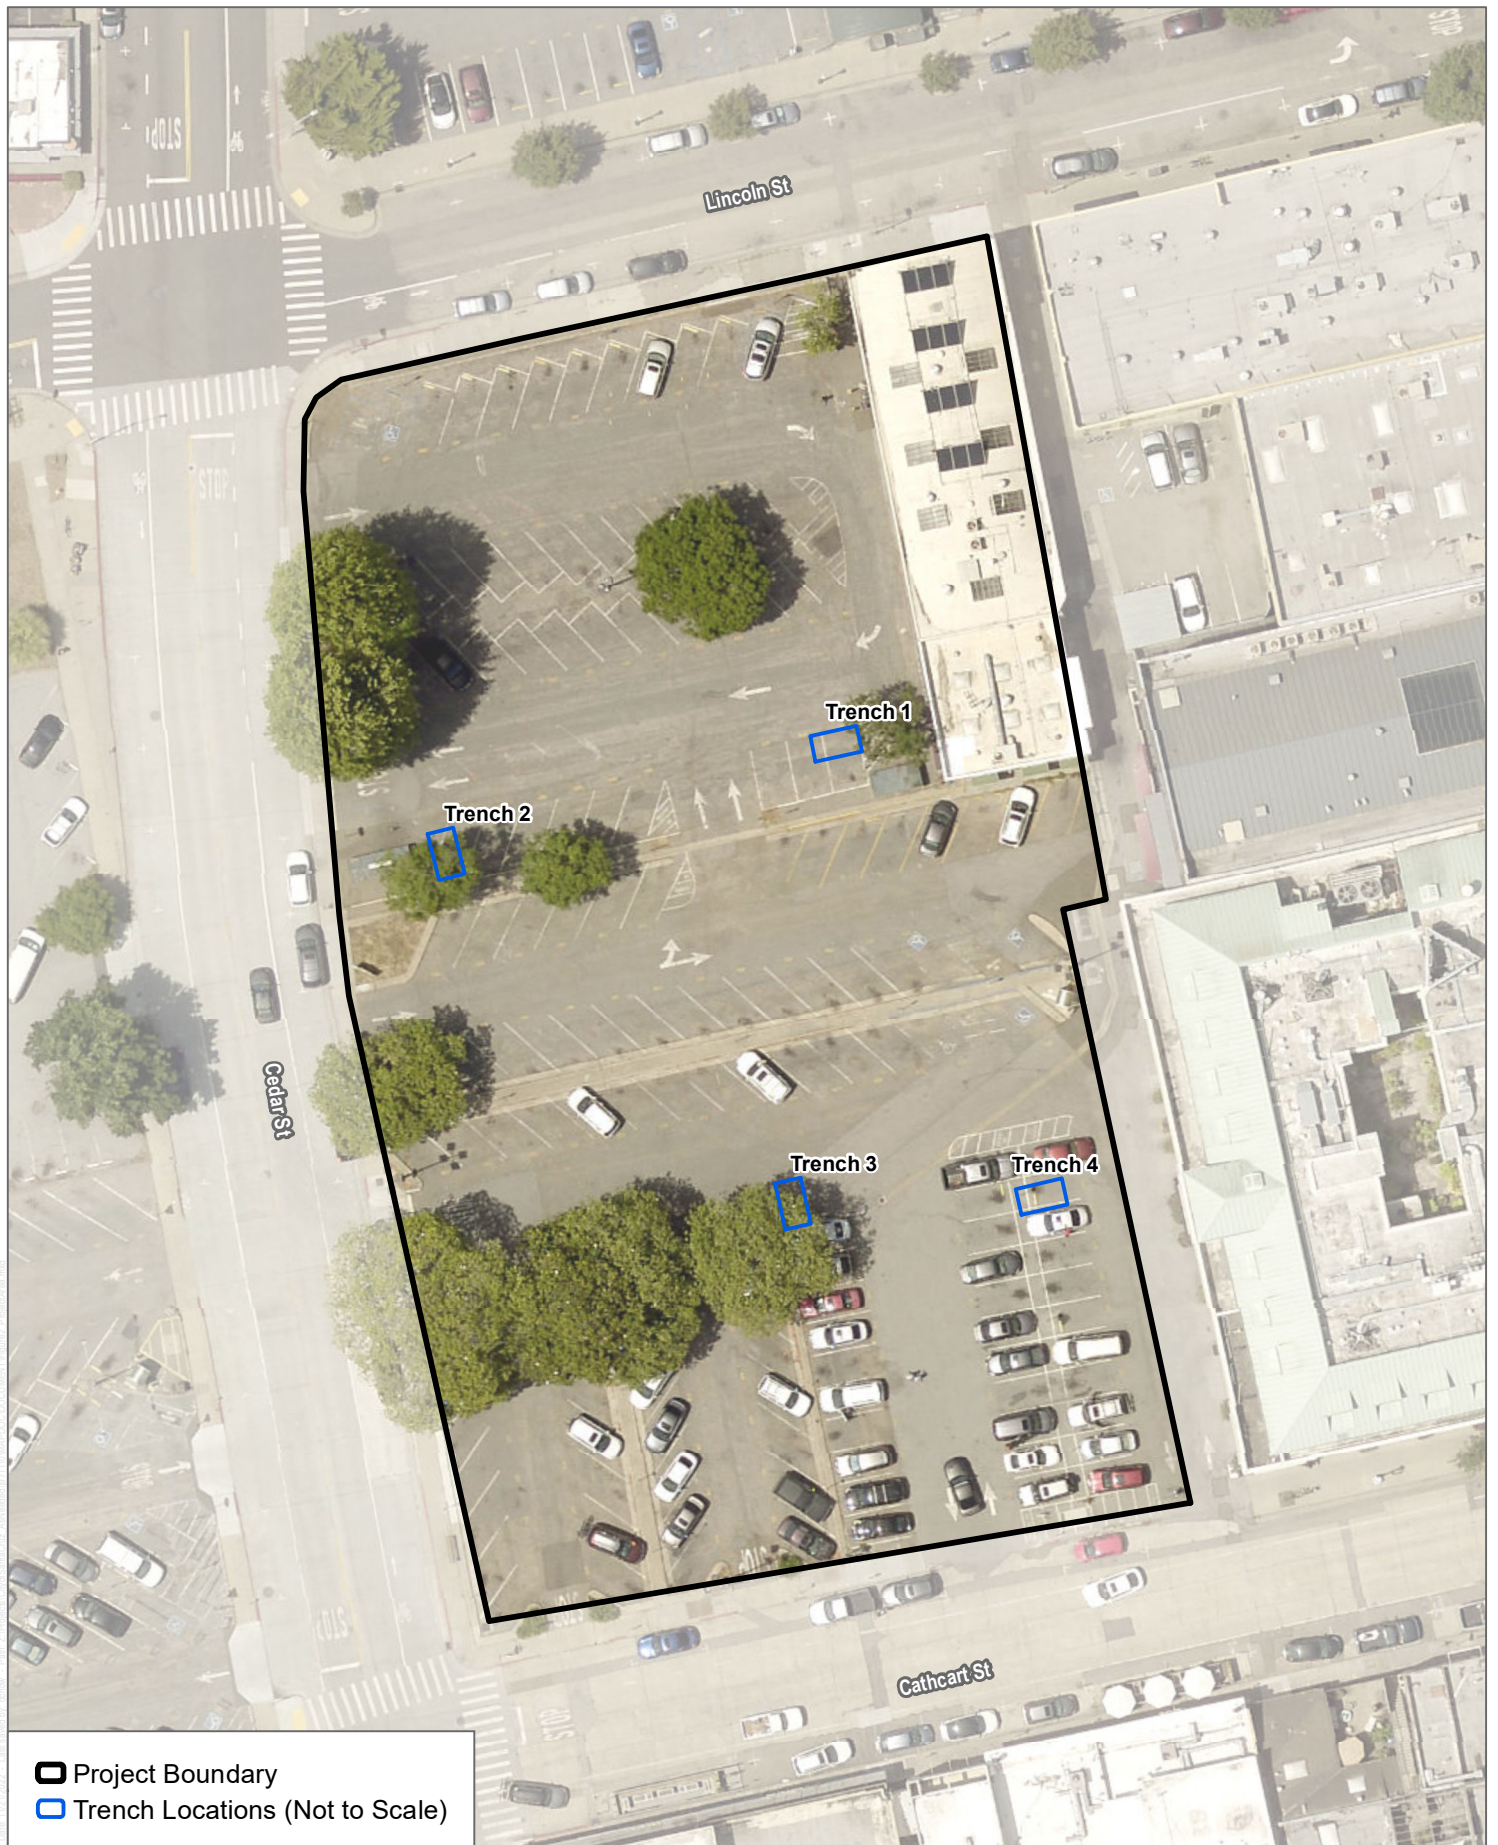
FIGURE 2

SOURCE: Digital Globe Imagery (accessed 2022), Open Street Map 2019

Augers were hand-excavated in arbitrary 1-foot levels from the lowest depth of each TT to a depth of 7.5 feet below ground surface (when possible), with the excavated matrix screened through 0.25-inch mesh. All excavated matrix was screened through 0.25-inch mesh. The locations of the four TTs are shown on an ariel photograph in Figure 2 and on the 1892 Sanborn Map in Figure 3 (see Section 2.3, Project Background).

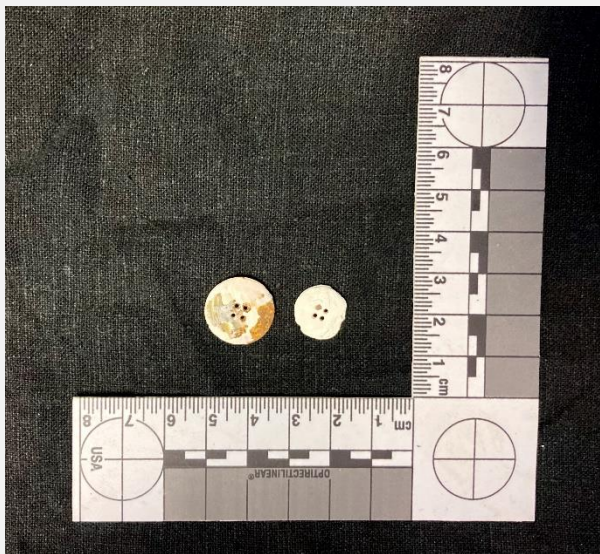
Photo 5. Cat # 123 consists of two degraded shell beads with 4 holes in the center recovered from TT 2 Feature 2. Buttons such as these were typical of men's shirts and were produced by hand and mechanically throughout the 19th century.

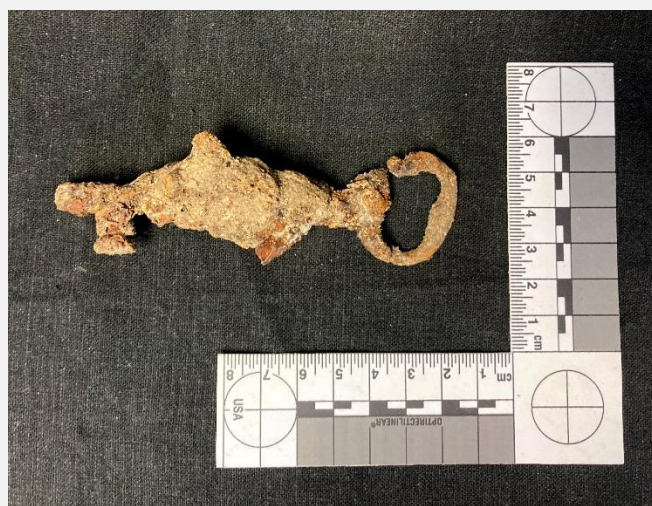
Photo 7. Cat # 131 is a barrel key with the bow broken off recovered from TT2 Feature 2. Barrel keys were similar to skeleton keys but lighter and hollow. This key was likely used in a door lock between the early to mid-1800s.

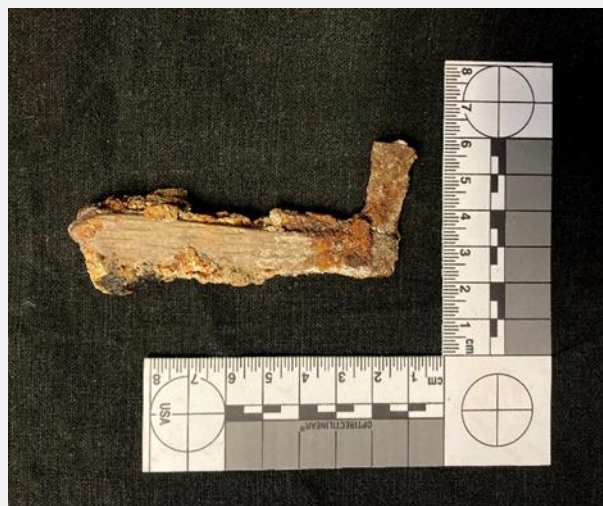
Photo 8. Cat # 131 is a pocketknife with the blade broken off recovered from TT2 Feature 2. This knife has faux-bone engraving on at least one side and was a common style between the 1850s through the early 1900s.

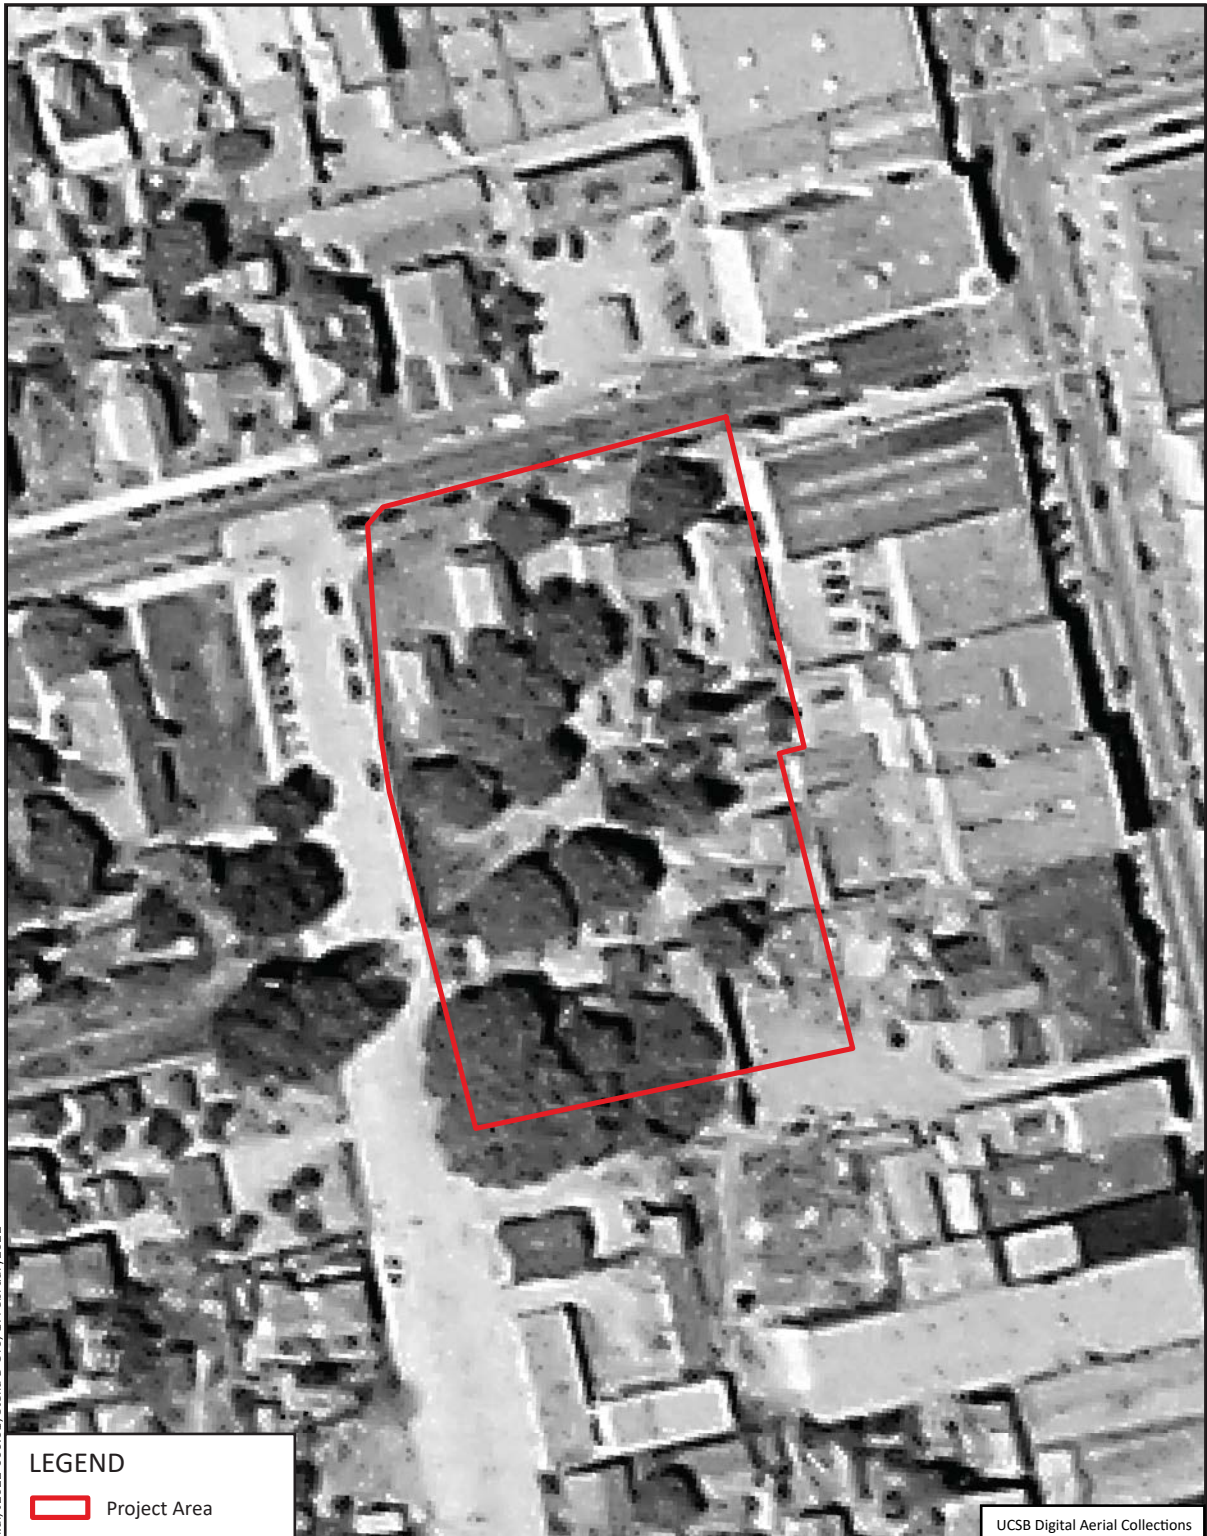
Figure 9. Detail of a 1940 aerial photograph with the Project Area.

An aerial photograph from 1940 shows the same configuration of structures as the 1915 Sanborn; however, there appears to be a structure in the lot south of 17 Lincoln Street. It should be noted that structures may be obscured by the presence of trees (Figure 9).

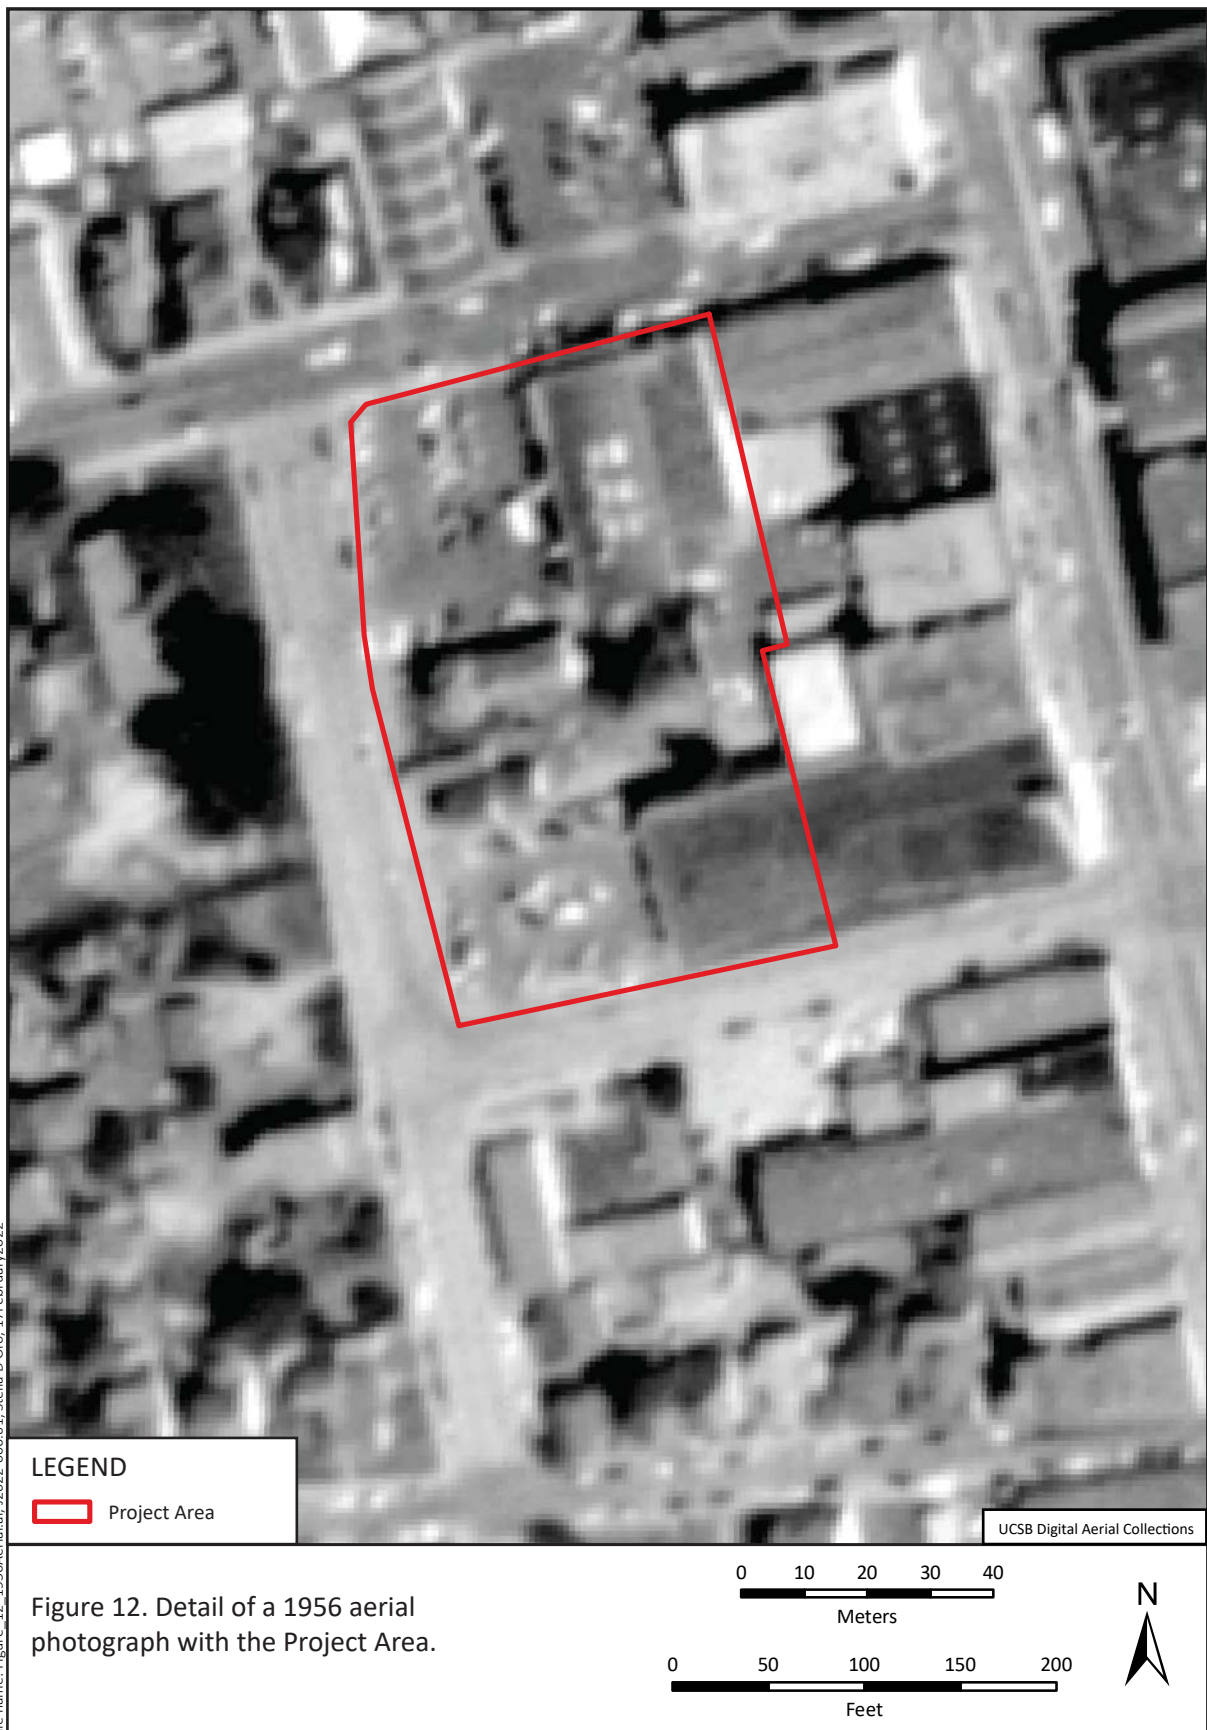
Figure 12. Detail of a 1956 aerial photograph with the Project Area.

An aerial photograph from 1956 indicates the dwellings on Lincoln Street have been replaced with a parking lot in the northwest portion, two large structures in the center, and the alley in the northeast corner of the Project Area. The dwelling at 11 Cedar Lane still appears to be standing, however, there is a larger structure to the north of it. The southwestern portion of the Project Area had become a parking lot and the southeastern portion of the Project Area is occupied by the rear half of a large structure (Figure 12).
