Downtown Library and Affordable Housing Project

Environmental Review - February 2023

Phase II Archaeological Testing and Evaluation Report

Downtown Library Mixed-Use Project Santa Cruz, California

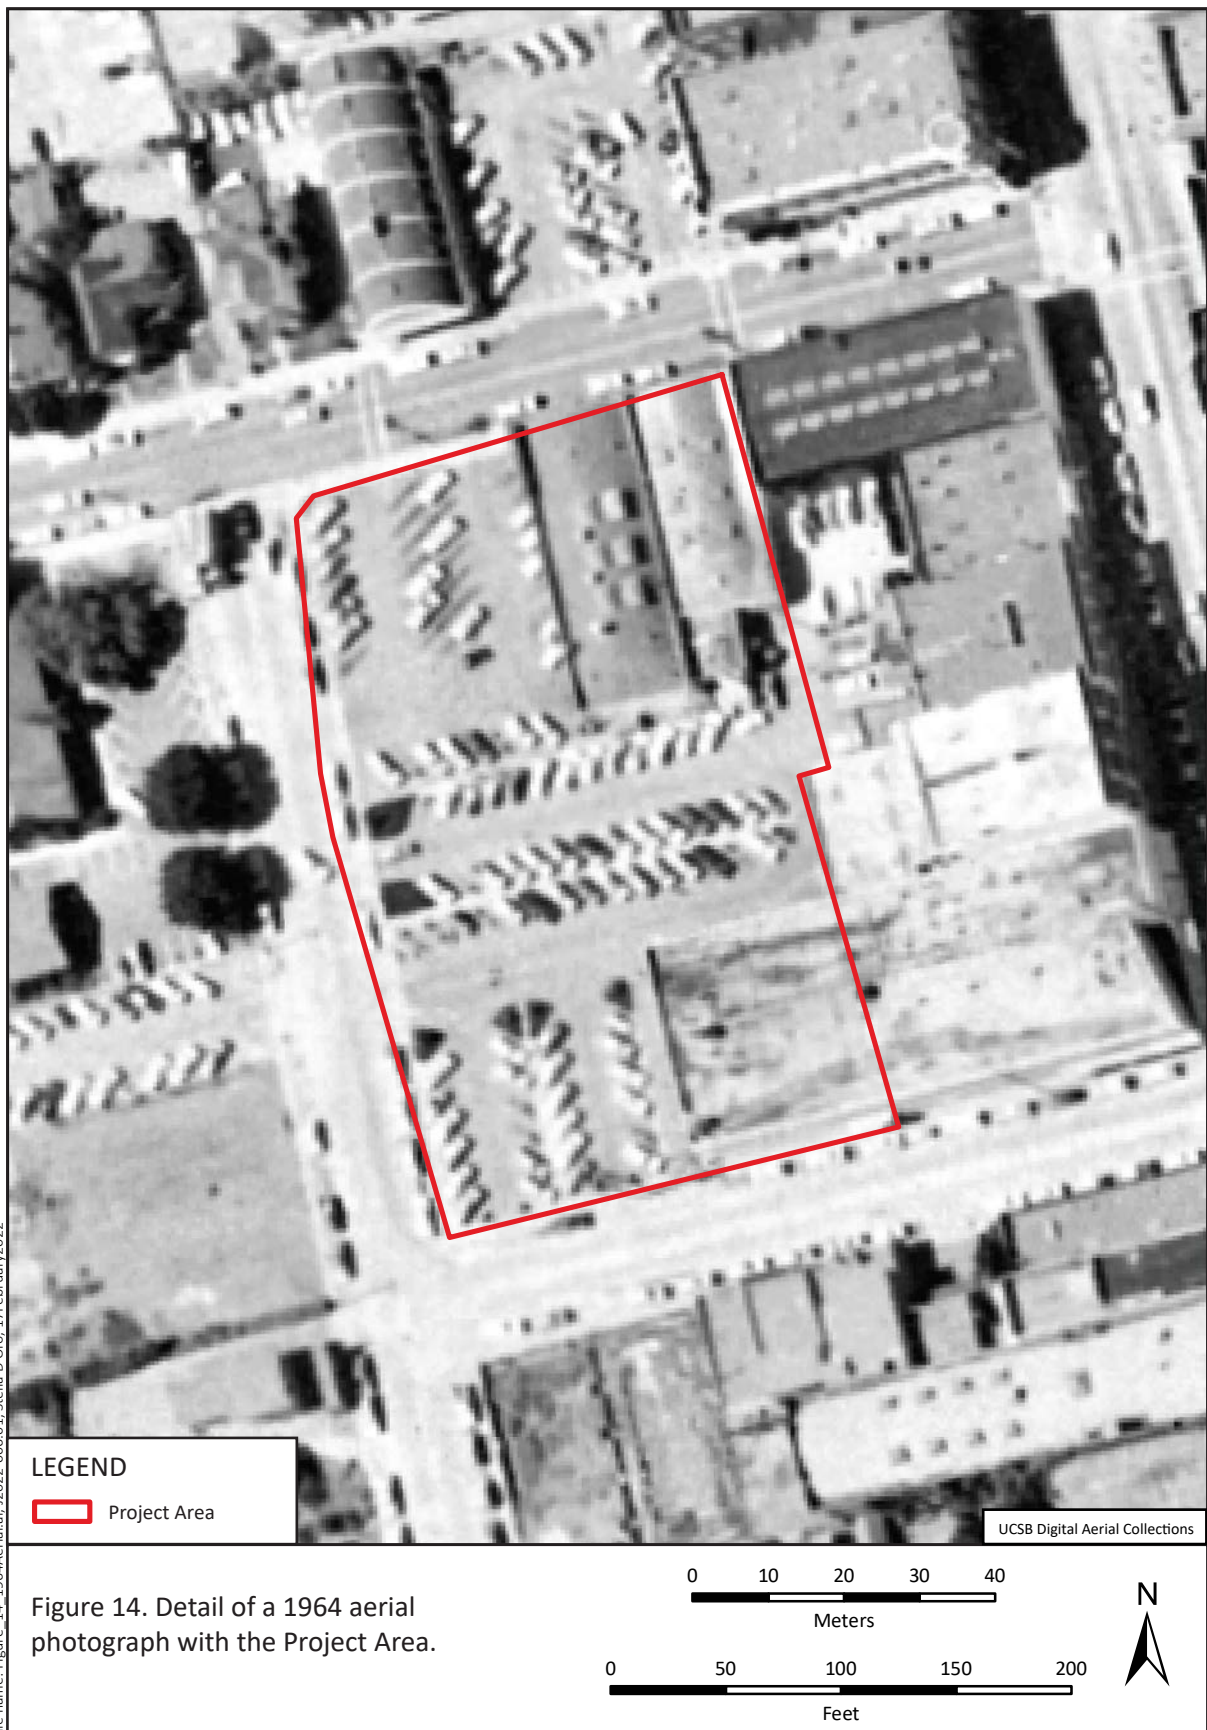
Figure 14. Detail of a 1964 aerial photograph with the Project Area.

An aerial photograph from 1964 shows the same configuration of structures as the 1957 Sanborn, except there are no longer any structures along Cedar Street. The entire Project Area had become a parking lot with the exception of the two stores and alley way along Lincoln Street and the mezzanine floor of the department store in the southeastern portion of the Project Area (Figure 14).
