# **Arana Gulch Habitat Management Plan City of Santa Cruz**

## **Year 3 (2016) Annual Report**

CDFW Permit No. 2081 (a)-13-013-RP  
Coastal Development Permit No. 3-11-074 (Arana Gulch)

*February 10, 2017*

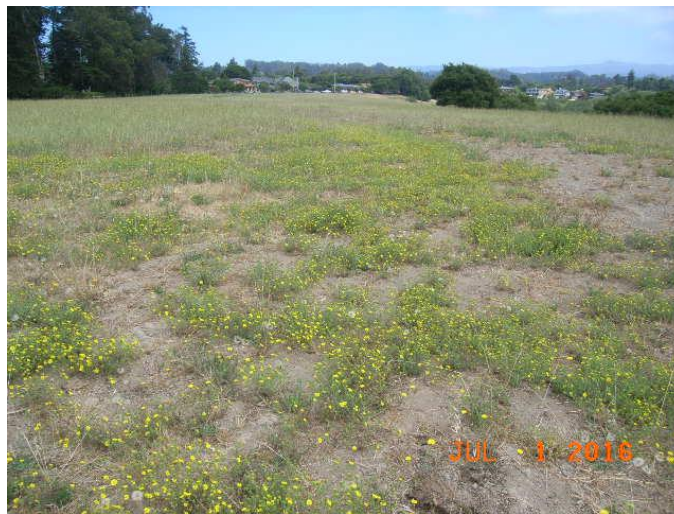
Areas subject to hydromulch and hydroseeding for erosion control as part of trail construction were observed in 2016. No erosion was noted in these areas and no additional seeding was conducted in 2016. An area with construction-related gravel was scraped in December 2016 to remove the gravel; the topsoil was retained and re-scattered in place. The location of the scraped area is depicted in **Figure 3**. **Figure 4** depicts the site after removal of the gravel. No other actions were done along the central construction access way in 2016.

**Figure 2. Condition of temporary construction access road, July 2016**

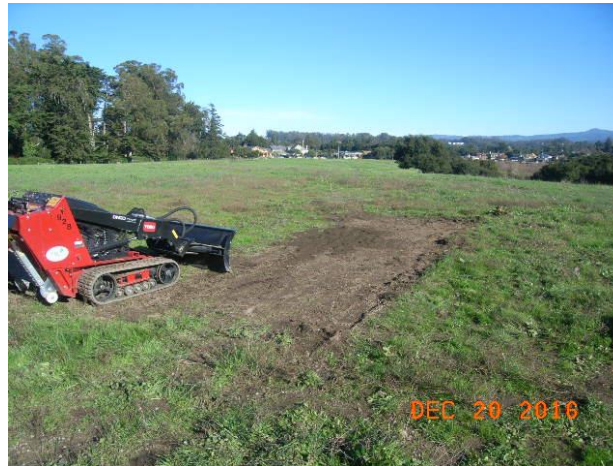
**Figure 4. Scraped area along temporary construction access road, December 2016**

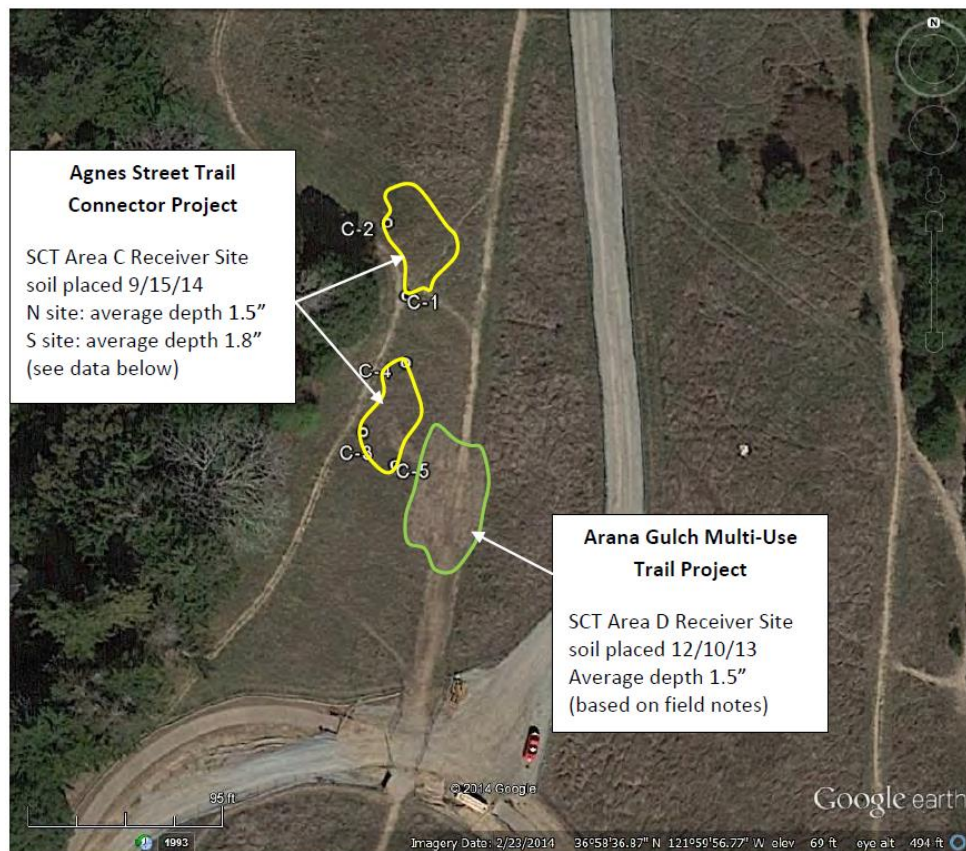
In 2016, native and non-native plants continued to establish at the Tarplant Area D receiver site, similar to site observations in 2015. Native species observed included coast tarweed (*Deinandra corymbosa*) and California poppy (*Eschscholzia californica*) as well as non-native species include hare barley (*Hordeum murinum ssp. leporinum*), oats (*Avena spp.*), wild lettuce (*Lactuca sp.*), cat's ear (*Hypochaeris sp.*), filaree (*Erodium sp.*), wild radish (*Raphanus sativus*), ryegrass (*Festuca perennis*), and ripgut brome (*Bromus diandrus*). No SCT was documented from this receiver site in 2016.

**Figure 6. Multi-Use trail soil receiver sites on aerial photo, 2013 and 2014**

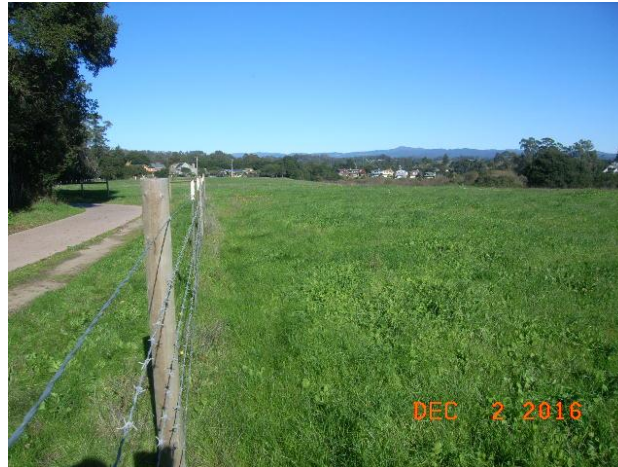
In July 2016, native and non-native plants were growing at the Tarplant Area C receiver site. Native species observed included coast tarweed (*Deinandra corymbosa*) and California poppy (*Eschscholzia californica*). Non-native species include hare barley (*Hordeum murinum* ssp. *leporinum*), oats (*Avena* spp.), cat's ear (*Hypochaeris* sp.), filaree (*Erodium* sp.), wild radish (*Raphanus sativus*), and ryegrass (*Festuca perennis*). No SCT was documented from the receiver site in 2016. The condition of this receiver site in 2016 is shown in **Figure 7**.

**Figure 7. Condition of soil receiver site adjacent to Tarplant Area C, November 2016**

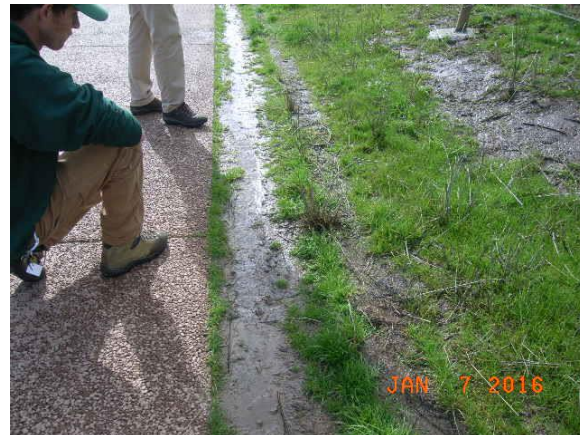
**Figure 9. Water collecting on upslope edge of east-west trail, January 2016**

Poor drainage along the edge of the east-west trail was observed in winter 2016. An AMWG member expressed concern that water was not passing under the trail, as designed, and water was prevented from reaching the downslope prairie (**Figure 9**). City staff installed a series of small gravel drains to enable water to penetrate the engineered drainage system under the pathway, as depicted in **Figure 10**. Staff believed that the clay content of the top soil was not allowing effective penetration to the drainage rocks beneath it. City staff monitored these areas during December and found that they were effective.

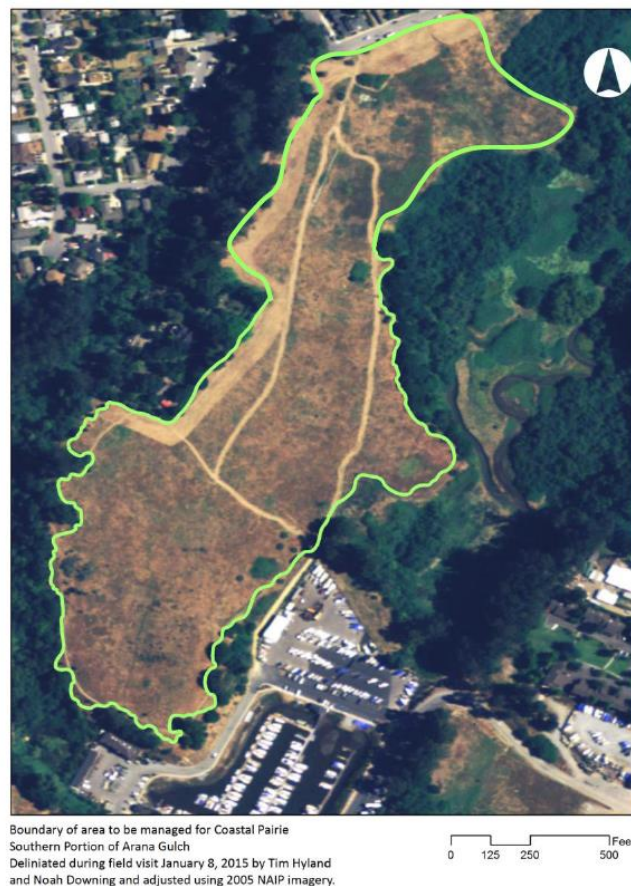
**Figure 13. Delineated grassland, April 2015**

Grassland mowing occurred outside the grazing fences within areas delineated to remain as grassland. The grassland area to be maintained includes all areas within the grazing fences and areas extending to the drip line of the adjacent woodland, as depicted in **Figure 13**. Perimeter fuel break mowing was also identified along the trails.

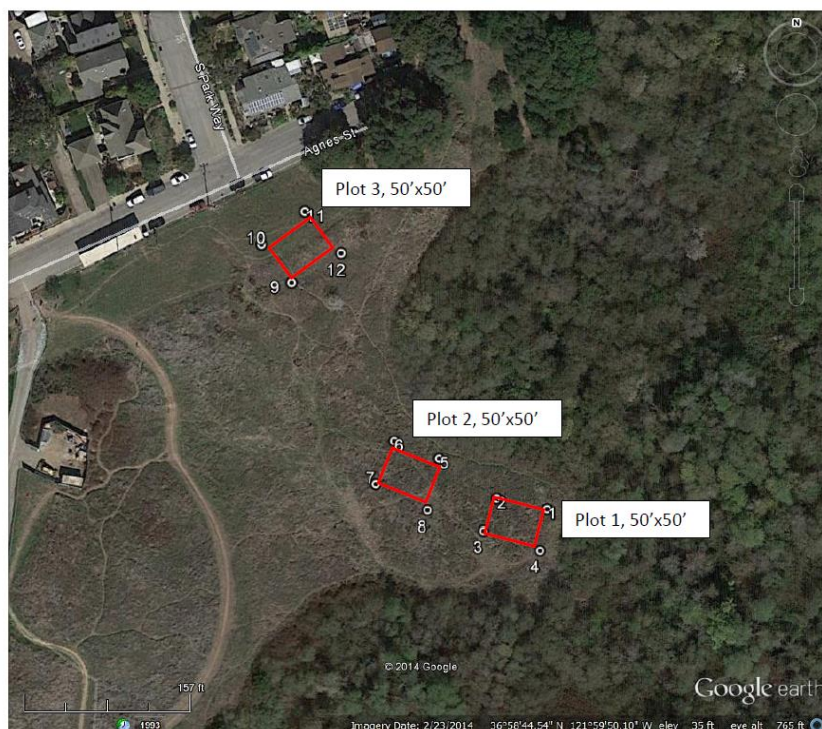
In 2014, the AMWG evaluated the northeast portion of the grassland (near Agnes Street) and whether this area should be retained in the delineated grassland. Three 50x50-foot scrape plots were created in 2014 to evaluate native plant recruitment. No native plant recruitment was noted in 2015. The AMWG will continue to monitor the scrape plots to see if any native plants grow before determining whether or not to keep this northeastern area as part of the coastal prairie. No additional vegetation sampling or scrape plots were recommended for this area. **Figure 15** shows the location of the scrape plots.

**Figure 15. Location of scrape plots created in October 2014**

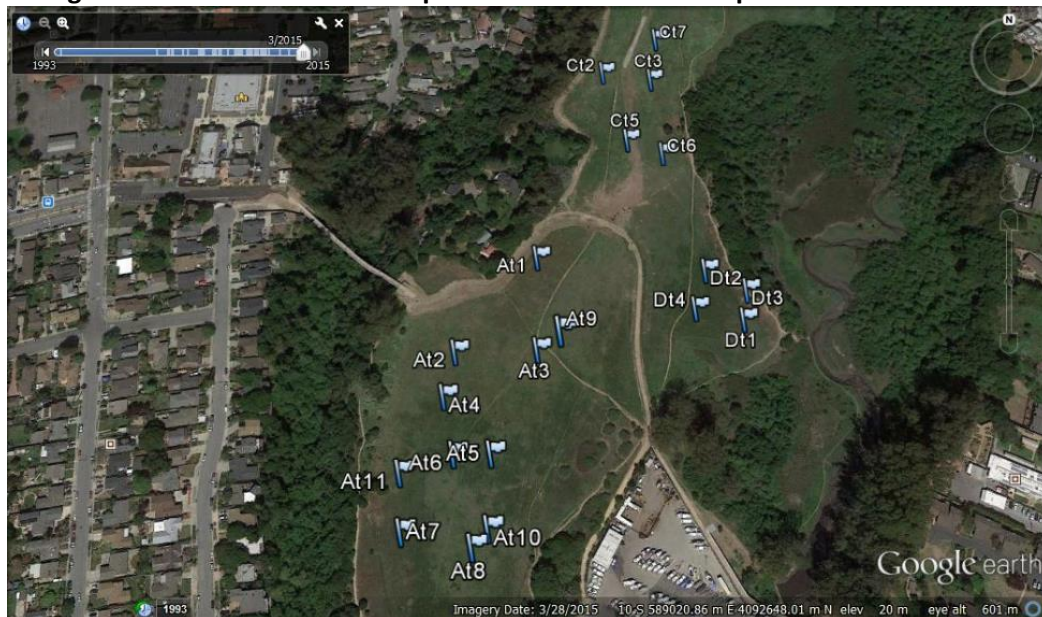
**Figure 17. Permanent transect placement on the coastal prairie at Arana Gulch.**

All of the rebar and caps were destroyed in a mowing on April 24, 2014. Therefore, it was necessary to re-install every vegetation transection in 2015 using the same GPS points and compass bearings. New rebar was required and the plastic caps were replaced with metal caps imprinted with “the City of Santa Cruz” on April 16-17, 2015. During the monitoring on April 26-27, 2016, some transects were missing rebar on one end and a few slight adjustments were made to alignments, but otherwise the transects were intact. **Figure 17** shows the locations of the 11 transects in Area A, 5 in Areas C, and 4 in Area D.

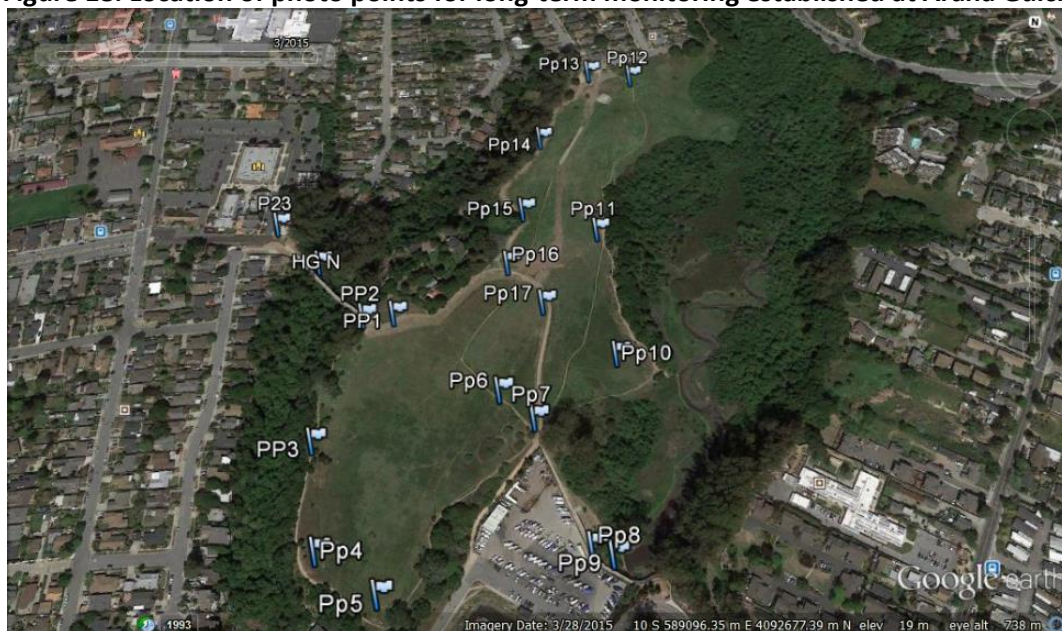
**Figure 18. Location of photo points for long-term monitoring established at Arana Gulch.**

**Photo Monitoring.** Photo points for long-term monitoring were established during the monitoring in April 2015. A total of 15 points were distributed throughout the coastal prairie with two additional points on the Arana Creek Causeway and two on Hagemann Bridge (**Figure 18**). All points were located at either an interpretative sign or a fence corner for easy reference. Four photos were taken per point in a clockwise order facing into the enclosure; Photo 1 looks straight ahead, Photo 2 is to the right, Photo 3 looks straight behind, and Photo 4 to the left. Using a compass and taking photos of the cardinal directions would have entailed an extra step and instead using the infrastructure as a point of reference made intuitive sense and was efficient. All photos were captured in about one hour when the sun was overhead. The two points taken on the causeway looking into Arana Creek included the

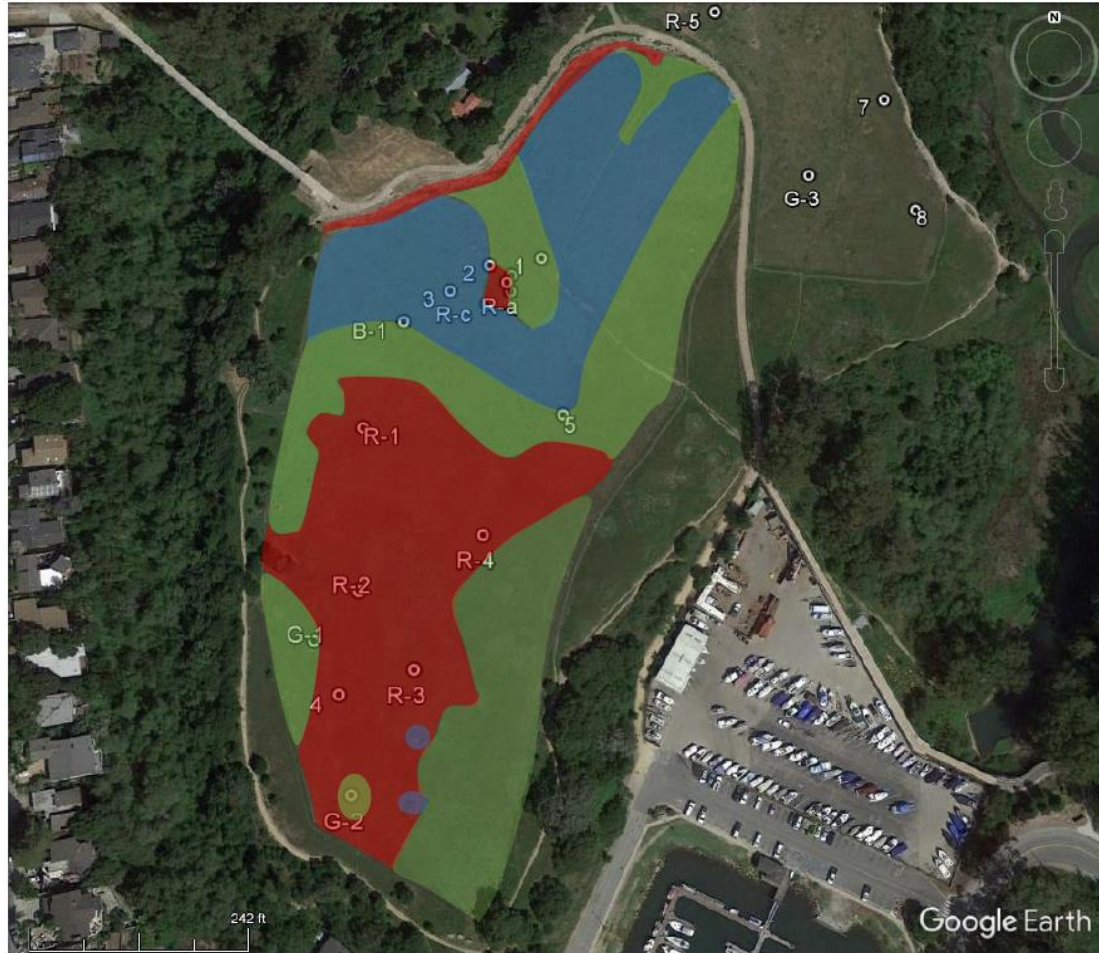
**Figure 28. RDM map for Grazing Area A, October 2016**

BLUE: Highest RDM (exceeds objective (>650 lbs./acre))  
GREEN: Middle RDM (meets objective (500-650 lbs. per acre))  
RED: Lowest RDM, below objective (<500 lbs./acre)

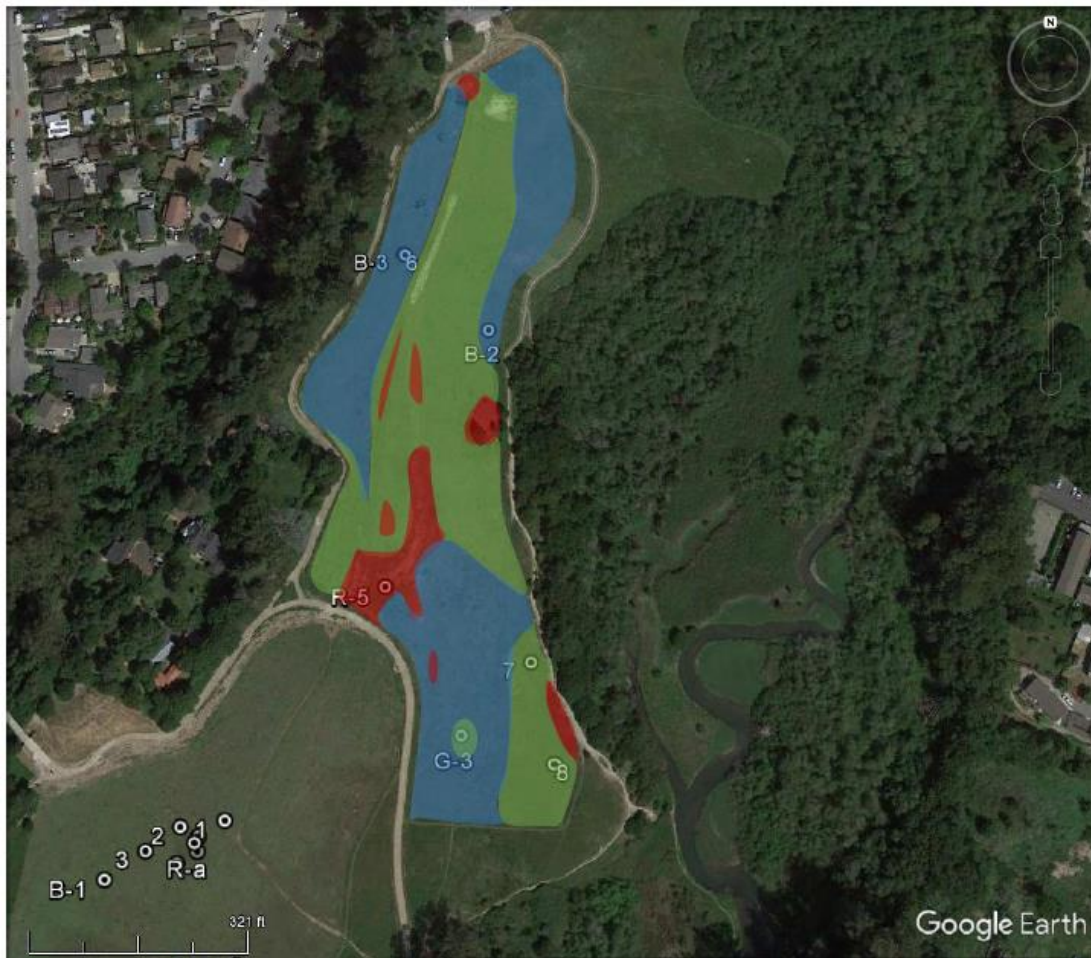
**Figure 29. RDM map for Grazing Areas C and D, October 2016**

BLUE: Highest RDM (exceeds objective (>650 lbs./acre))  
GREEN: Middle RDM (meets objective (500-650 lbs. per acre))  
RED: Lowest RDM, below objective (<500 lbs./acre)

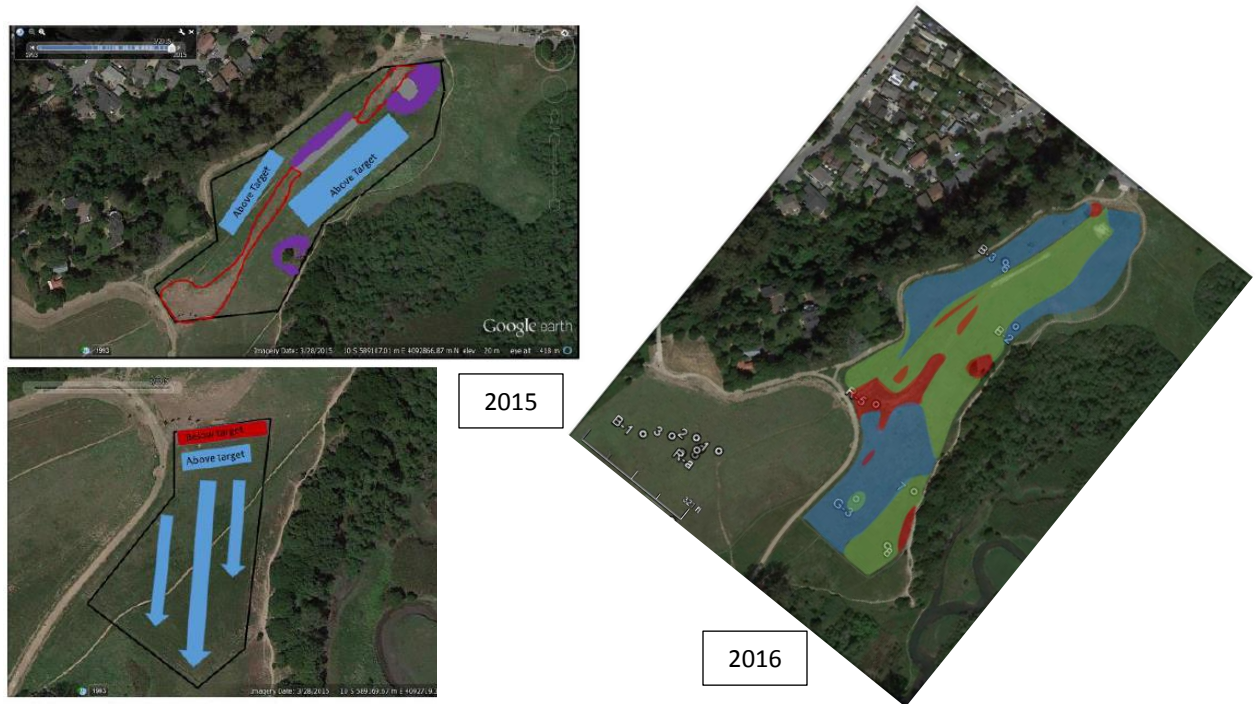
**Figure 34. Comparison of RDM for Areas C and D in 2015 and 2016**

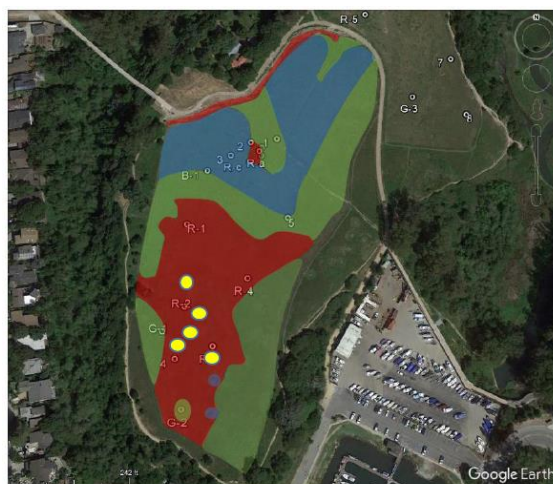
Areas of lowest RDM increased in Area A from 2015 to 2016. Red RDM levels were recorded in the central portion of the grazing area where cattle were encouraged to graze to benefit the SCT. More green RDM levels were recorded in Areas C and D in 2016 than in 2015, as a result of additional grazing in these Areas in 2016. Observations of SCT in 2016 were all found within areas mapped with the lowest RDM levels, as depicted in **Figure 35**.

**Figure 35. SCT patches (in yellow) depicted on RDM Map, Area A 2016**

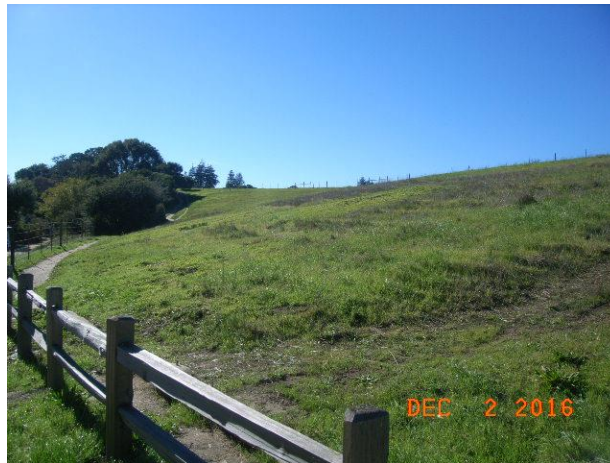
**Figure 36. Hillside after removal of cotoneaster, Himalaya blackberry, and English ivy, December 2016**

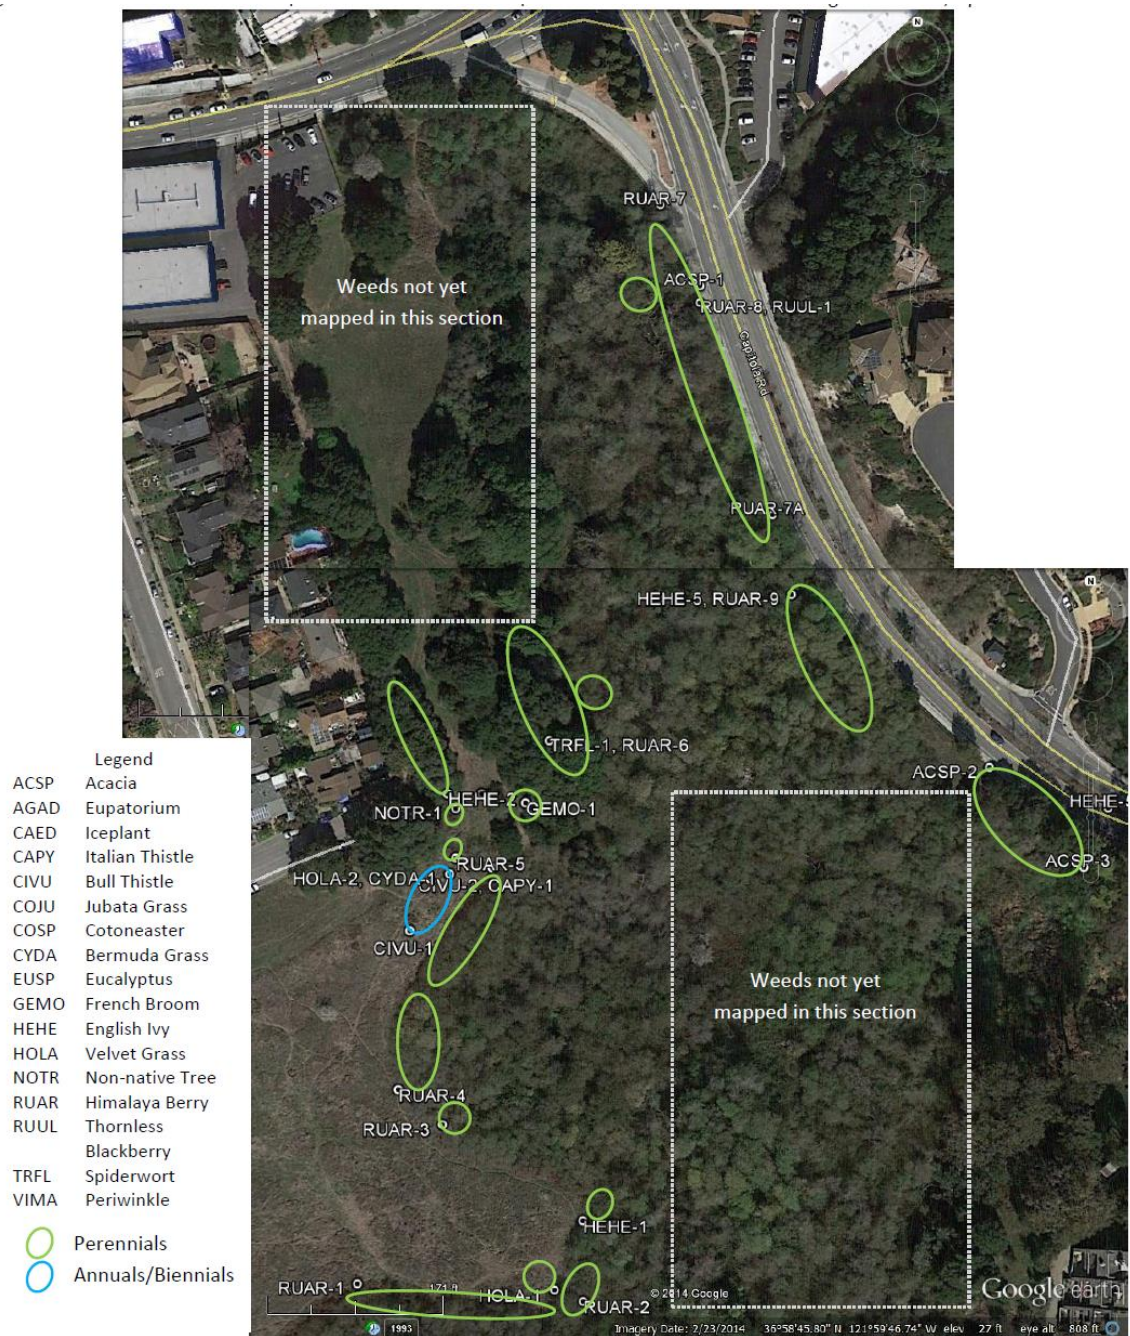
Arana Gulch Greenbelt – Location of Invasive Plant Species in Arana Creek Management Area  
April, 2015 - Sheet 1 of 4

**Figure 37A. Location of Invasive Plant Species within Arana Gulch Creek Riparian Woodland and Wetland Management Area, April 2015**
