# **2019 Wastewater Treatment Facility Annual Summary Report & Outfall Inspection Report**

## City of Santa Cruz Submarine Outfall Inspection Report

# 2019 Dye Study

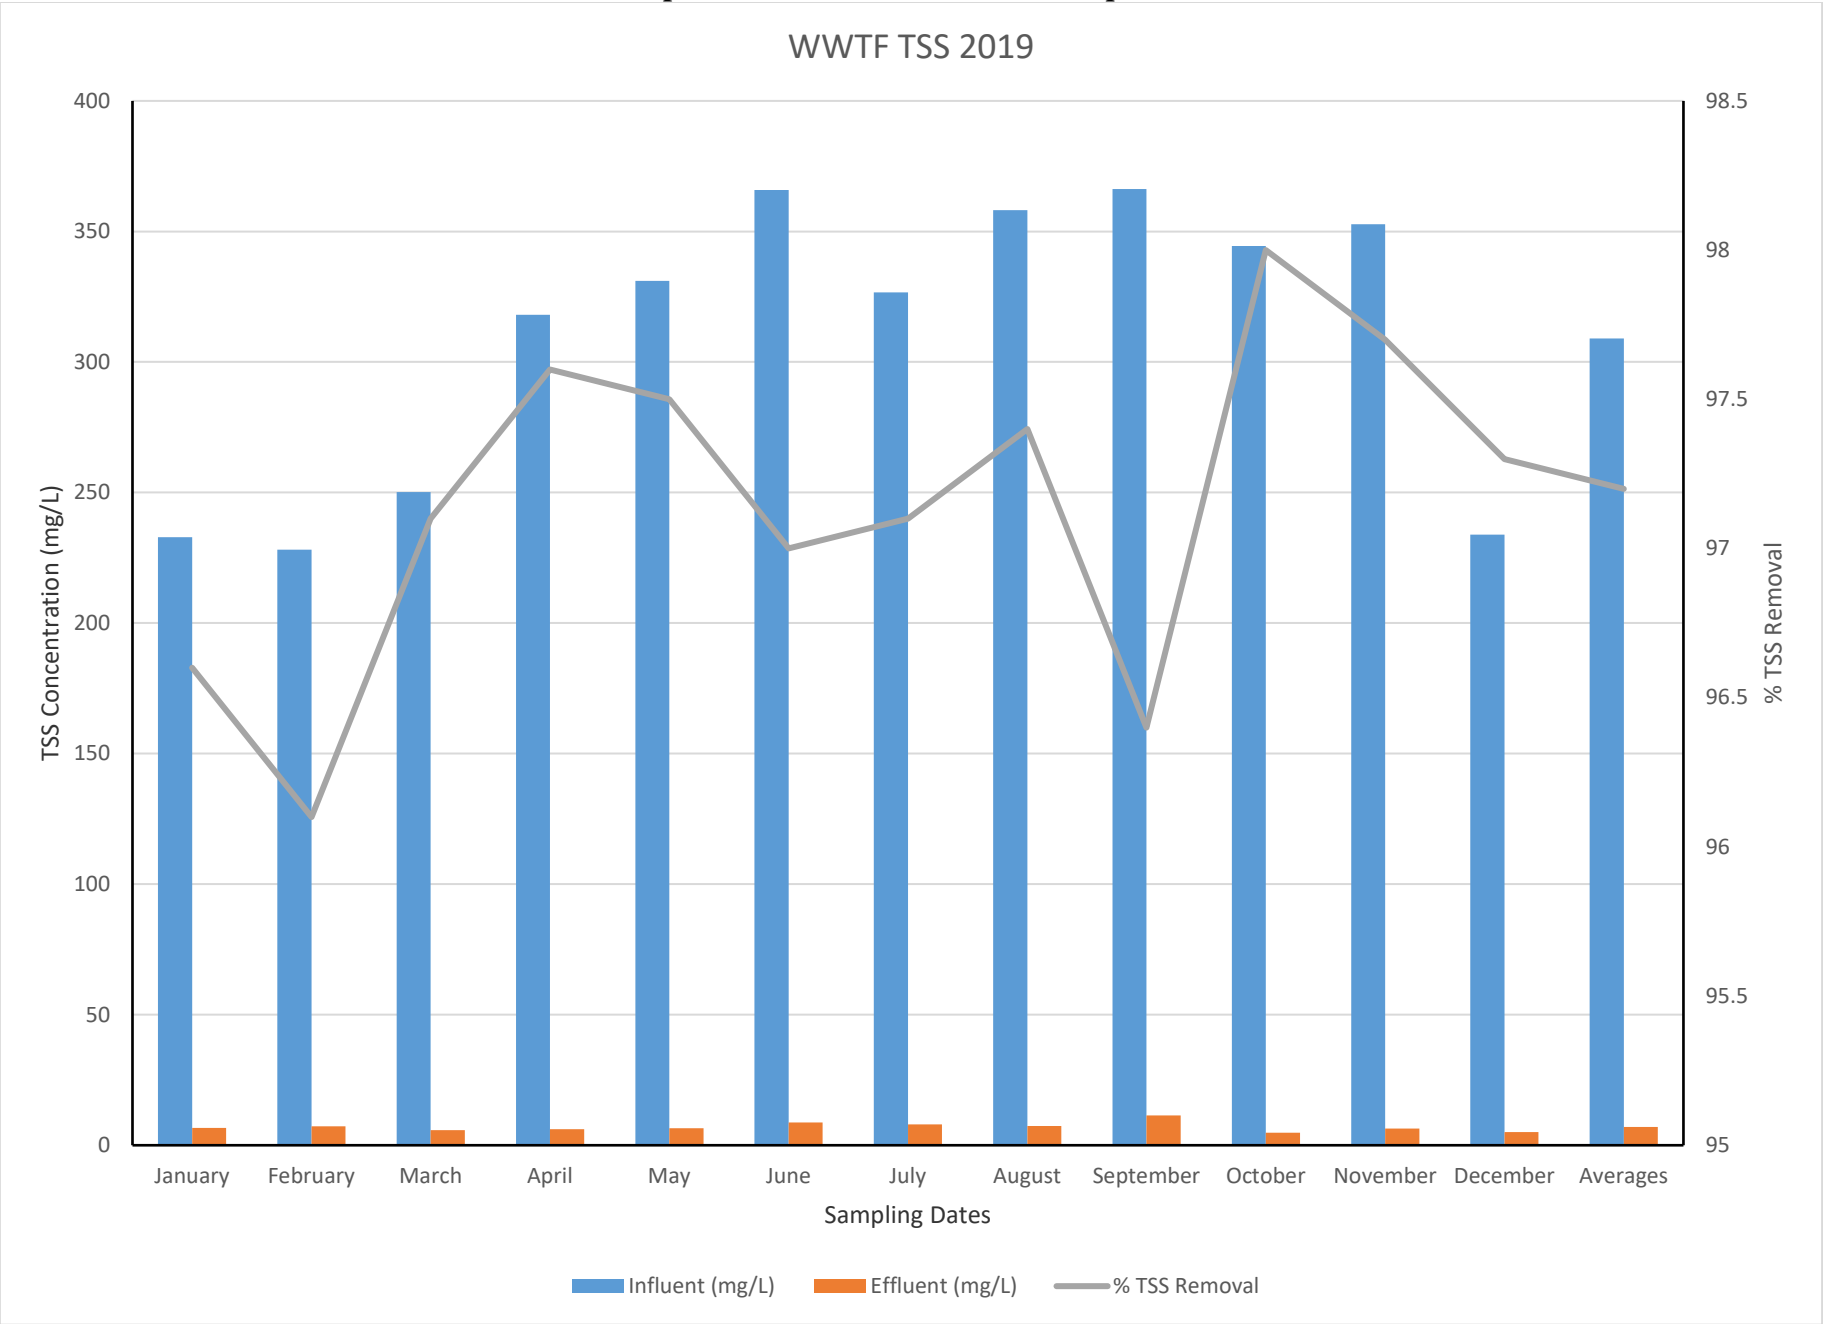
**Graph 1: WWTF TSS Treatment Graph 2019**

- Total Suspended Solids (TSS ) removal averaged 97.7 % throughout the year;
  - Final Effluent concentration averaged 7.0mg/L in 2019, with an
  - Average Influent intake concentration of 309.1mg/L.

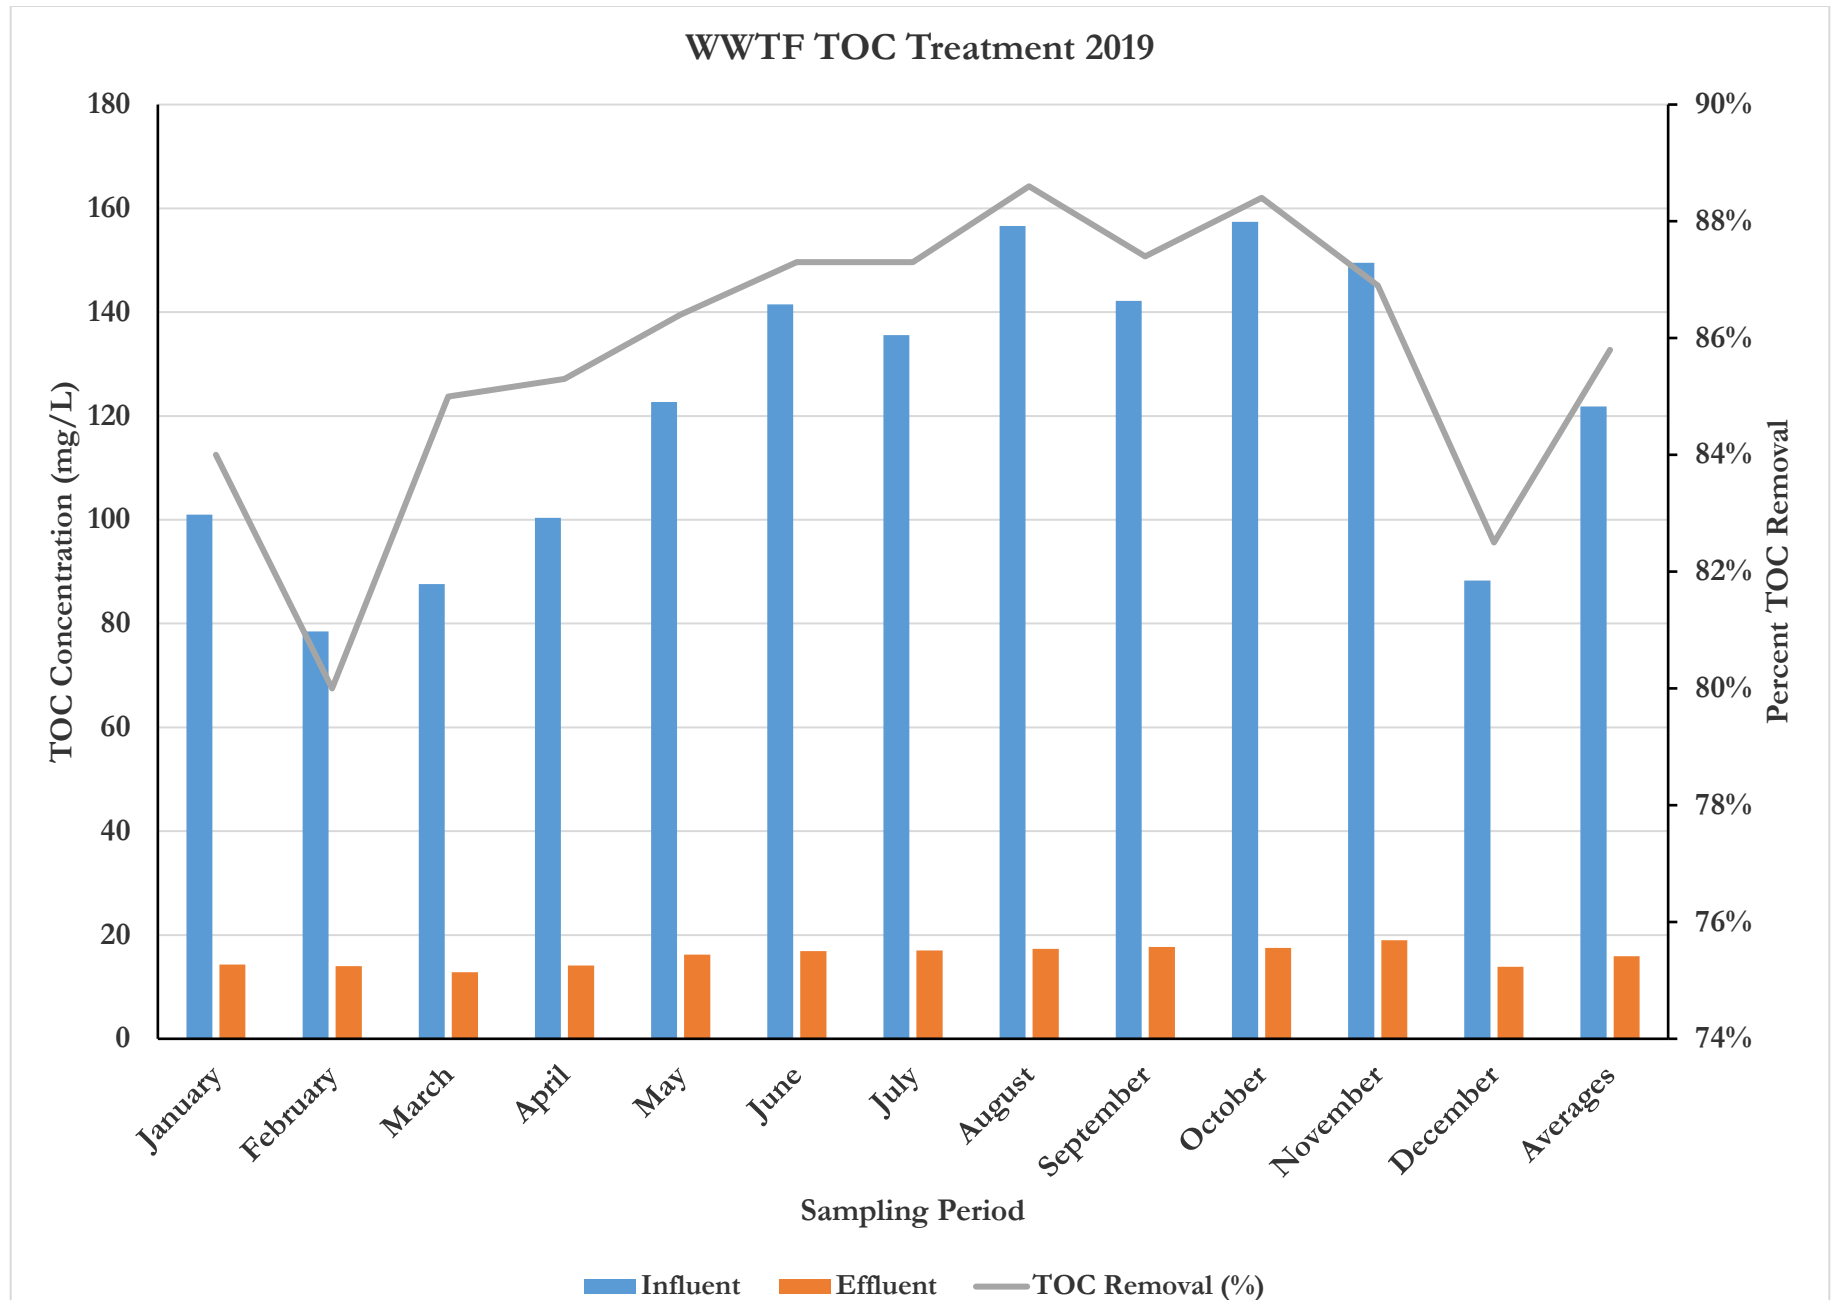
Graph 2: WWTF TOC Treatment Graph 2019

- Total Organic Carbon (TOC) removal averaged 88.8% throughout the year. The monthly average effluent concentration was 15.9mg/L.
- Metals removal was variable with a high efficiency greater than 90% for Aluminum and Copper and less than 10% for Boron and Potassium. Performance efficiencies in metals and metalloids are constrained by the paucity of data. They were measured twice only during the year.

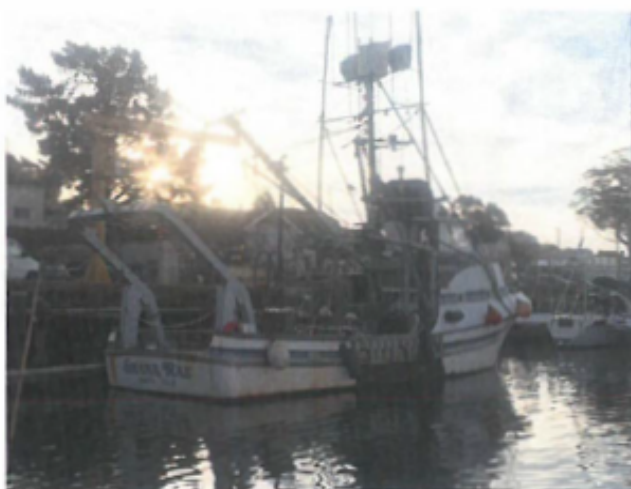
The inspection included a survey of the out of service, 2000 foot long, and 36 inch outfall. This open ended submarine outfall has no diffusers. Although a rip rap wall was located in an area with a barren sand bottom, at the coordinates provided, the outfall was never physically viewed.

ROV operations were conducted utilizing the local work vessel M/V Shanae Rae.

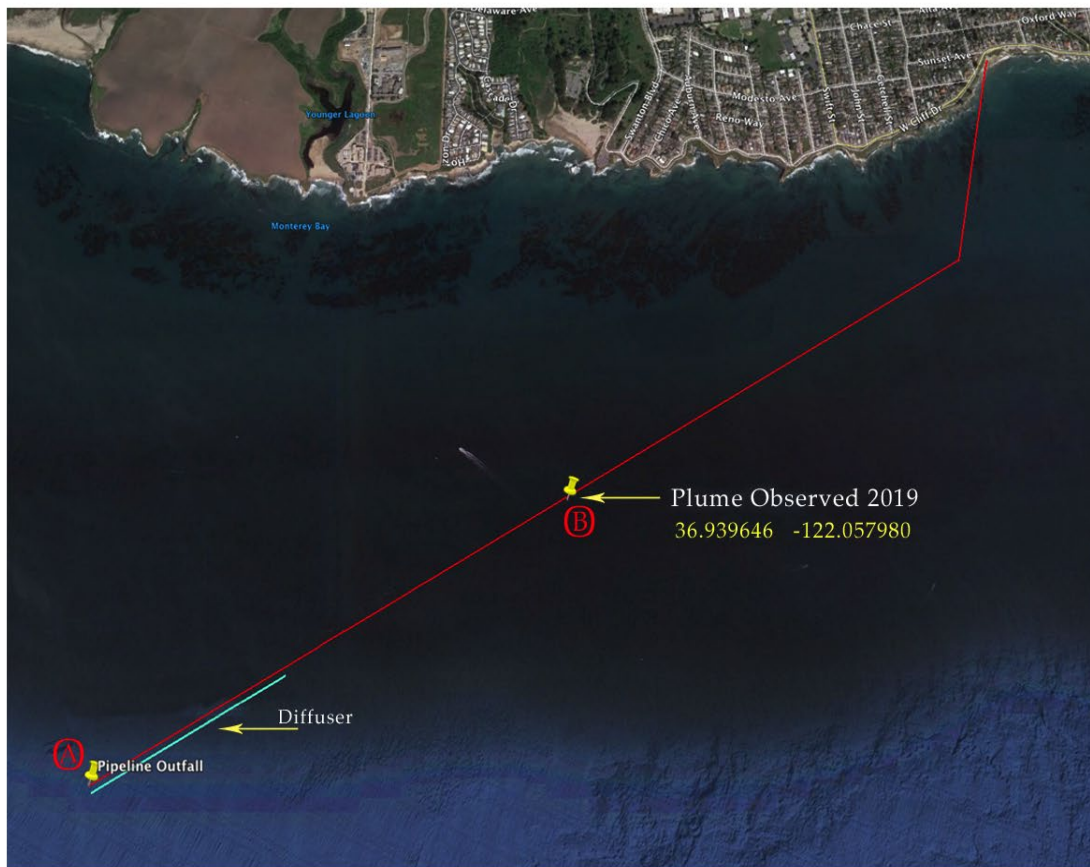
Figure 1

On Thursday, November 21, 2019 the City of Santa Cruz conducted a dye test of the Wastewater Treatment effluent ocean outfall to visually search for leaks. An overflight was performed between 11:50 & 12:35 pm using the aerial services of **Skywords Aerial Services**. An on-board standard global positioning system (GPS) was used for navigation and positioning.

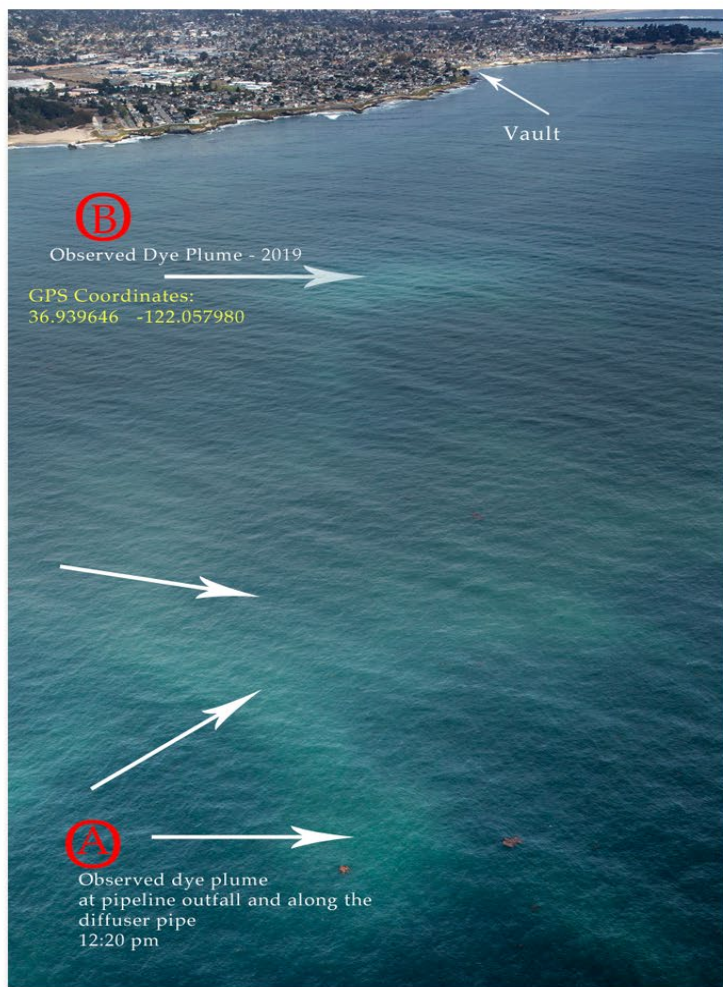
Continuous flight lines were flown and observations made along the pipeline from the vault to the outfall from 11:55 to 12:30pm. The dye dispersed rapidly along the diffuser line and exiting at the outfall end of the pipe. The dye plume was very quickly and broadly dispersed. An additional broadly dispersed plume was observed along the pipeline depicted in Figures 2&3 at point B. No other dye was observed along the length of the pipeline during the course of the flight.

**Figure 2** - At 12:20 a broadly dispersed dye plume was seen emanating from the pipeline along the diffuser pipe and at the outfall location A. A plume is also visible at location B-GPS coordinates of 36.939646 / -122.057980.

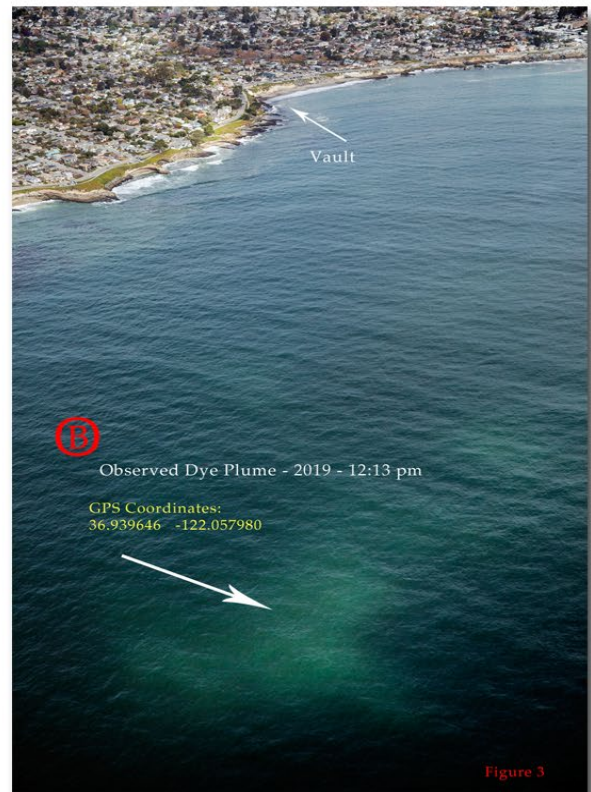
Figure 3

**Figure 3** - At 12:13 the dye was observed at location B from a closer viewpoint.
