ARBORIST REPORT-

Tree Inventory & Preliminary Construction Impacts for:

Ocean Place — Ocean/Hubbard Streets & May Avenue APN Numbers: 008-331-03 & 04,05,06,07,08,12,13,14,15,25,26,27,28,29,30,31,32,35,41 Santa Cruz, CA 95060 May 15,2020

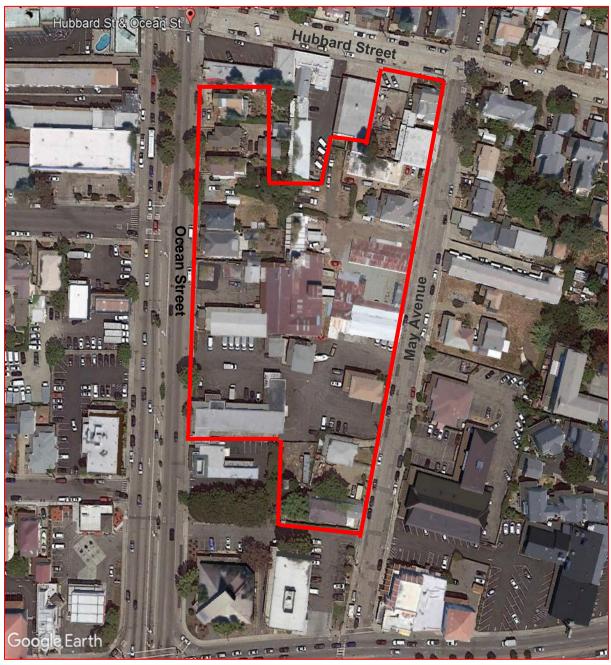
Image #1 - Project site.

Several residential and commercial properties comprise the proposed project site, fronting the streets of Ocean, May and Hubbard (Image #1).
