LONG-RANGE PROPERTY MANAGEMENT PLAN CHECKLIST

Agency Name: **City of Santa Cruz Successor Agency**

1124 Pacific Avenue
Santa Cruz, California

Vicinity Map
Phase I/II Environmental Site Assessment
Former Del Mar Theatre
1124 Pacific Avenue
Santa Cruz, California

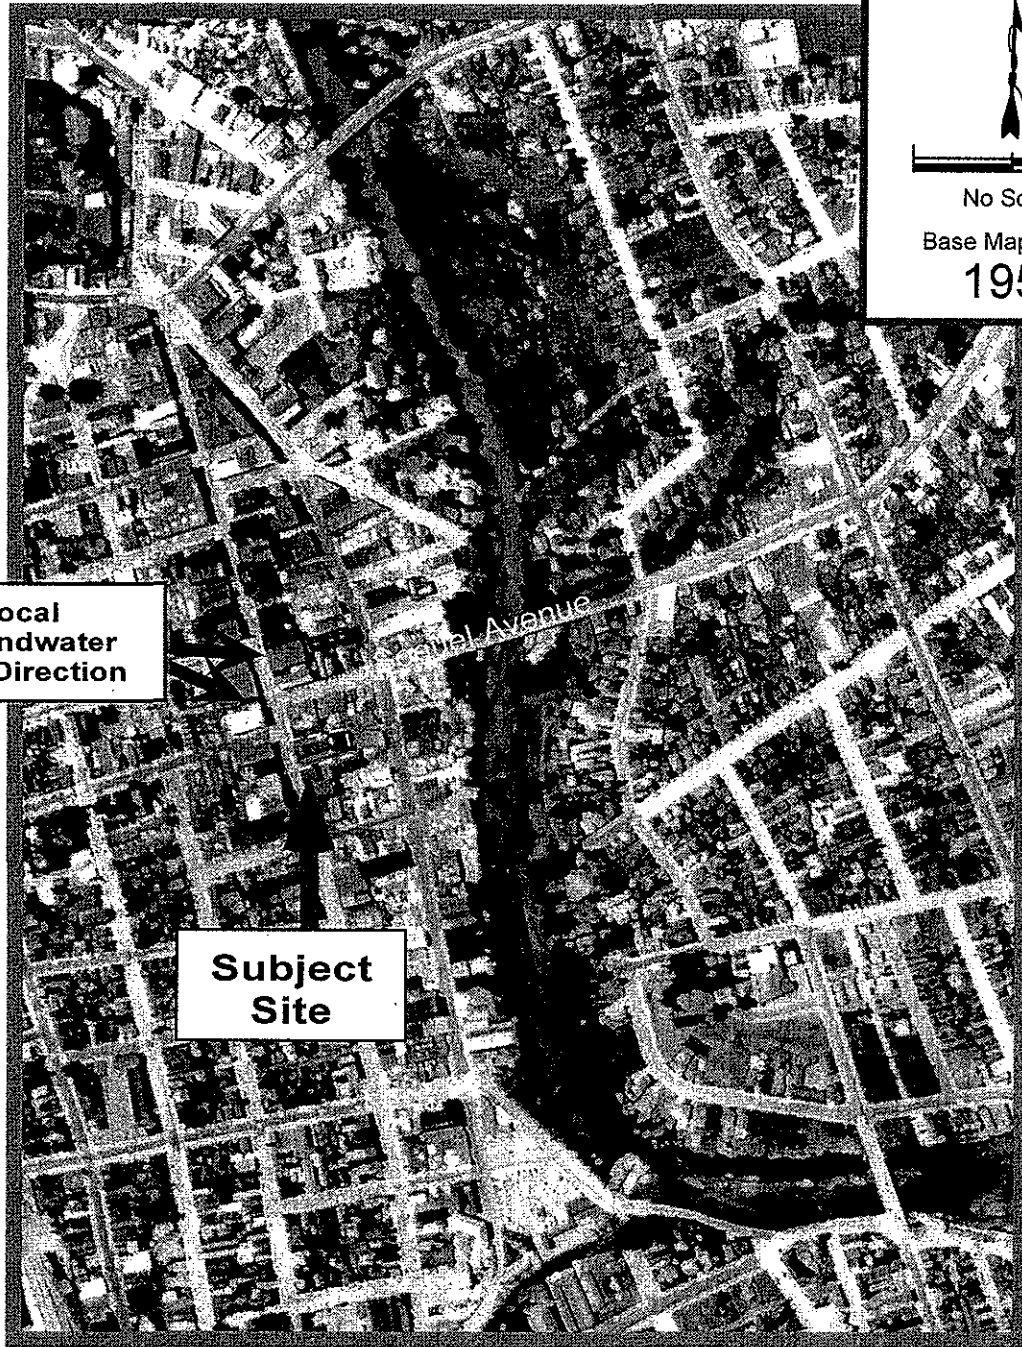
No Scale
Base Map Dated
1957

- Historical insurance maps indicate the subject site previously contained a dry cleaner and laundry service (maps dated 1905 and 1920, see Figure 3). These maps show the back portion of the parcel (southeast corner) to contain fuel oil-boilers, aboveground tanks, and "oil tanks in ground".
- Two, capped 2½-inch diameter pipes were observed adjacent to the furnace in the basement of the Del Mar Theater. The pipes appeared suspiciously like discontinued, fuel product piping for the nearby furnace. There was no apparent petroleum hydrocarbon staining or residue inside the pipes but there was a slight fuel oil odor. The subsurface pipes appeared to turn under the slab and exit out the back end of building.

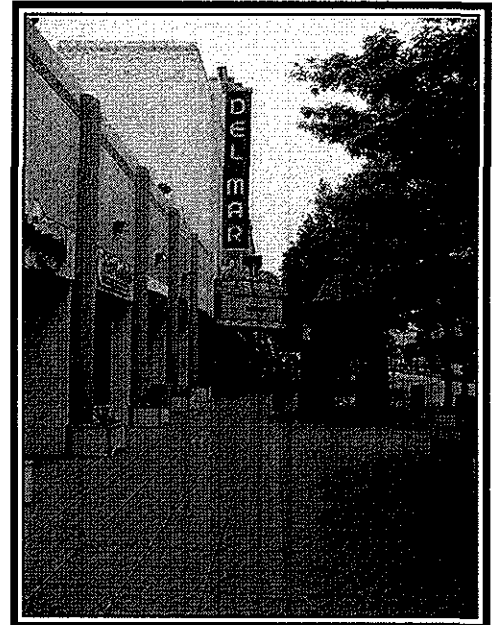
Del Mar Theater, Pacific Avenue

- ▶ # of buildings + size/age/condition, occupants/vacancies & nature of business: *The site contains a single structure, the Del Mar Theater, which is located along the main business thoroughfare for downtown Santa Cruz. The concrete-constructed Del Mar Theater building footprint is approximately 160'x 75' in size and has primarily been used as a movie house (currently vacant). The structure also contains individual shop spaces having frontage along Pacific Avenue. The shop spaces are used for an import shop (#1120), a gift shop (#1122) and an tourist information center (#1126).*

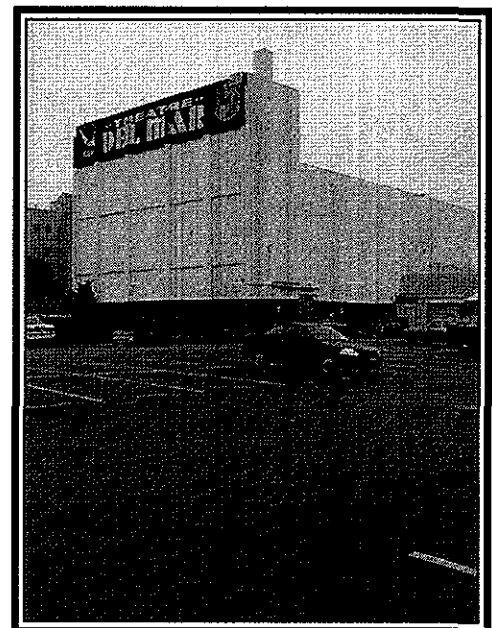
Del Mar Theater, rear view

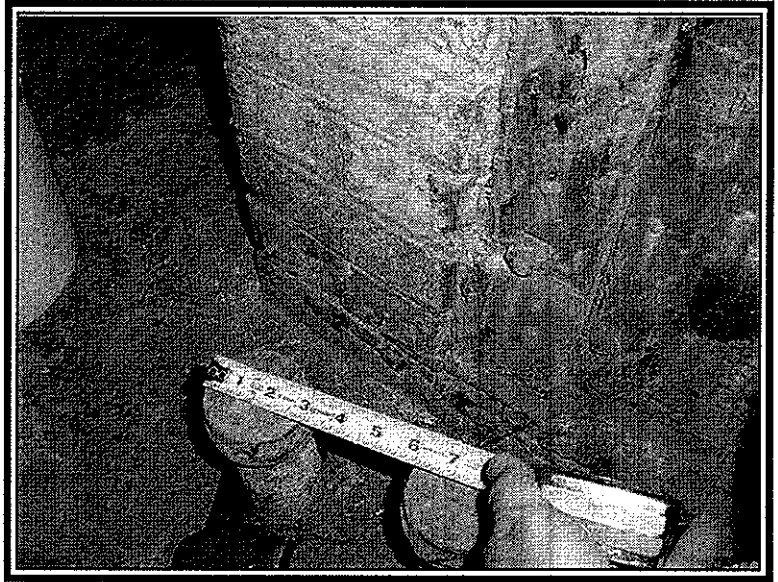
- ▶ Exterior surface coverings?
Yes No
Concreted walkways and asphalt parking lot.
- ▶ Paving patches/staining?
Yes No
- ▶ Manholes/utility covers? (Describe) Yes No
Utility vaults (PG&E).
- ▶ Any Stacks visible on roof? Yes No
- ▶ Mounds or depressions? Yes No
- ▶ Do surface water catch basins drain? Yes No
Apparently; no ponded water noted.
- ▶ Any ditches or drainages? Yes No

Typical concrete walkways and surface drains.

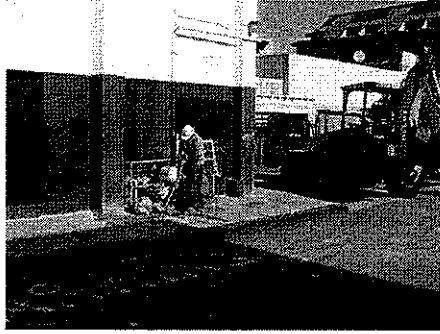
Del Mar - Check for Heating Oil Tank

1-Sawcut.JPG

2-Concrete Removal.JPG

3-Gas Line.jpg

4-Dig Out to 12'.JPG

5-Excavation Limits.JPG

8.12 Backhoe Trenching: On May 23, 2001, a backhoe was used to search for a suspected fuel oil storage tank by potholing a 12-foot deep exploratory trench adjacent to the furnace room. The earthwork was conducted by an excavation contractor certified to work with hazardous materials (Portico, Inc. of Aptos). Careful inspection revealed no evidence of an underground tank, product piping, or contamination. The excavated hole was backfilled, compacted and the cement sidewalk replaced.
